MONONAME 819 DAM  
CAPE GIRARDEAU COUNTY, MISSOURI

MISSOURI INVENTORY NO. 30211

PHASE I INSPECTION REPORT  
NATIONAL DAM SAFETY PROGRAM

PHASE I INSPECTION REPORT  
NATIONAL DAM SAFETY PROGRAM  
MONONAME 819 DAM - ID NO. 30211

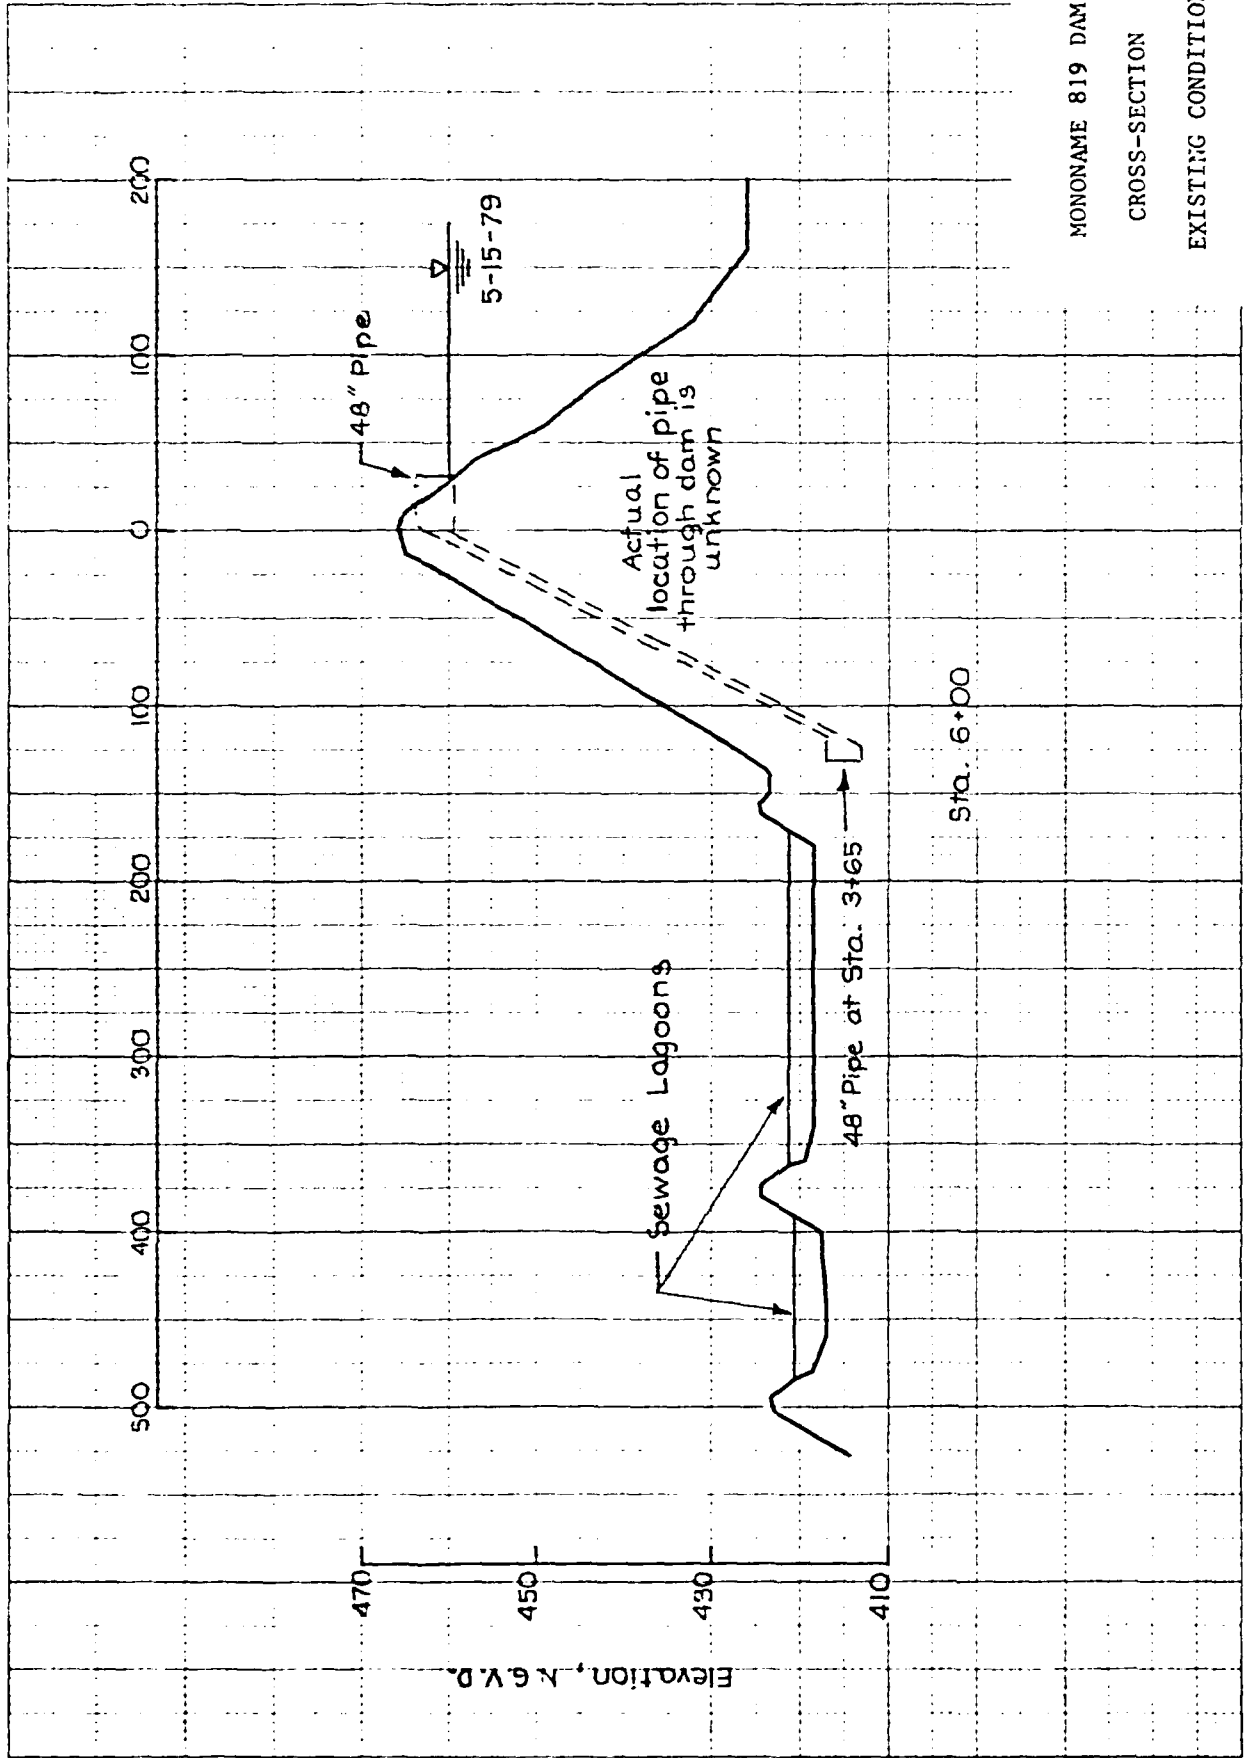
PLATE 4

b. Dam. No detrimental settlement, cracking, slides, or animal burrows were observed in or near the earth embankment (see Photo 1). A typical existing cross-section of the embankment is shown on Plate 4. A dam plan view is shown on Plate 3. The existing upstream slope is 1V on 3.42H, and the existing downstream slope is 1V on 3.05H. The crest width was measured to be approximately 25 feet.
