WILDWOOD DAM
JACKSON COUNTY, MISSOURI
MO 20045

PHASE 1 INSPECTION REPORT NATIONAL DAM SAFETY PROGRAM

WILDWOOD LAKE DAM
JACKSON COUNTY, MISSOURI
MISSOURI INVENTORY NO. 20045

PREPARED BY:
BLACK & VEATCH
CONSULTING ENGINEERS
KANSAS CITY, MISSOURI

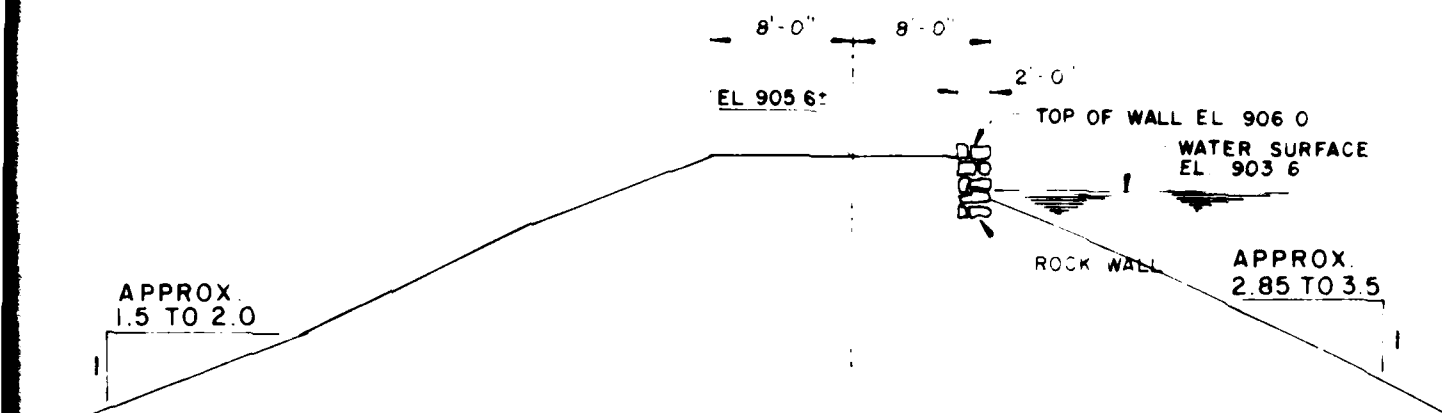
WILDWOOD LAKE
CROSS SECTION

- (1) Type - earth embankment
- (2) Length - 540 feet
- (3) Height - 30 feet \pm
- (4) Top width - 16 feet
- (5) Side Slopes - varies approximate 1.5 to 2.0H to 1V down stream
slope 2.85 to 3.5 H to 1V upstream slope (see Plate 4)
- (6) Zoning - (unknown)
- (7) Impervious Core - (unknown)
- (8) Cutoff - Core trench (unknown)
