WEATHERBY DAM
PLATTE COUNTY, MISSOURI
MO. 10690

PHASE 1 INSPECTION REPORT NATIONAL DAM SAFETY PROGRAM

SEPTEMBER 1978

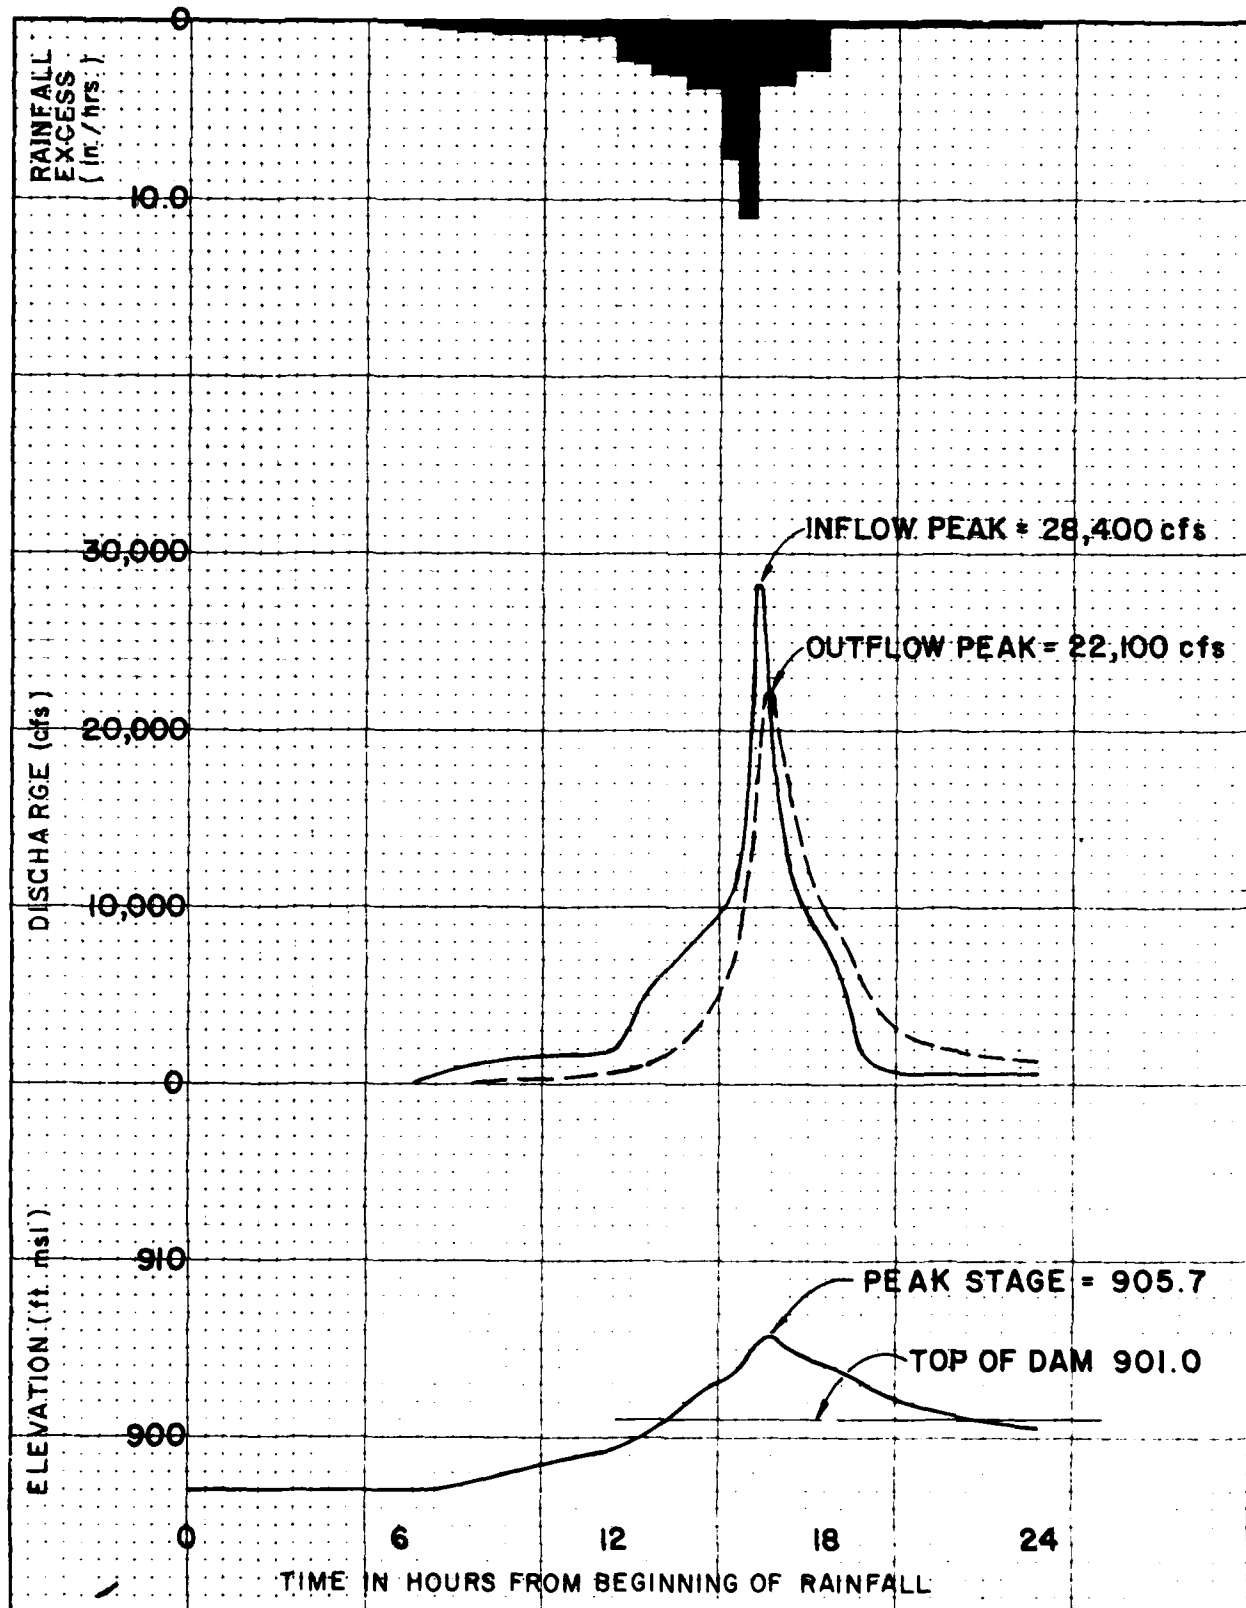
**WEATHERBY LAKE
 PROBABLE MAXIMUM FLOOD
 HYETOGRAPH, HYDROGRAPHS
 & STAGE-TIME CURVE**

4. Floods are routed through the spillway using HEC-1, modified Puls to determine the capability of the spillway. Inflow and outflow hydrographs are shown on Plates A-1, A-2, and A-3.

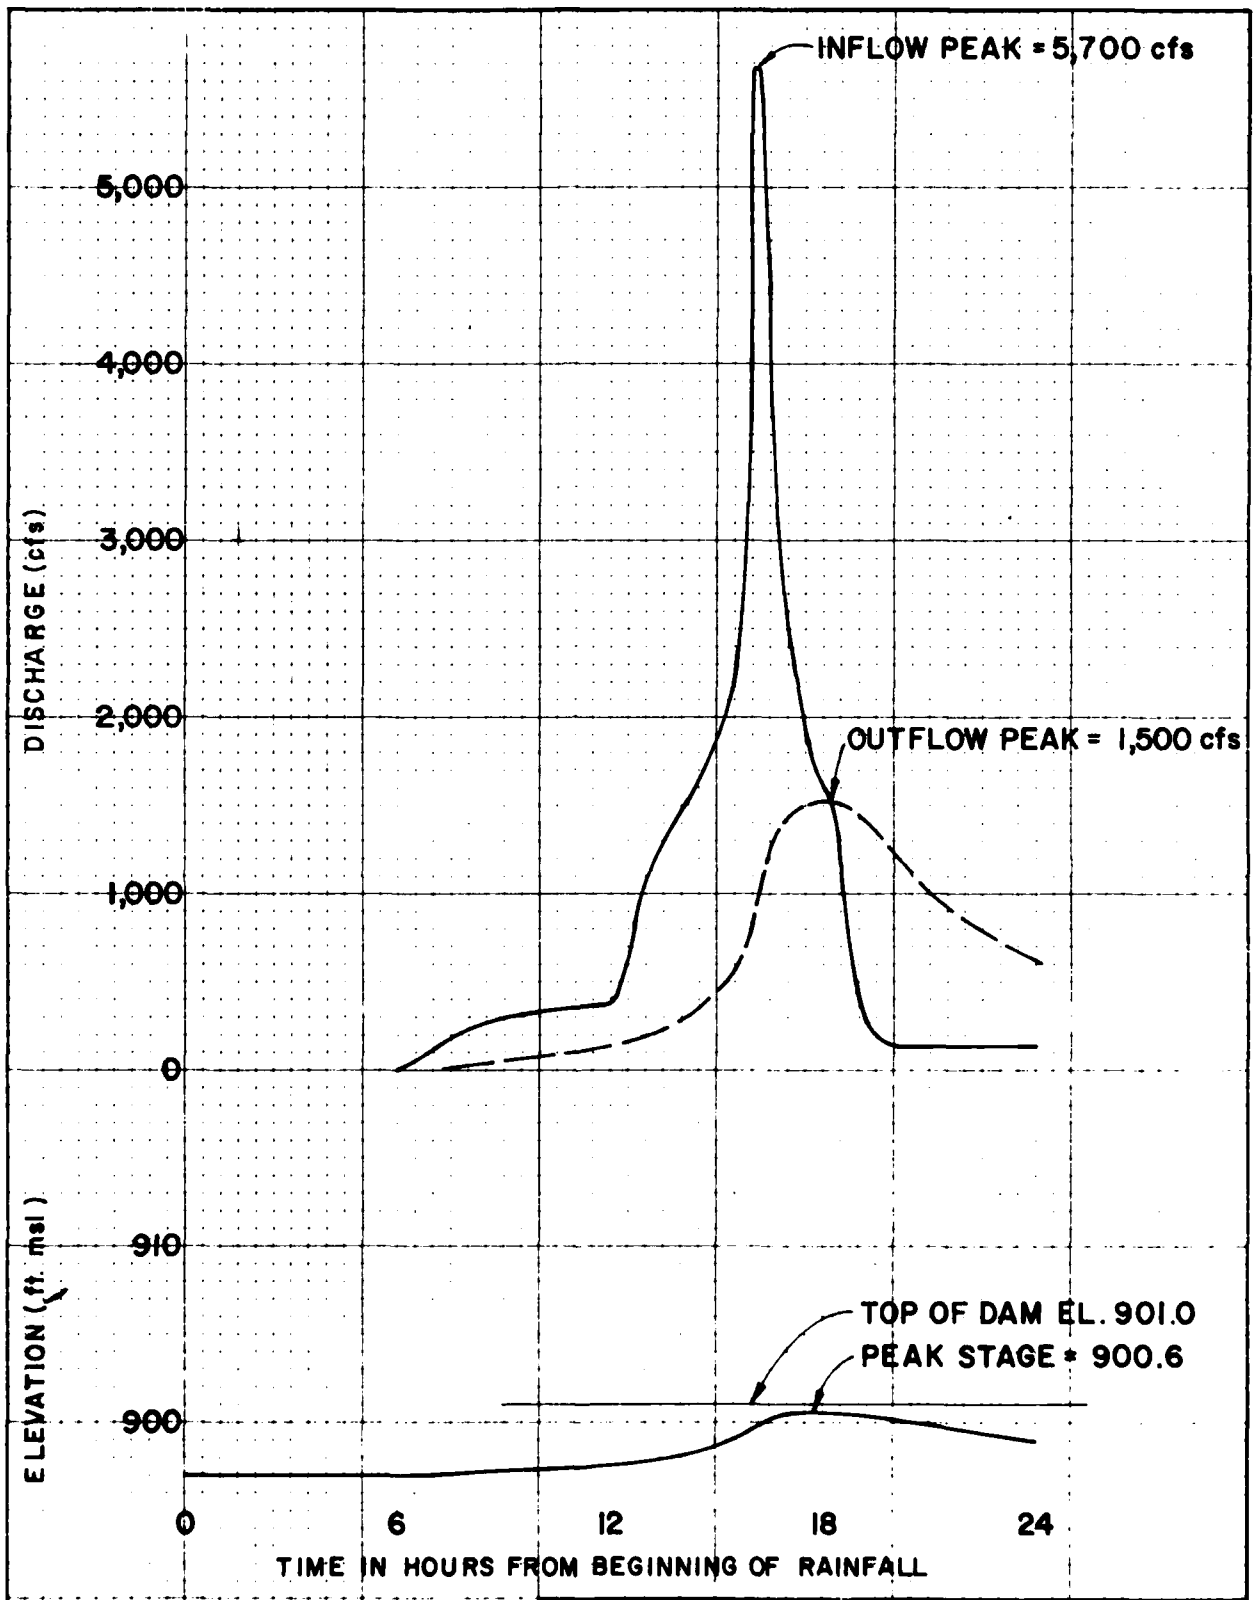
**WEATHERBY LAKE
20% PROBABLE MAXIMUM FLOOD
HYDROGRAPHS &
STAGE-TIME CURVE**

Our inspection and evaluation indicate the spillway does not meet the criteria set forth in the guidelines for a dam having the above size and hazard potential. The spillway will pass 20 percent of the probable maximum flood without overtopping.
