**DRESSER NO. 4 DAM
WASHINGTON COUNTY, MISSOURI
MO 30474**

**PHASE I INSPECTION REPORT
NATIONAL DAM SAFETY PROGRAM**

JUNE 1979

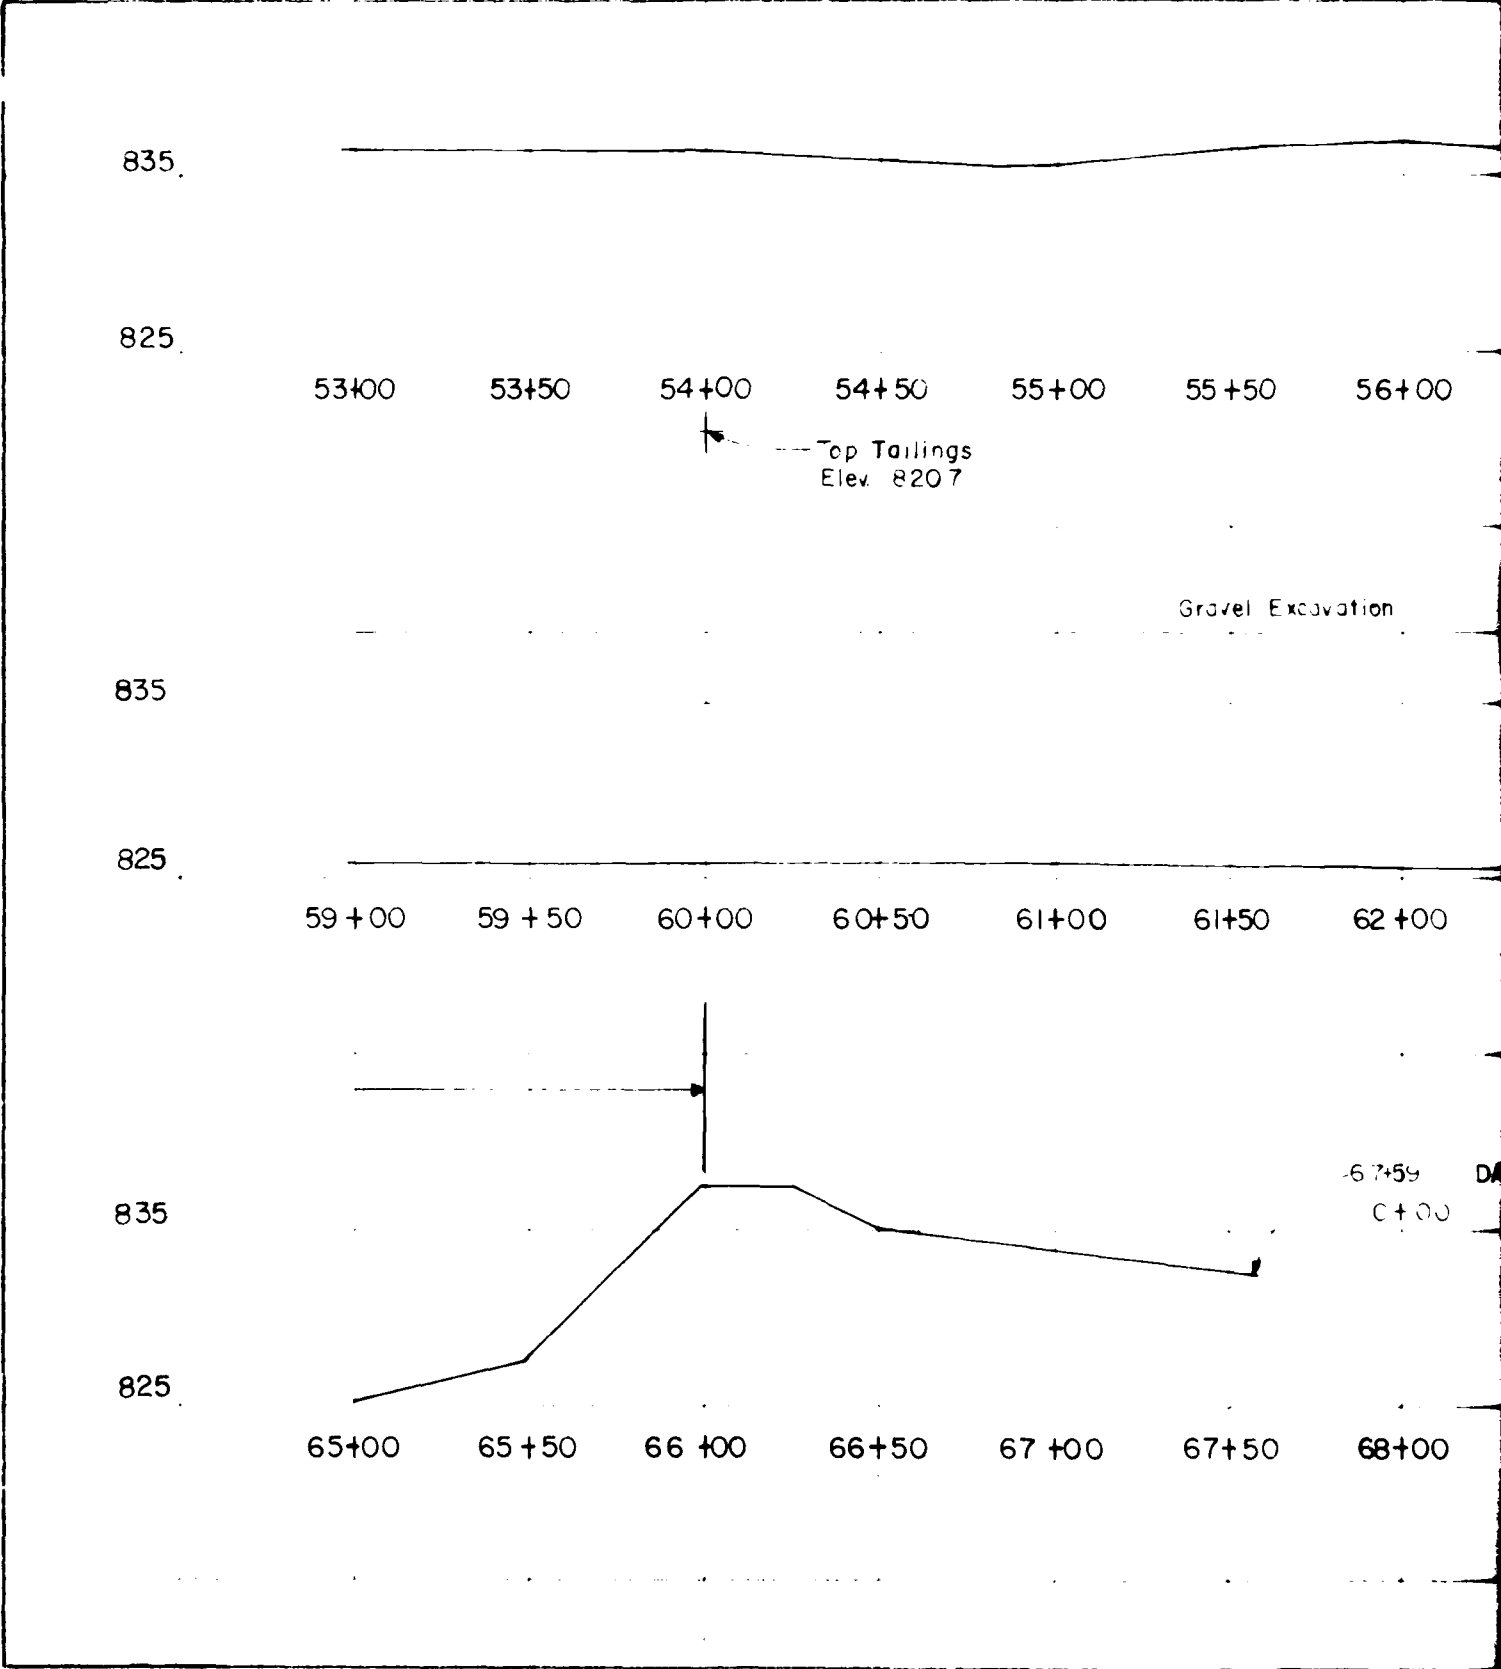
PLATE 4D

Gravel is being excavated from the dam at the east side of the impoundment. The tailings surface is higher than the crest of the dam in this area as a result of the excavation activity (see Plate 5B, Dam Cross-Section at Station 59+00 and Photo No. 2).

Gravel Excavation

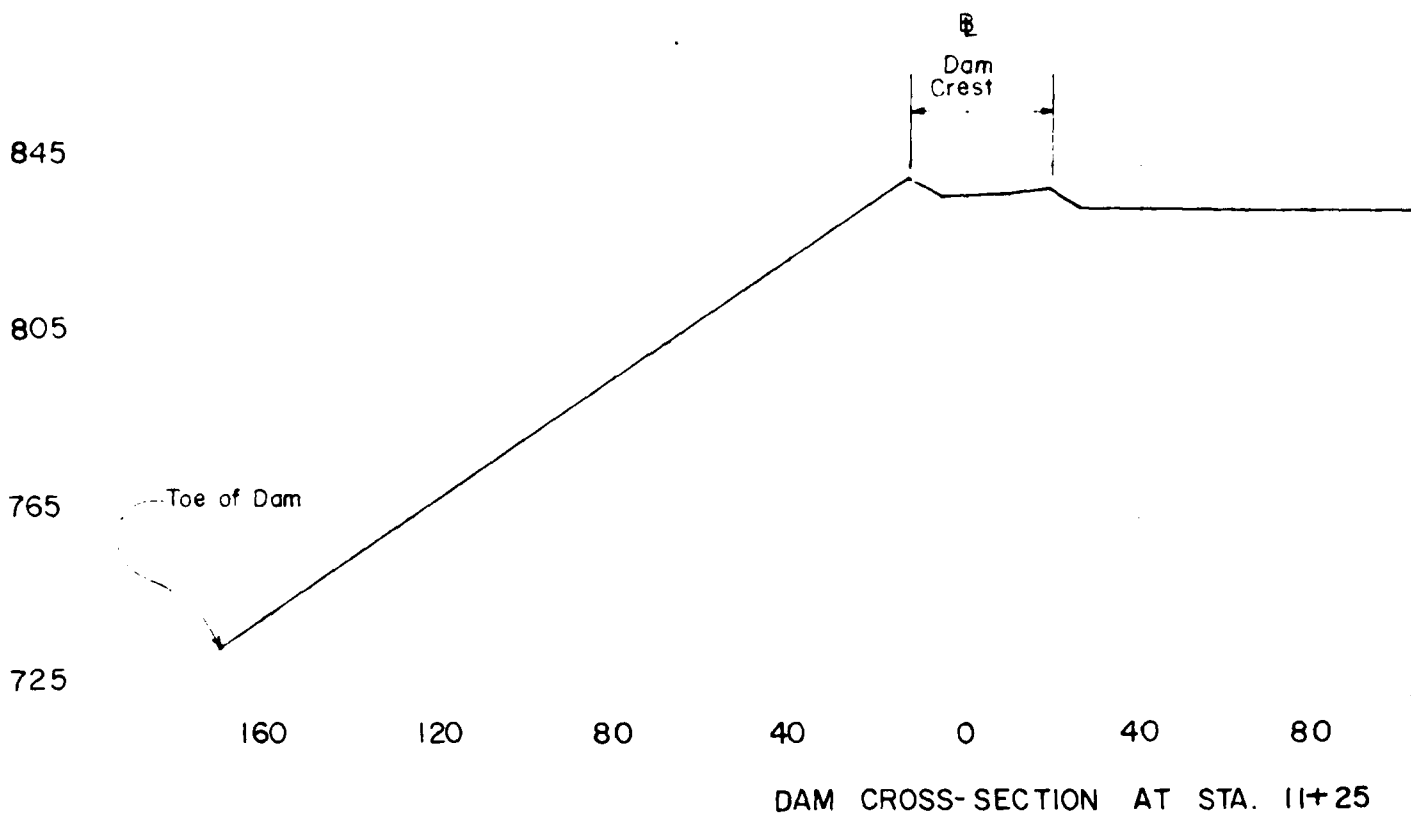
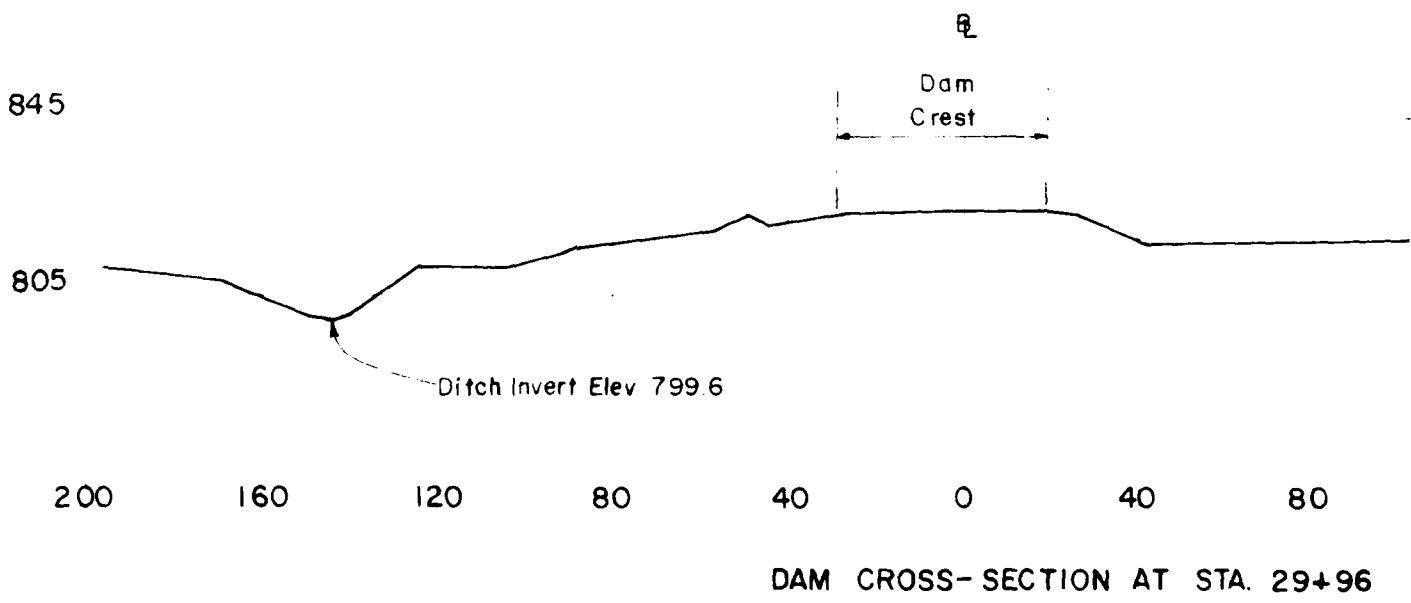
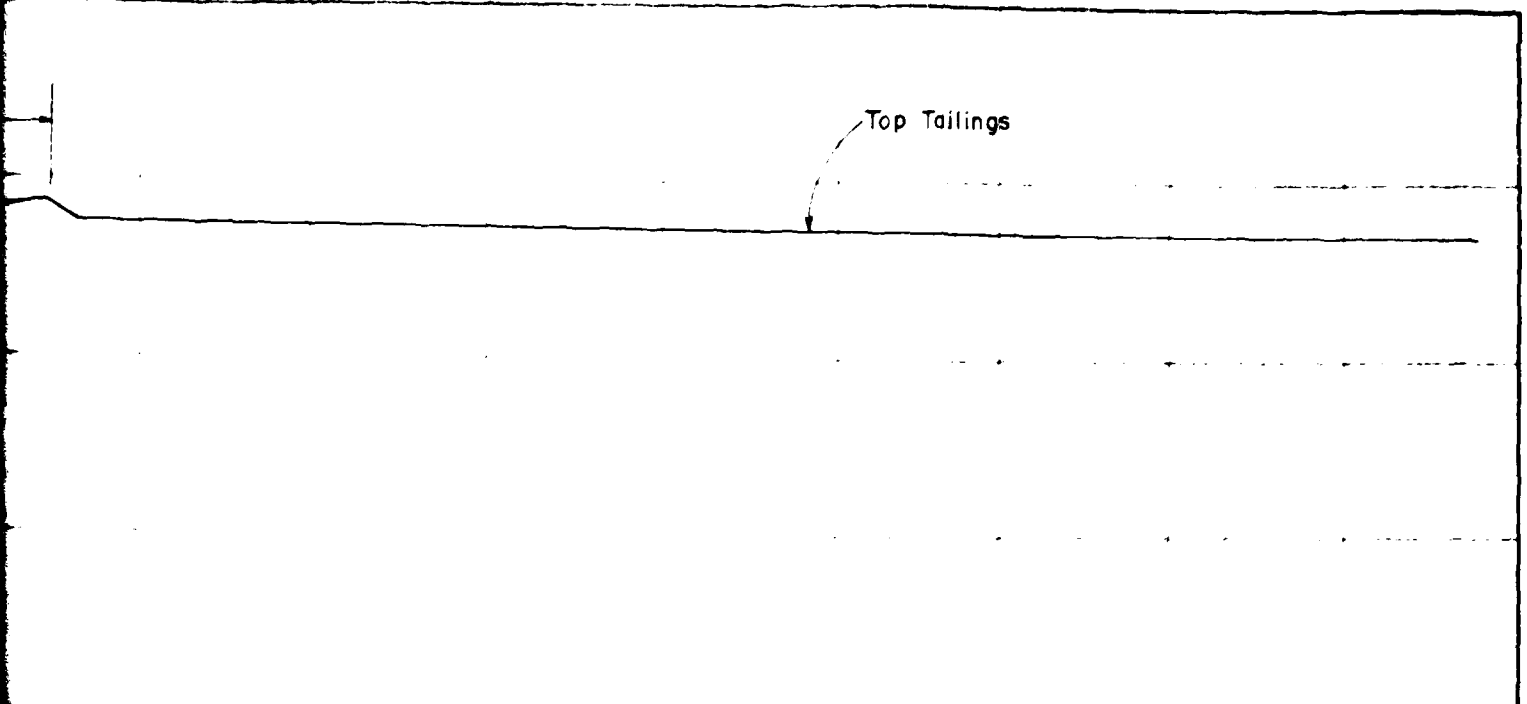
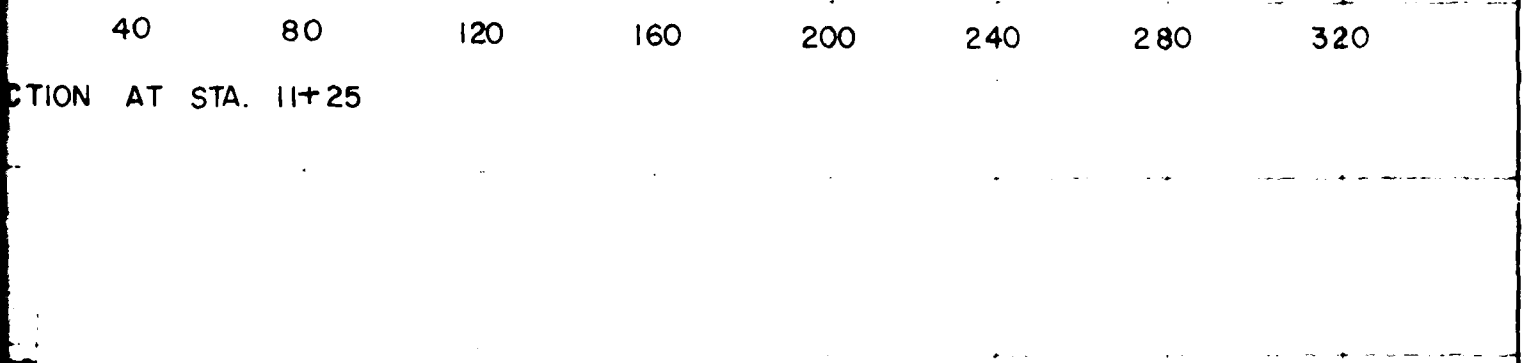
PLATE 5B

The diversion ditch on the west and south sides of the impoundment is U-shaped and about 8 to 10 feet deep. A cross-section of the ditch is shown in Plate 5A. The ditch is in clayey soil. The flow at the time of the inspection was measured to be about 12 inches deep. The ditch discharges into the pond formed by Lower Dresser No. 4 Dam (I.D. 31123) that is located downstream.
