**RICHWOODS MINE 'B' MILL DAM
WASHINGTON COUNTY, MISSOURI
MO. 31404**

**PHASE 1 INSPECTION REPORT
NATIONAL DAM SAFETY INSPECTION**

Name of Dam	Richwoods Mine "B" Mill Dam
State Located	Missouri
County Located	Washington
Stream	Unnamed Tributary of Ditch Creek
Date of Inspection	3 June 1980

PHASE I INSPECTION REPORT
NATIONAL DAM SAFETY PROGRAM
RICHWOODS MINE B MILL DAM - INVENTORY NO. 31404

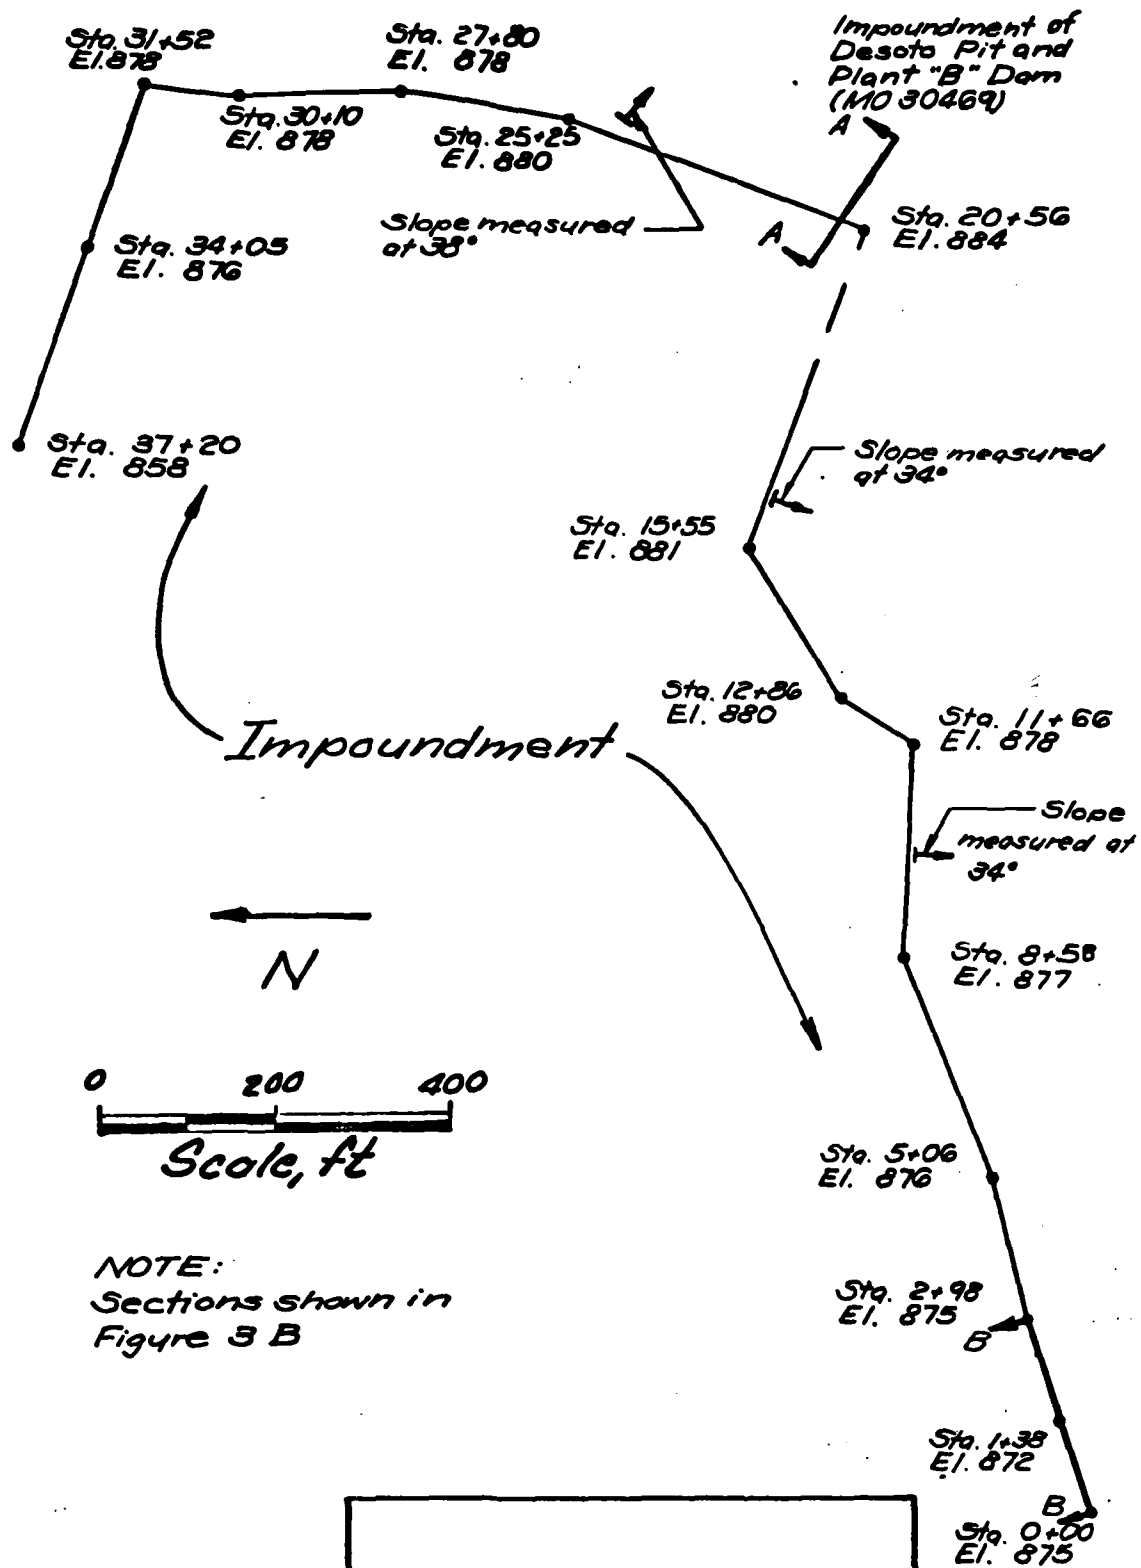
Fig. 3 A

- a. General. Dam was inspected on 3 June 1980 without the owner's representative present. This inspection indicated the dam is in an unsatisfactory condition.
- b. Dam. The Richwoods Mine B Mill Dam consists of coarse tailings locally referred to as "chat". This material is sandy gravel and sand (GW, SW). It is cohesionless and can be easily eroded. The material is end-dumped on the crest of the dam by trucks. Compaction is limited to truck traffic. Slopes on the dam generally are at the angle of repose for this material, 33 to 35 degrees. A 40 degree slope angle was measured on portions of the maximum section (Fig. 3B).
