**STAR MINE DAM
WASHINGTON COUNTY, MISSOURI
MO 31005**

**PHASE 1 INSPECTION REPORT
NATIONAL DAM SAFETY INSPECTION**

STAR MINE DAM
Washington County, Missouri
Missouri Inventory No. 31005

Phase I Inspection Report
National Dam Safety Program

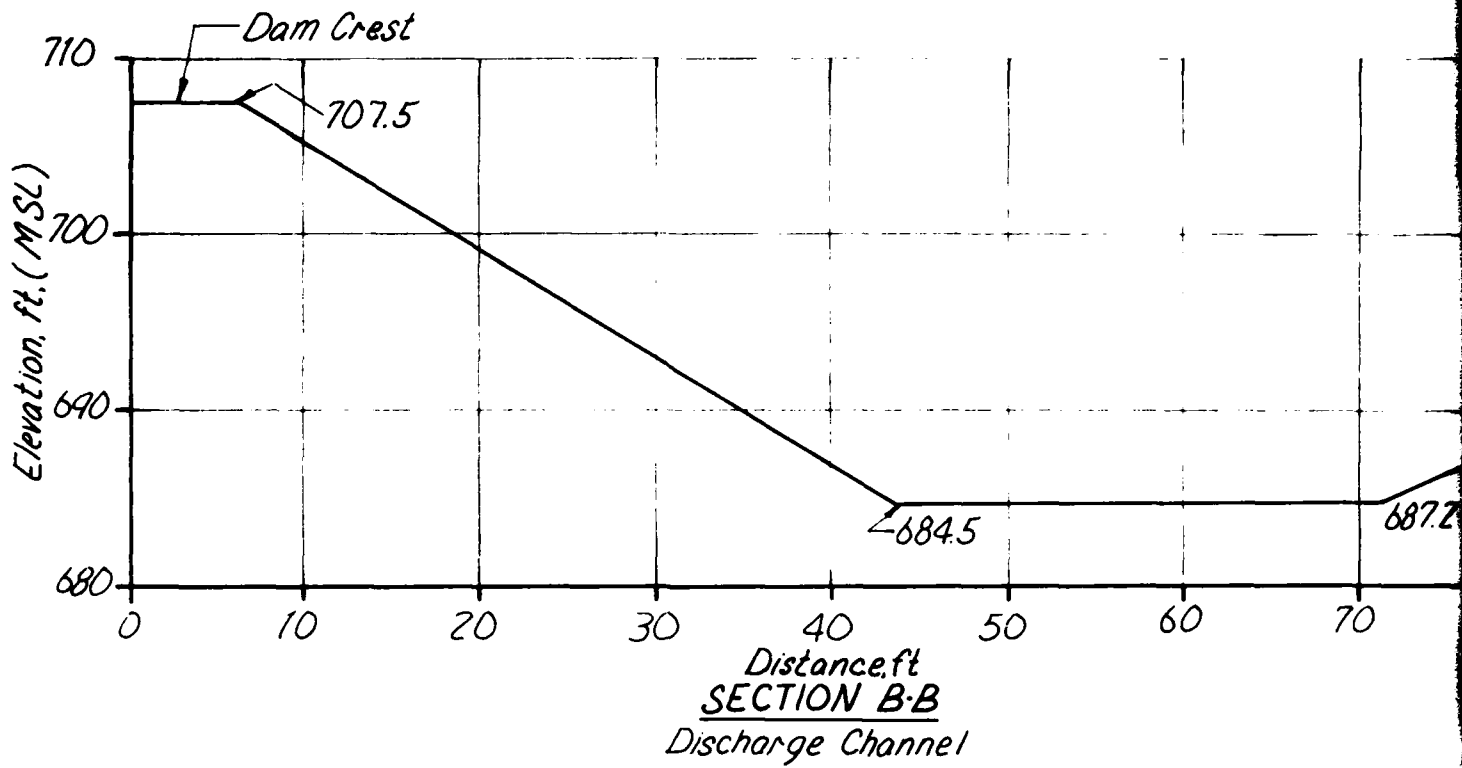
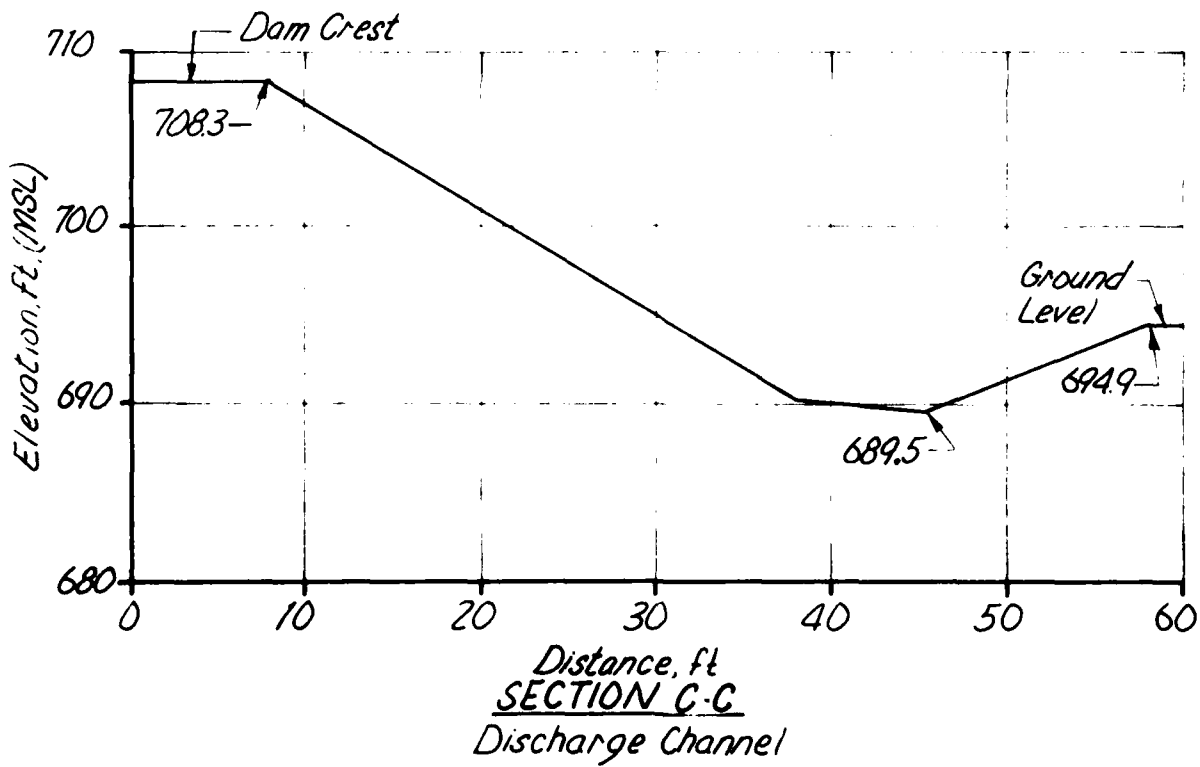
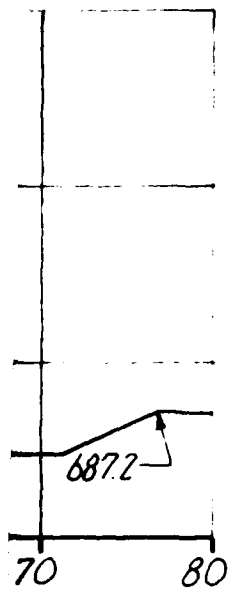
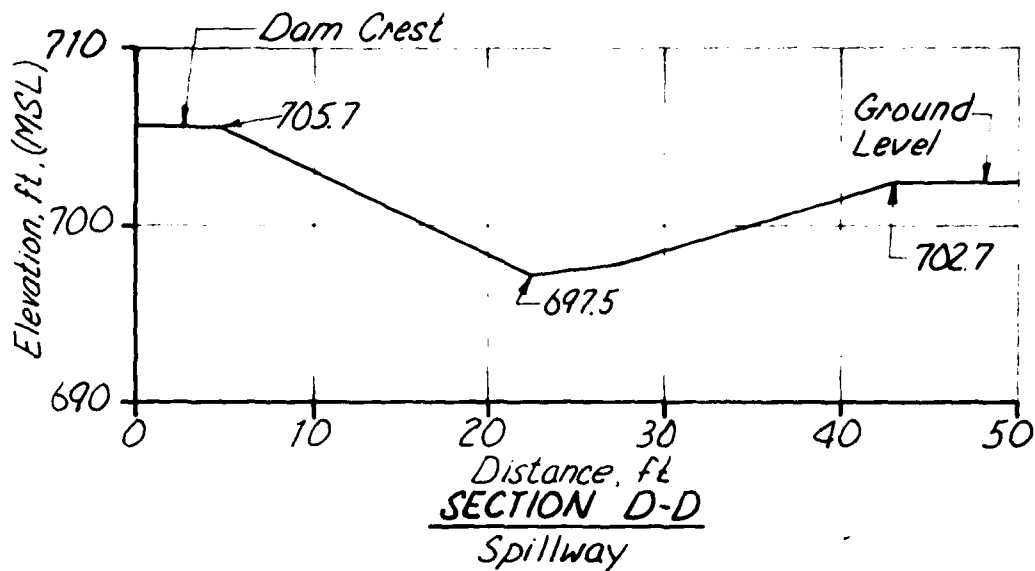
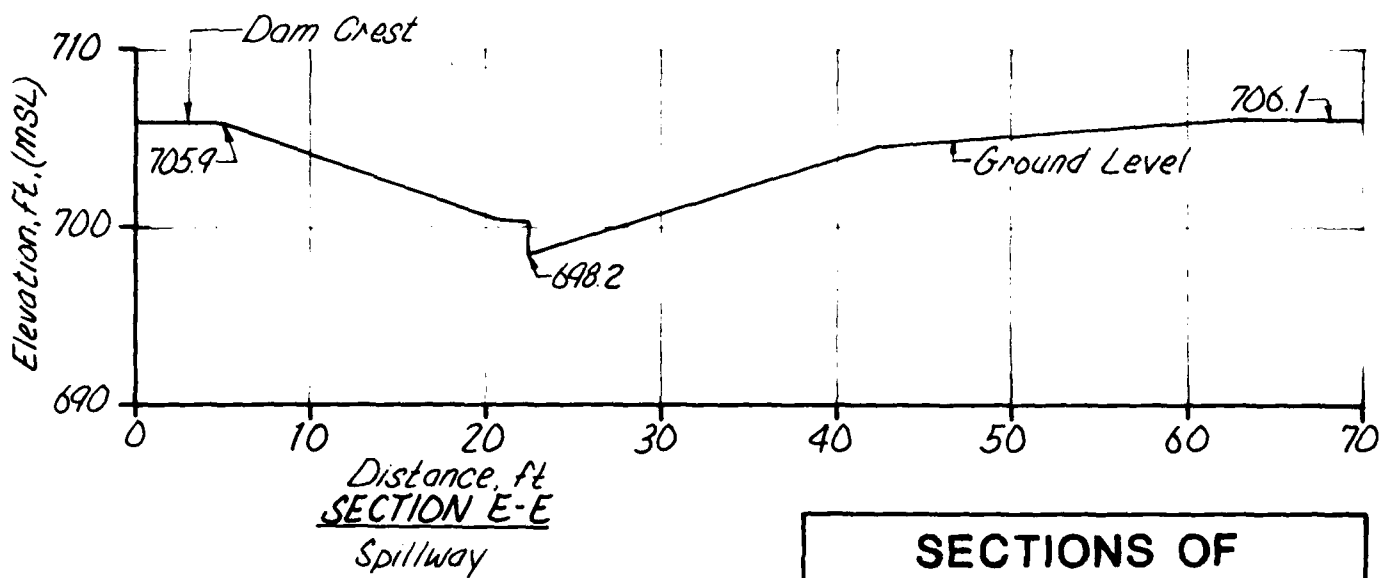
**SECTIONS OF
SPILLWAY AND
DISCHARGE CHANNEL**

- d. **Overtopping potential.** One of the primary considerations in the evaluation of Star Mine is the assessment of the potential for overtopping and consequent failure by erosion of the embankment. Since the spillway of this dam is rather rocky and well covered by plants, significant erosion of the spillway due to high velocity discharge is not expected. The lowest portion of the dam is approximately 300 ft from the spillway at the point marked as "depression" in the attached Figure 3-A. Our analyses indicate that spillway discharge of greater than 900 cubic feet per second would result in overtopping of this embankment. This flow corresponds to approximately 90 percent of the Probable Maximum Flood (PMF). The PMF is defined as the flood event that may be expected to occur from the most severe combination of critical meteorologic and hydrologic conditions that are reasonably possible in the region.

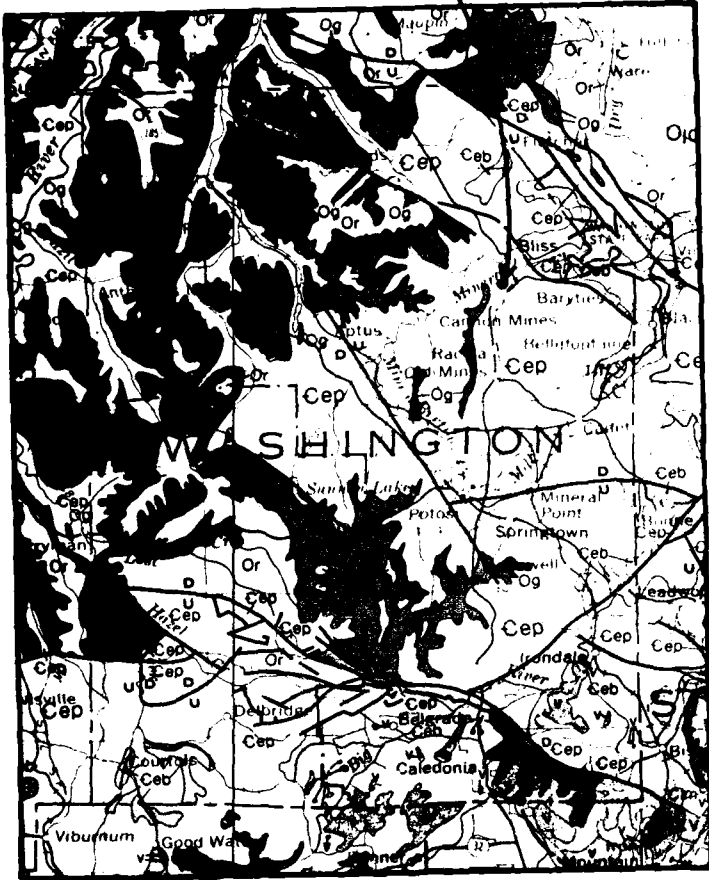
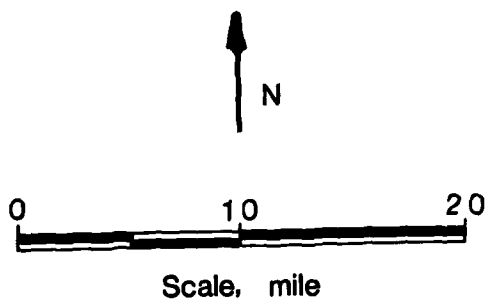
REGIONAL GEOLOGIC MAP	
STAR MINE DAM	
MO 31005	Fig. 4

The dam is located on the northern flank of the Ozark structural dome. The regional dip of the bedrock is to the north. The bedrock in the vicinity of the dam is mapped on the Geologic Map of Missouri (1979) as Cambrian age Potosi and Eminence Formations (Fig 4). The dam site is near the upper part of this mapped unit, suggesting the bedrock is Eminence Formation. Wharton (1972) indicates the dam is approximately on the contact between the two formations.
