**SOMETHING GREEN A DAM  
WASHINGTON COUNTY, MISSOURI  
MO 30720**

**SOMETHING GREEN B DAM  
WASHINGTON COUNTY, MISSOURI  
MO 30719**

**PHASE 1 INSPECTION REPORT  
NATIONAL DAM SAFETY INSPECTION**

**SEPTEMBER 1980**

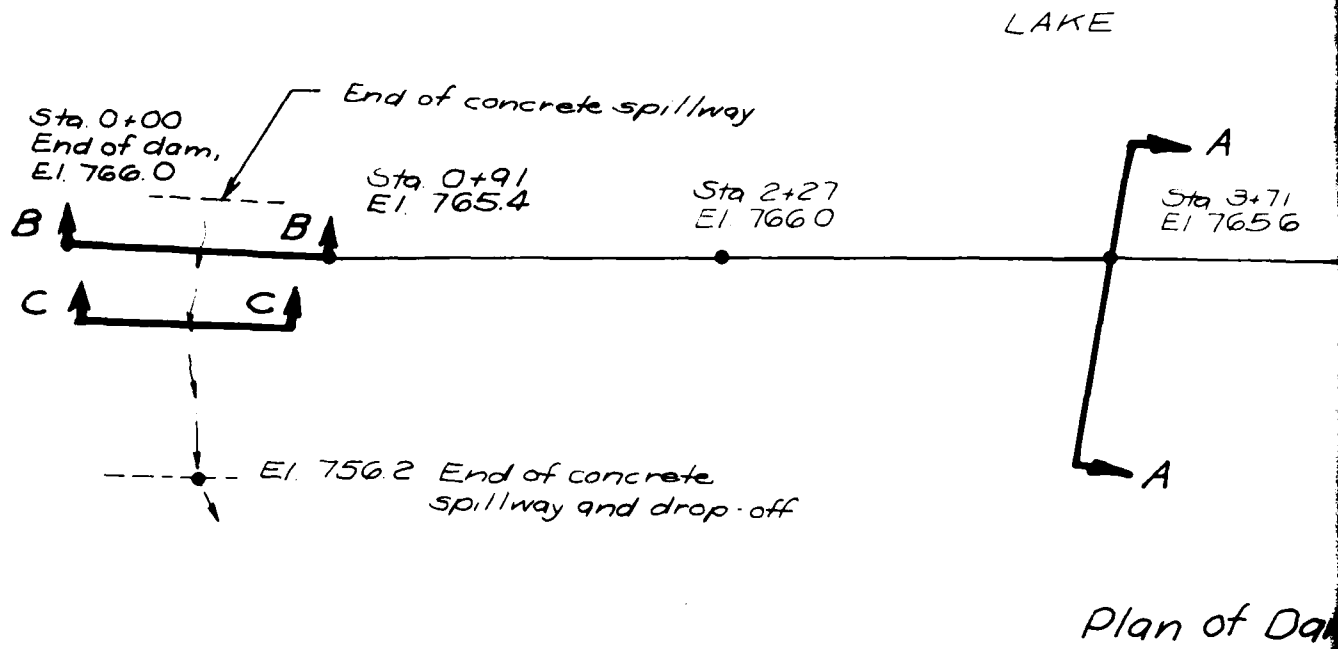
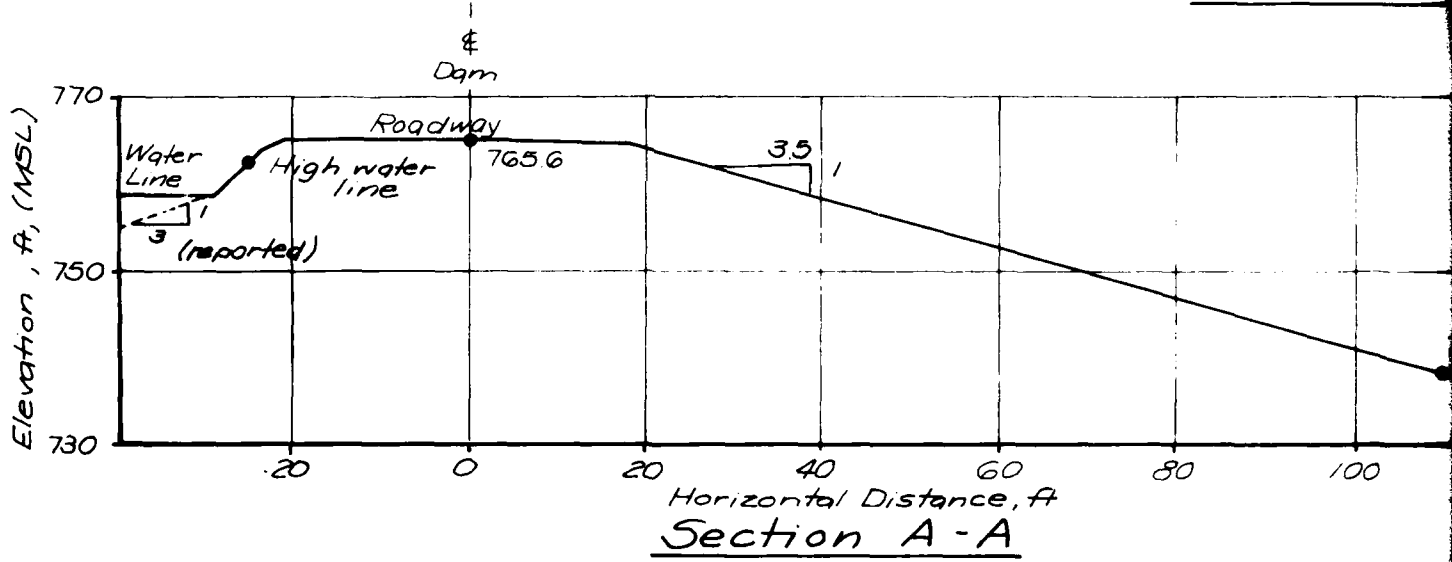
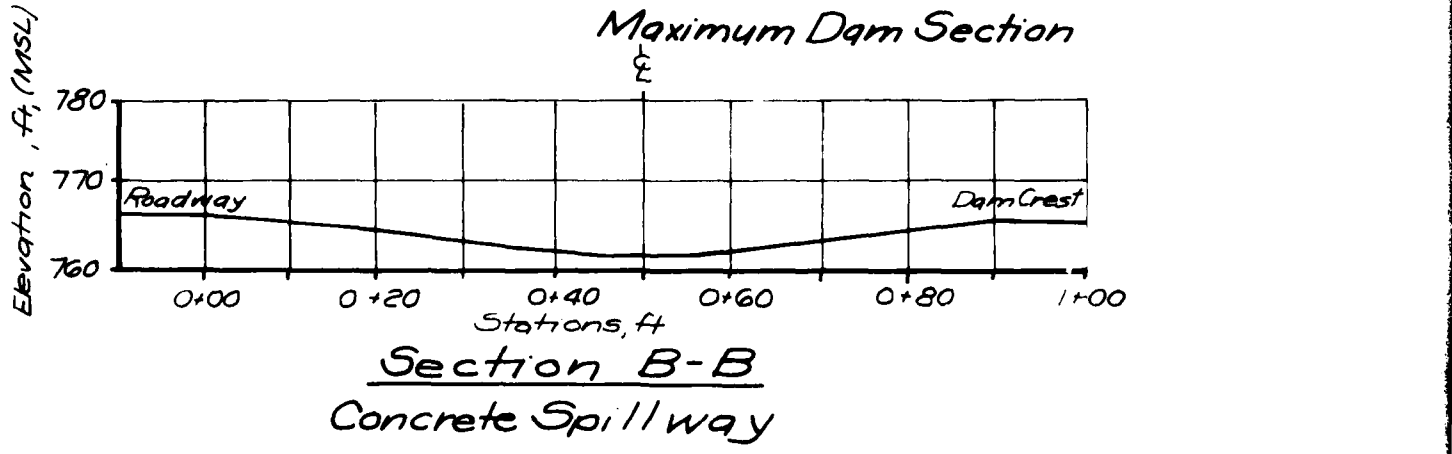
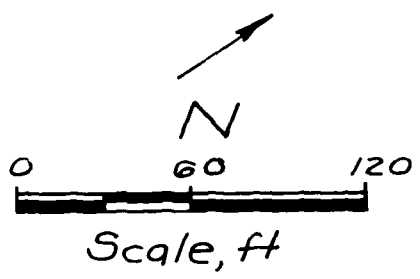
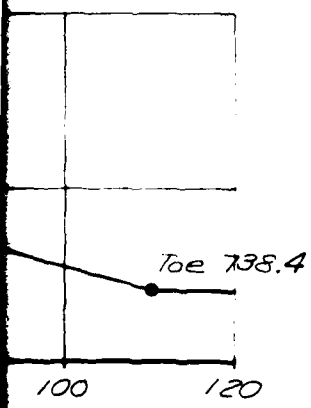
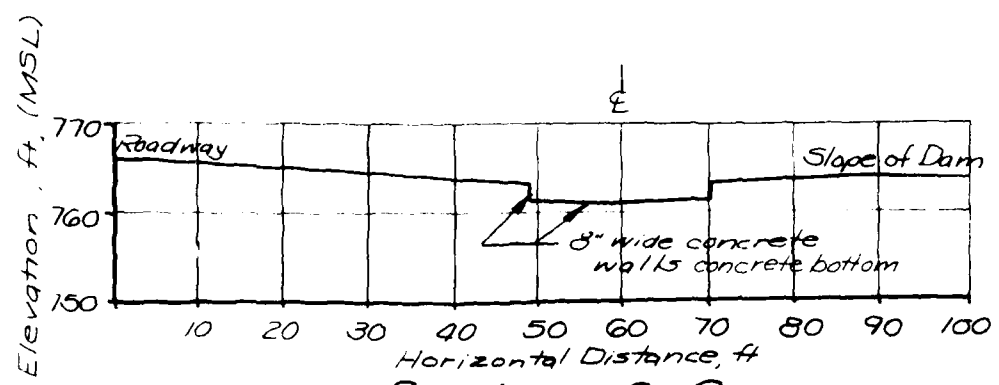
PLAN AND SECTIONS OF DAM AND SPILLWAY	
SOMETHING GREEN A DAM	
MO 30720	Fig. 3

The spillway is a broad trapezoidal concrete-lined weir at the dam axis and a rectangular concrete chute upstream and downstream of the weir. The trapezoidal weir has a controlling width of approximately 48 ft (Photo 1). The low point controlling outflow is at elevation 761.1 ft, about 4.3 feet below the crest of the dam. Approximately 25 ft downstream from the crest of the spillway, discharge flows are channeled into a 2 ft deep, 21 ft wide rectangular chute which extends 55 ft downstream to about a 4 ft eroded dropoff (Photo 2). There is no cutoff at the end of the chute to protect against undercutting.

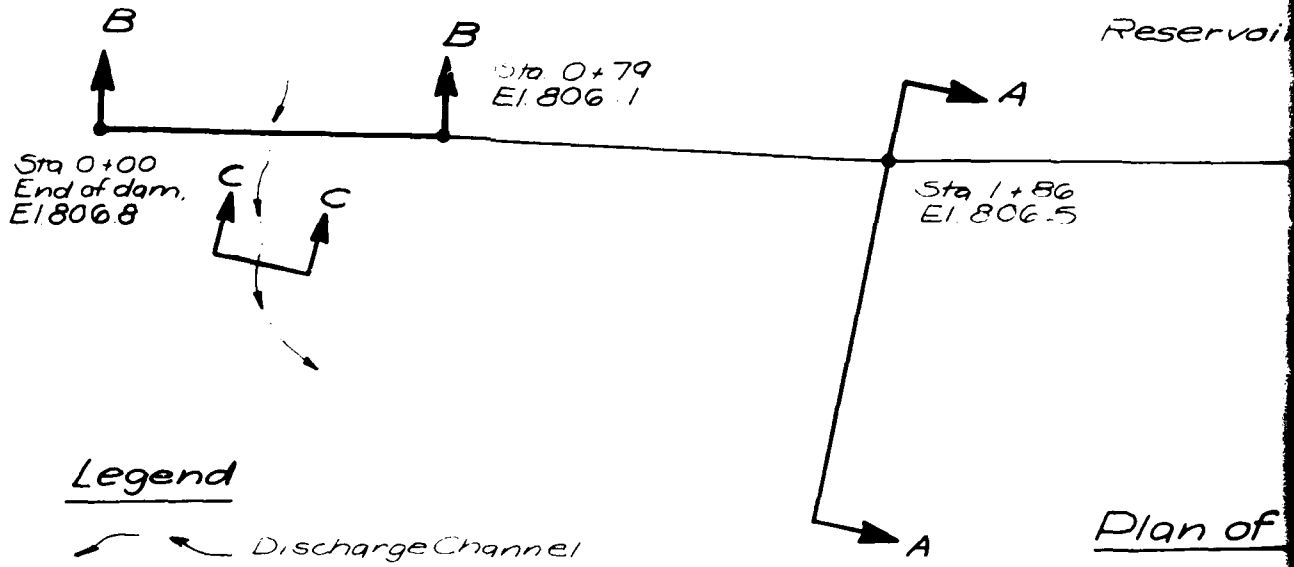
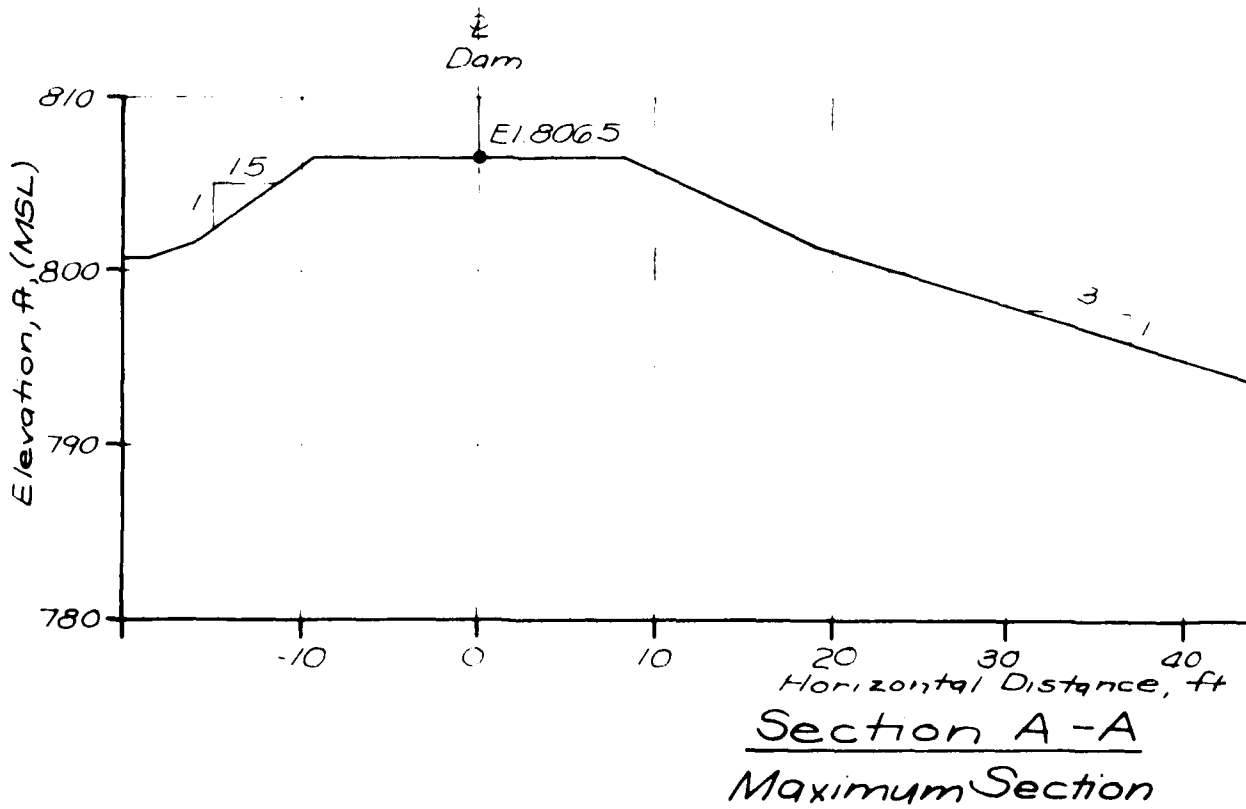
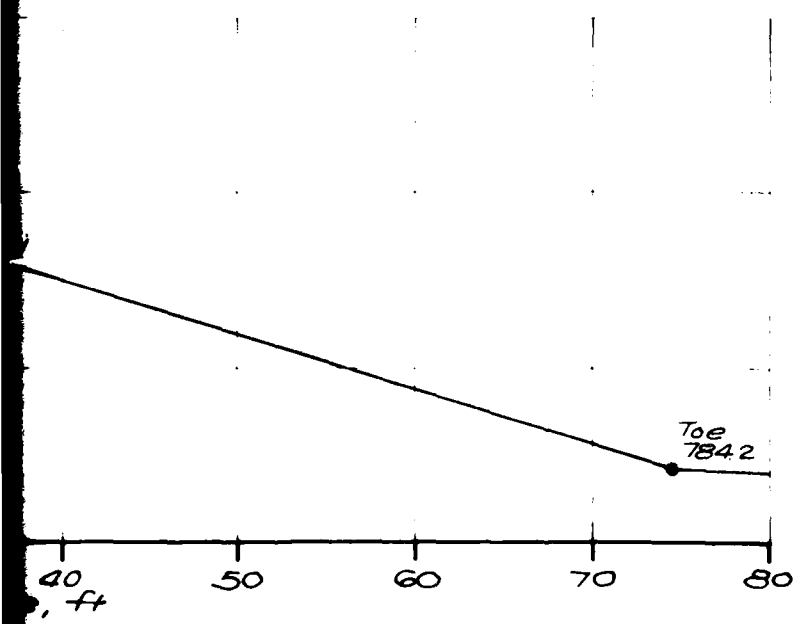
PLAN AND SECTION OF DAM	
SOMETHING GREEN B DAM	
MO. 30719	Fig. 3-A

- a. Description of dam and appurtenances. The Something Green B Dam is an earth fill dam impounding a recreational lake in north-central Washington County, Missouri (Fig. 1). The dam is approximately 447 ft in length and retains the impoundment on the northeast (Fig. 2). The dam is approximately 22 ft high at the maximum section. Elevations along the dam crest are nearly uniform at slightly over 806 ft MSL.

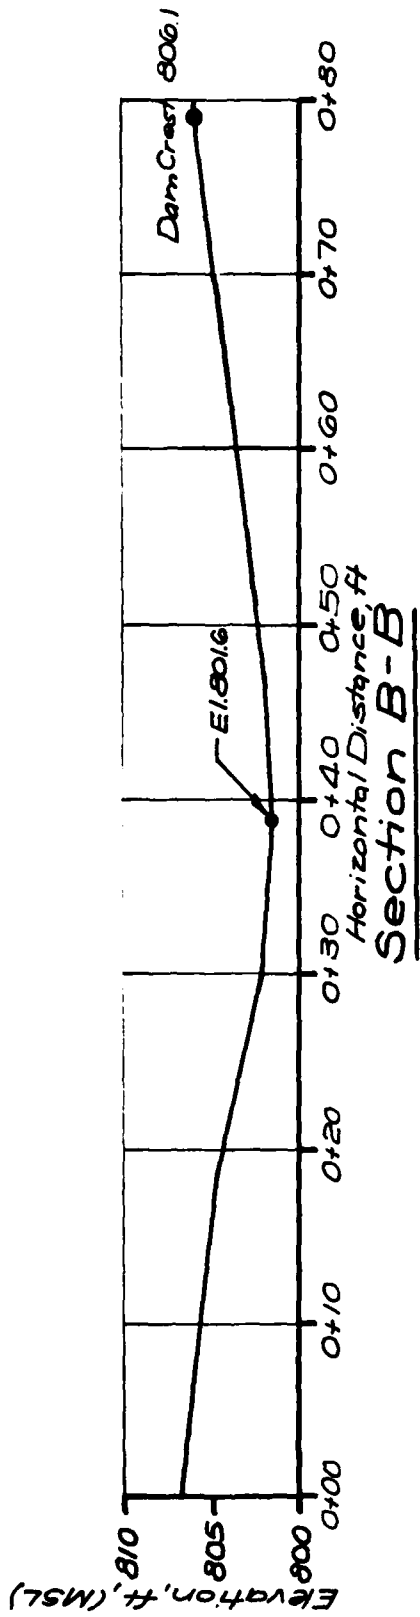
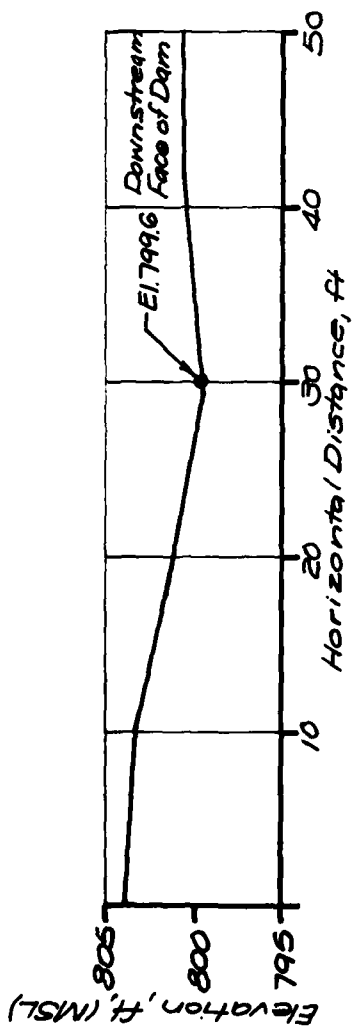
SECTIONS OF SPILLWAY AND DISCHARGE CHANNEL	
SOMETHING GREEN B DAM	
MO. 30719	FIG 3B

The spillway is a broad trapezoidal weir, partially lined with concrete, approximately 80 ft wide from the abutment to the crest of the dam (Photo 1). The low point controlling outflow is at elevation 801.6 ft, 4.4 feet below the crest of the dam.

The discharge channel below the lined portion of the spillway is eroded to bedrock (Photo 2). The discharge channel walls are residual stoney clay, which appears to be moderately erodible.

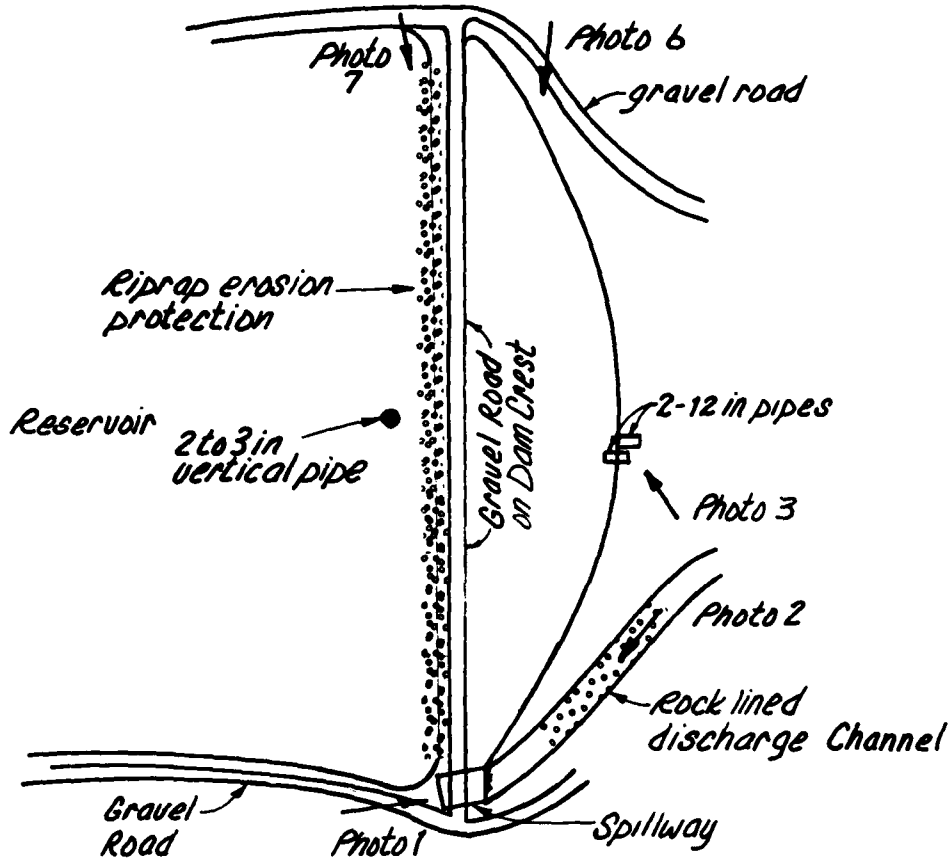
PHOTO LOCATION SKETCH	
SOMETHING GREEN B DAM	
MO 30719	Fig A1

(Photo 4 & 5 of downstream hazards)
