GUTHRIE LAKE DAM
CALLAWAY COUNTY, MISSOURI
MO. 10990

**PHASE I INSPECTION REPORT
NATIONAL DAM SAFETY PROGRAM**

Name of Dam: Guthrie Lake Dam, Missouri Inv. No. 10990
State Located: Missouri
County Located: Callaway
Stream: McKinney Creek
Date of Inspection: June 4, 1980

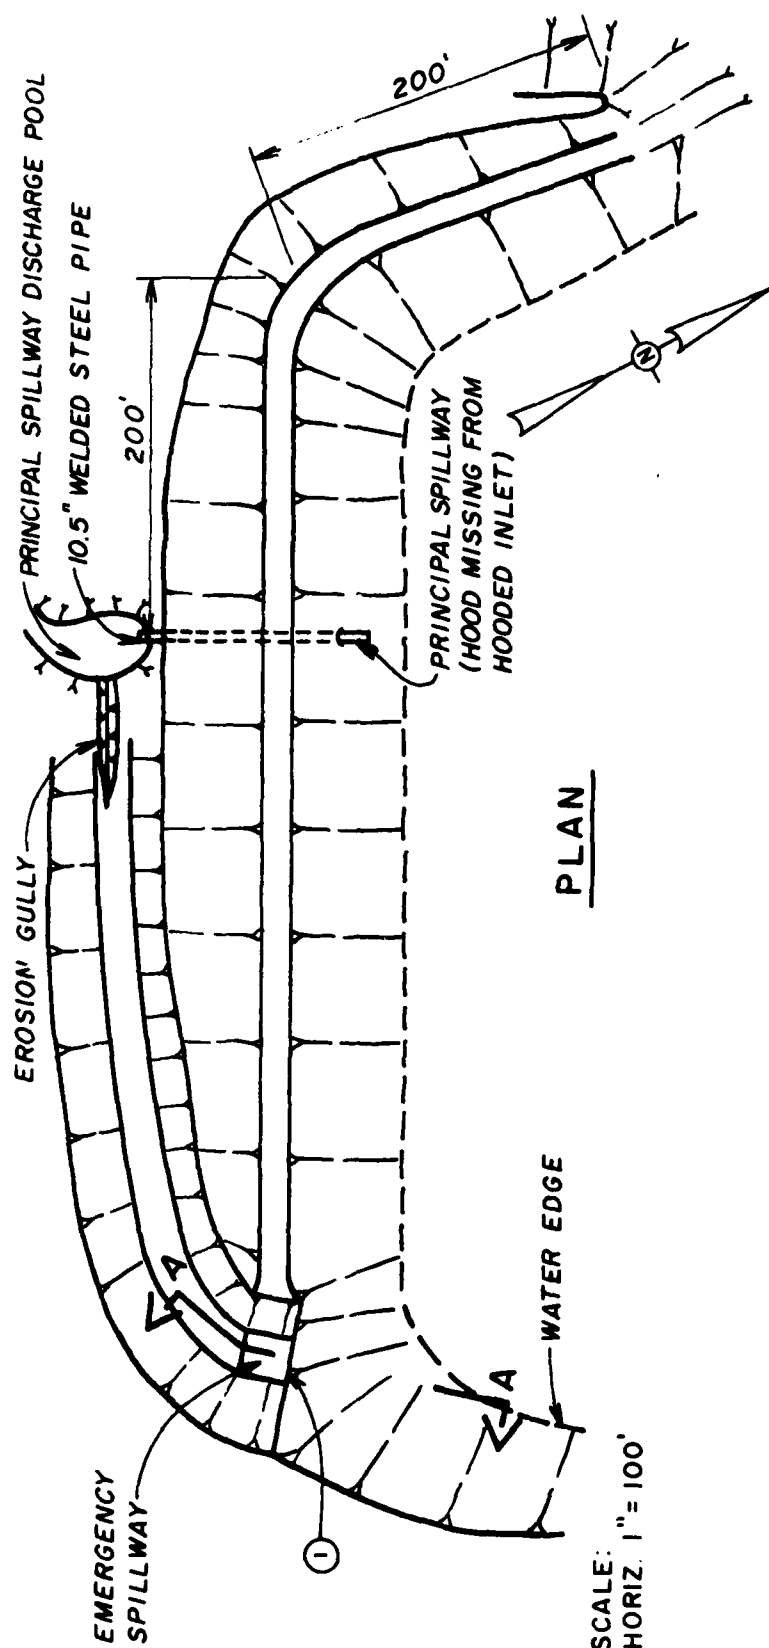
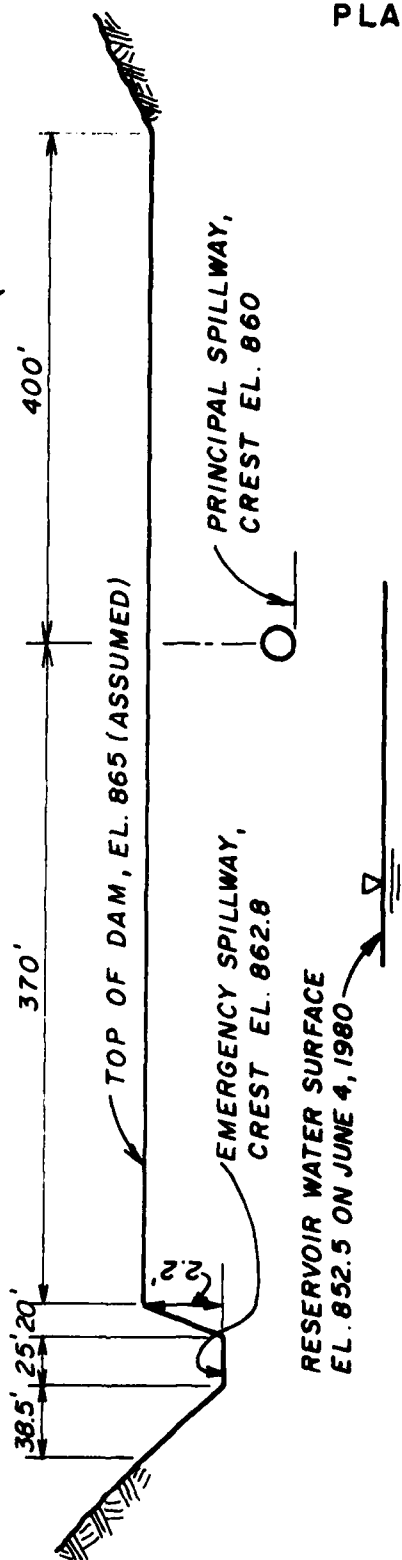
GUTHRIE LAKE DAM (MO. 10990)
 PLAN AND ELEVATION
 (SHEET 1 OF 2)

The dam is a homogeneous, rolled, earthfill structure between earth abutments, consisting of two straight portions of embankment angled at approximately 70 degrees to each other. A plan and elevation of the dam is shown on Plate 2 and Photos 1 through 3 show views of the dam. The major portion of the embankment has a bearing of approximately N 70° W and a length of 570 feet between the emergency spillway and the point of intersection of the two axes. The other portion of the dam runs in the North-South direction and has a length of 200 feet between the point of intersection of the two axes and the right abutment. The top of dam has a total length of 770 feet between the emergency spillway and the right abutment, and a top thickness which varies from 12 to 16 feet. The top of dam was measured to be level with an assumed elevation of 865 feet above mean sea level (M.S.L.). The maximum structural height of the dam was measured as 26 feet. The upstream slope was measured to be 1 vertical to 4 horizontal (1V to 4H), above the water surface. The downstream slope varies between 1V to 2H and 1V to 1.75H. According to Mr. Guthrie and Mr. Wilson, a 6-foot wide by 6-foot deep core trench was constructed parallel to the dam axis but not into bedrock.
