SEVAN DAM

JEFFERSON COUNTY, MISSOURI

MO 30453

PHASE I INSPECTION REPORT  
NATIONAL DAM SAFETY PROGRAM

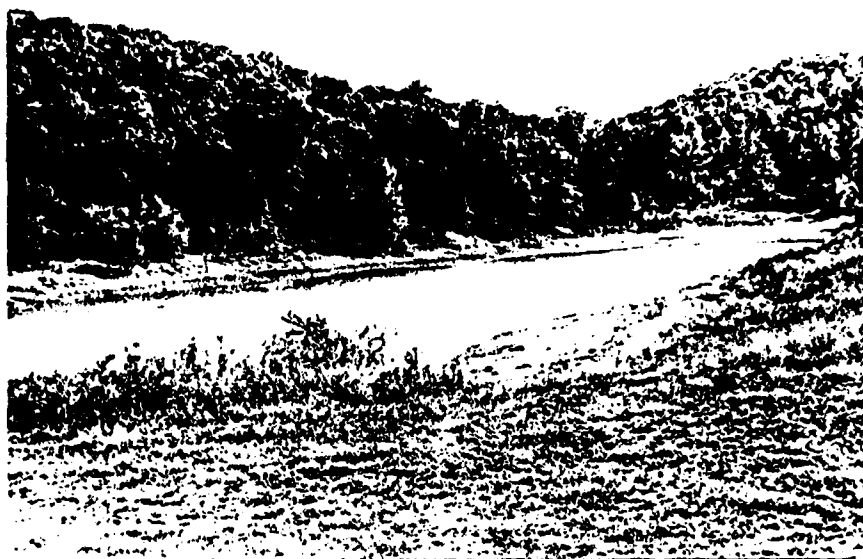
Photo 1 - View of Sevan taken at point to left of dam.
