MO. NO NAME NO. 258 DAM
JEFFERSON COUNTY, MISSOURI
MO. 30455

PHASE I INSPECTION REPORT
NATIONAL DAM SAFETY PROGRAM

JULY 1981

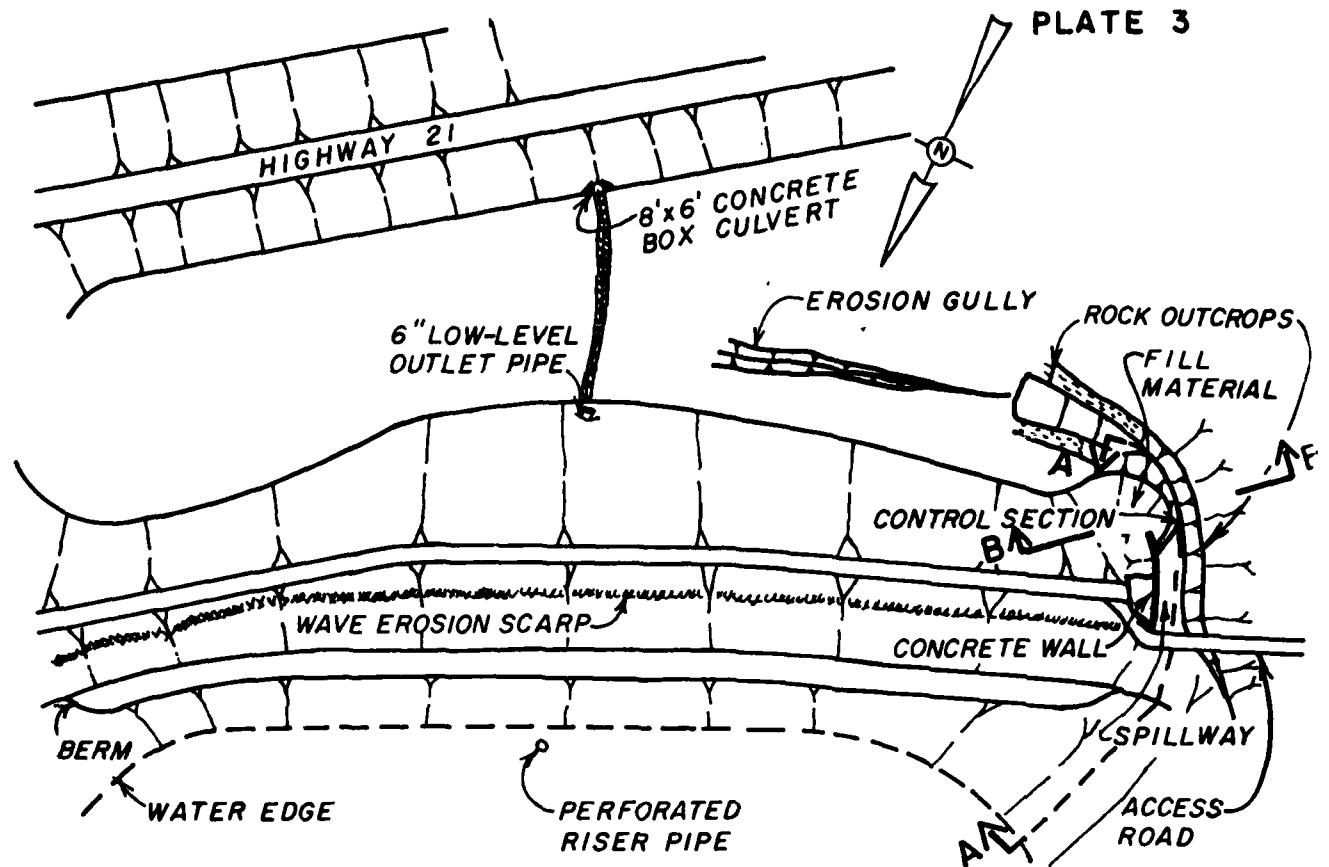
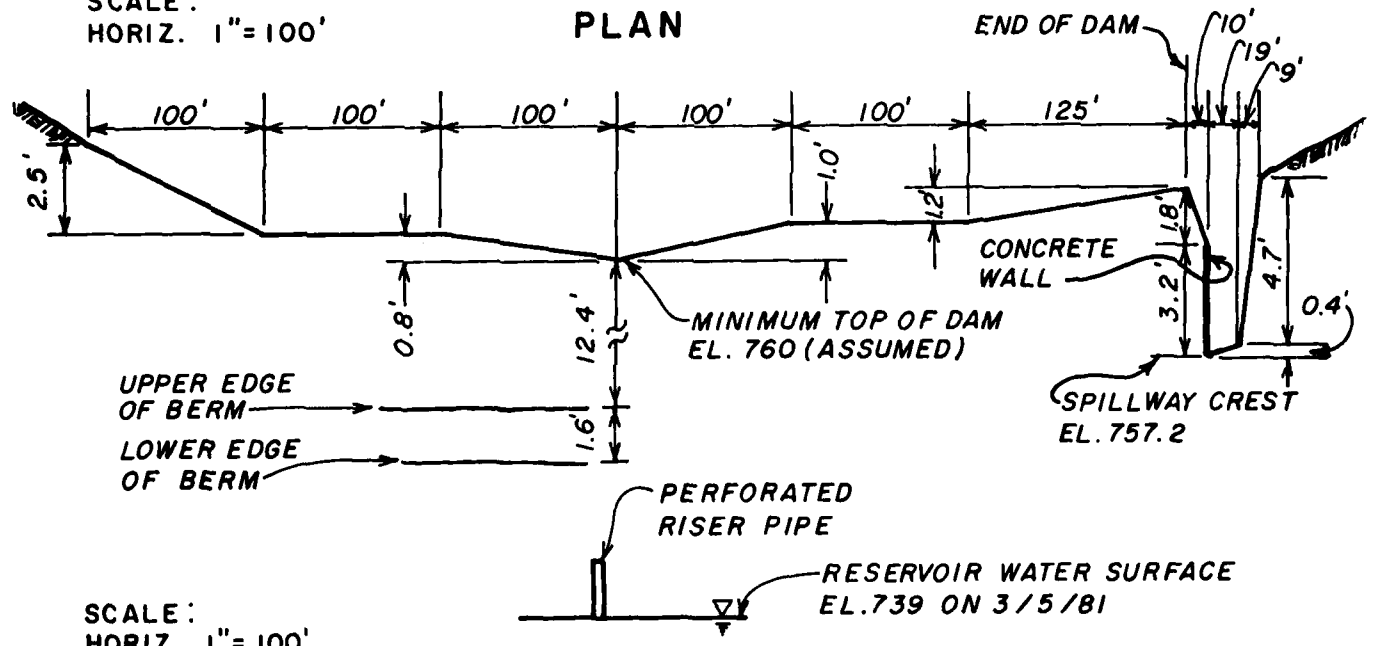
MO. NO NAME NO. 258 DAM (MO. 30455)
PLAN AND ELEVATION
(SHEET 1 OF 2)

The dam is an earthfill structure placed between earth abutments with an alignment that is curved in the downstream direction. A plan and elevation of the dam are shown on Plate 3 and Photos 1 through 3 show views of the dam. The top of dam has a length of 625 feet between the left abutment and the spillway and an assumed minimum elevation of 760.0 feet above mean sea level (M.S.L.). The minimum top of dam elevation was measured to be at a point 300 feet from the left abutment. From this point, the top of dam slopes upward at various degrees to both ends of the dam with a rise in elevation of 3.3 feet and 2.2 feet at the left and right sides, respectively. The embankment has a top width of nine feet and a maximum structural height of 35.3 feet. The downstream slope was measured to be 1 vertical to 2.25 horizontal (1V to 2.25H). A 15-foot wide berm was constructed on the upstream slope with a top elevation of 747.6 and 746.0 feet above M.S.L. at the downstream and upstream edges, respectively. The upstream embankment slope above the berm and below the berm to the water surface was measured to be 1V to 4H .
