MALE (C T) ASSOCIATES SCHENECTADY NY  
NATIONAL DAM INSPECTION PROGRAM. TILLSON LAKE DAM (NY00083), LO--ETC(U)  
AUG 81 K J MALE, W M SMITH

| REPORT DOCUMENTATION PAGE | | READ INSTRUCTIONS<br>BEFORE COMPLETING FORM |
|---|---|---|
| 4. TITLE (and Subtitle)<br>Phase I Inspection Report<br>Tillson Lake Dam<br>Lower Hudson River Basin, Ulster County, N.Y.<br>Inventory No. 83 | | 5. TYPE OF REPORT & PERIOD COVERED<br>Phase I Inspection Report<br>National Dam Safety Program |

31 Aug 81

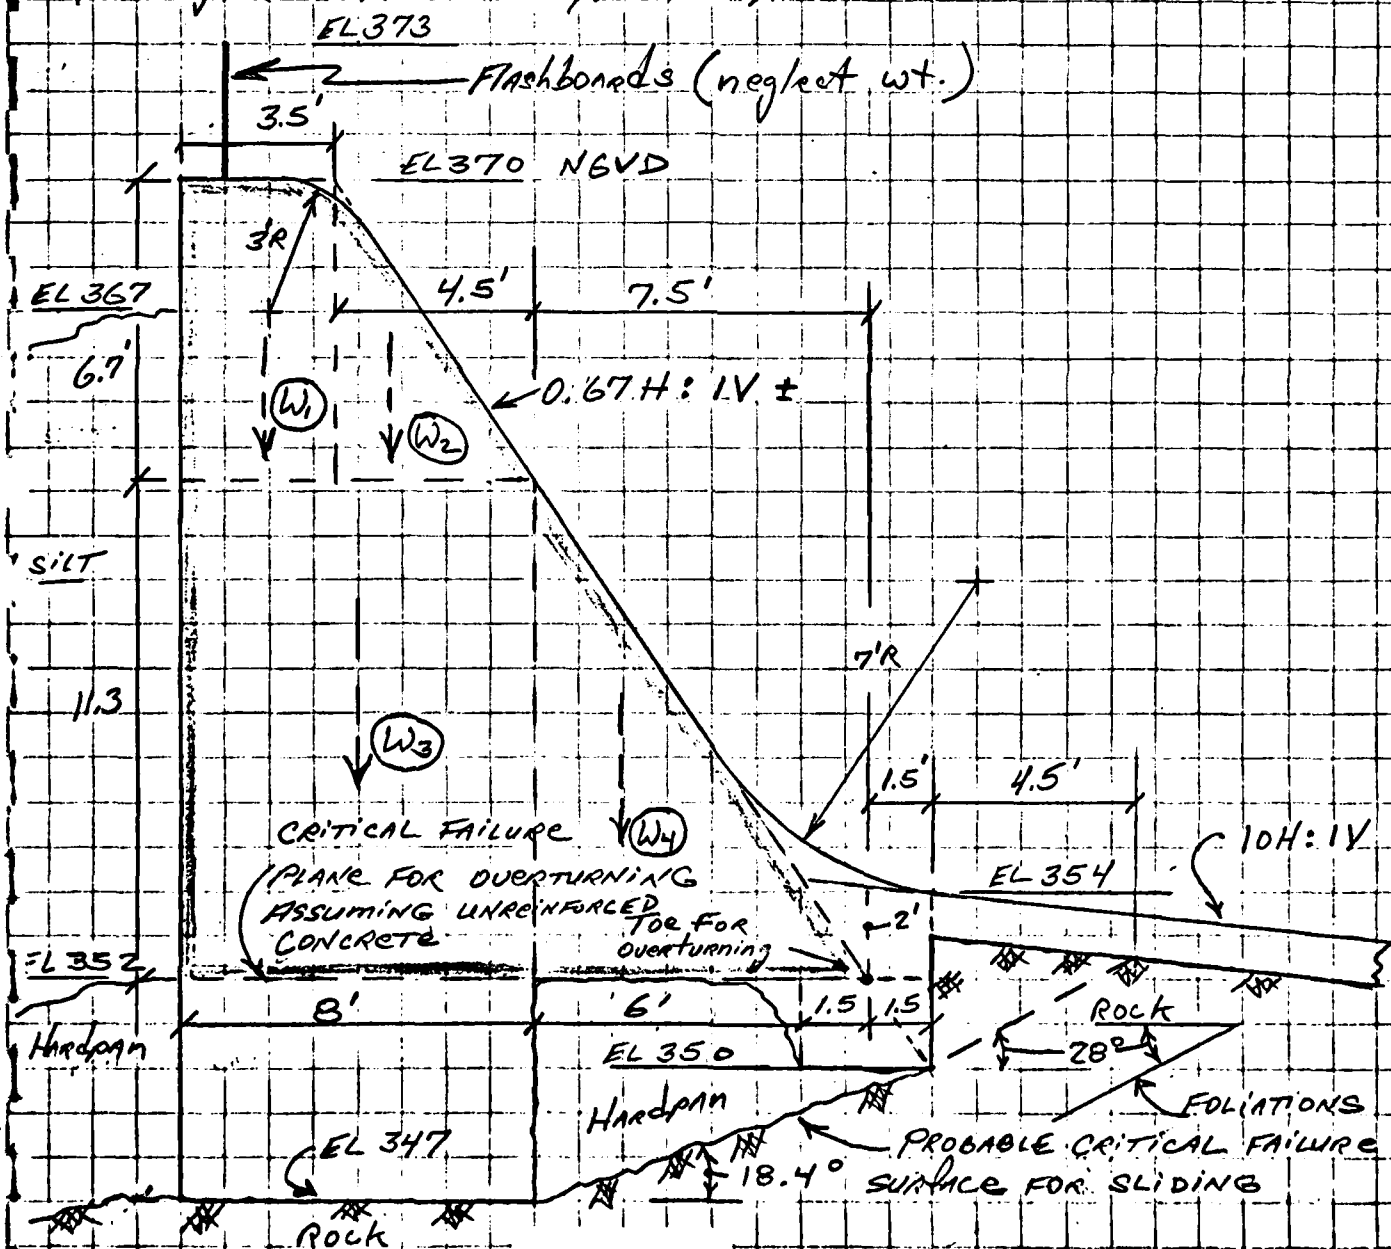
# STABILITY ANALYSIS OF SPILLWAY

CROSS SECTION FOR ANALYSIS (10' from right training wall, less than max. height and somewhat free from effects of lateral support of training wall, see Photos A-6A, 6B & 7B & dwg. Appendix G-1, NGVD base 90' higher than old dwg. base)

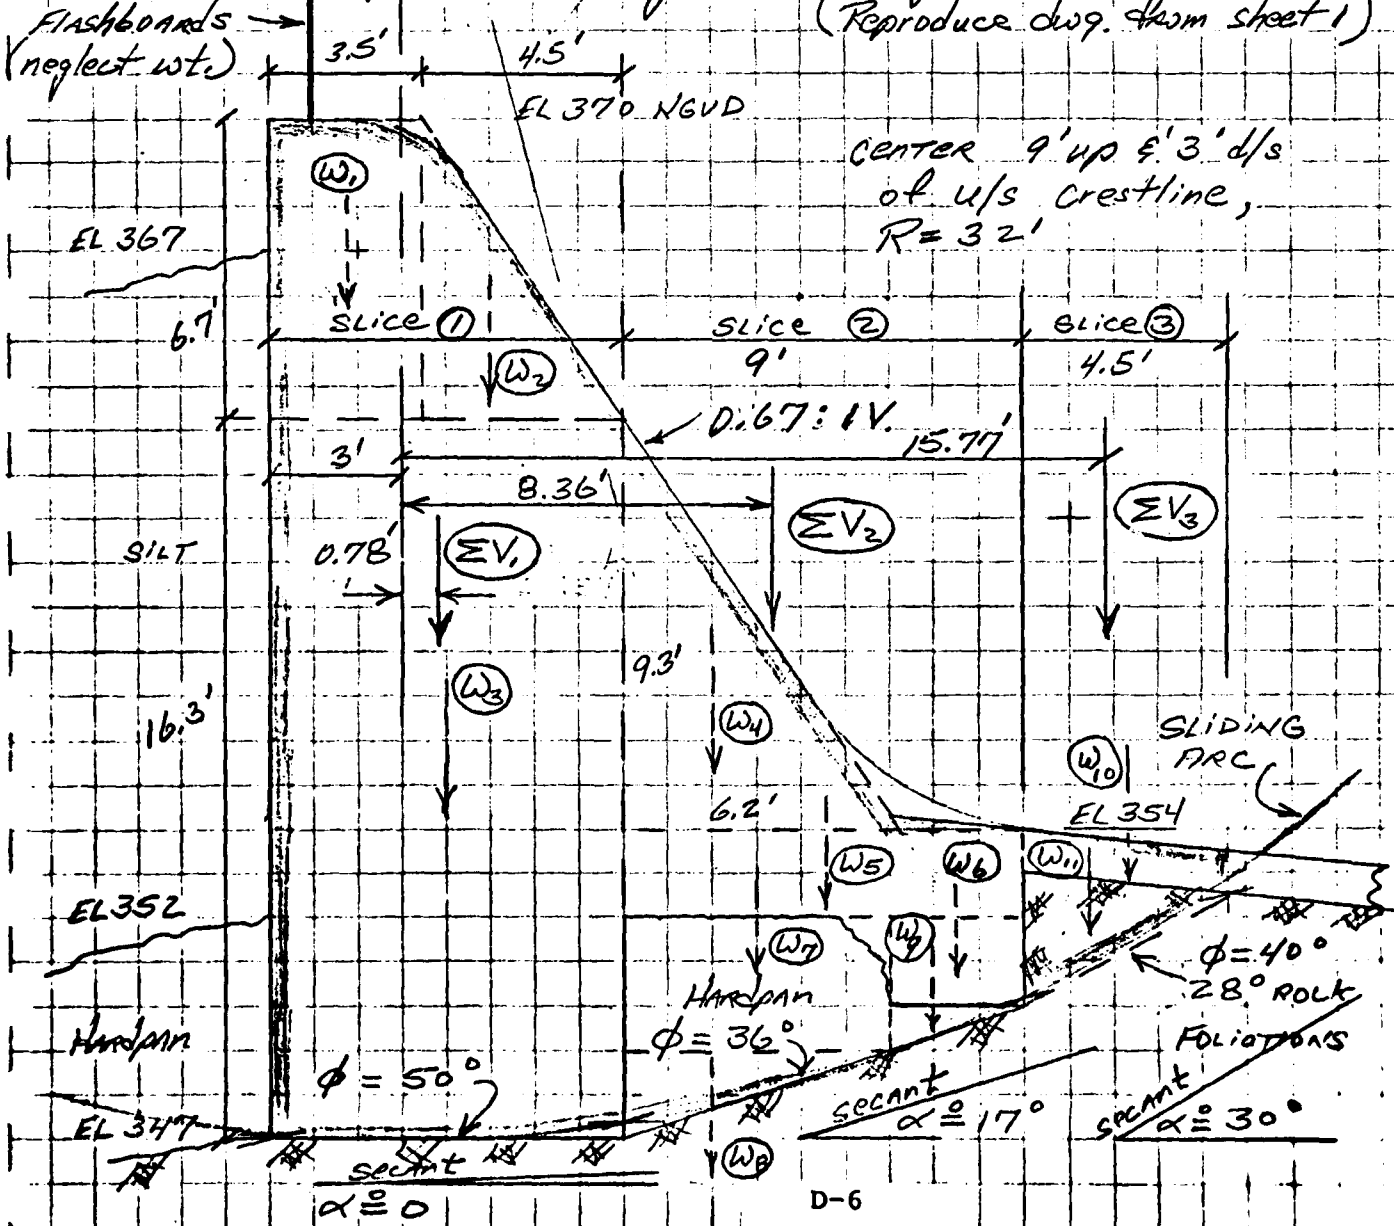
CASE 1 - SLIDING Rock foliations strike  $N 30^{\circ} E$  - almost parallel w/ spillway crest - but dip  $28^{\circ} N$ , i.e. u/s, see dwg. Appendix G-1 for direction. Since dip angle is large and is against direction of sliding, critical failure surface is a circular arc of best fit. To analyze use method of slices (Reference 30) & compute moments about center of arc. This takes into account reduction in net driving moment caused by weight of sliding mass acting in opposite direction. (Reproduce dwg. from sheet 1)

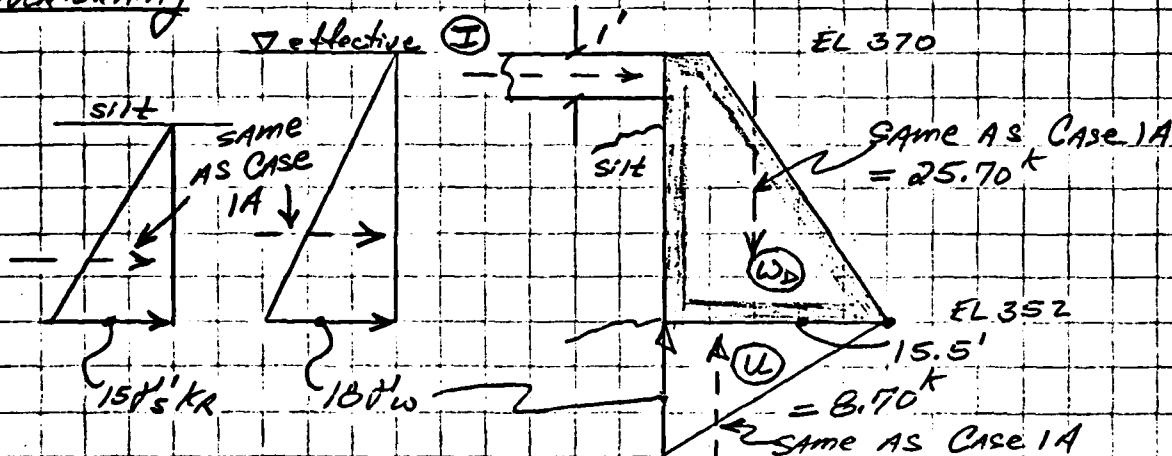
CASE 2 - Normal Pool plus Ice Load. Flashboards are normally removed for winter. MAY. recommended ice load (Ref. 1) = 10 k/ft & ice 2' thick. Use 5k/ft & ice 1.0' thick as appropriate for conditions at this dam.

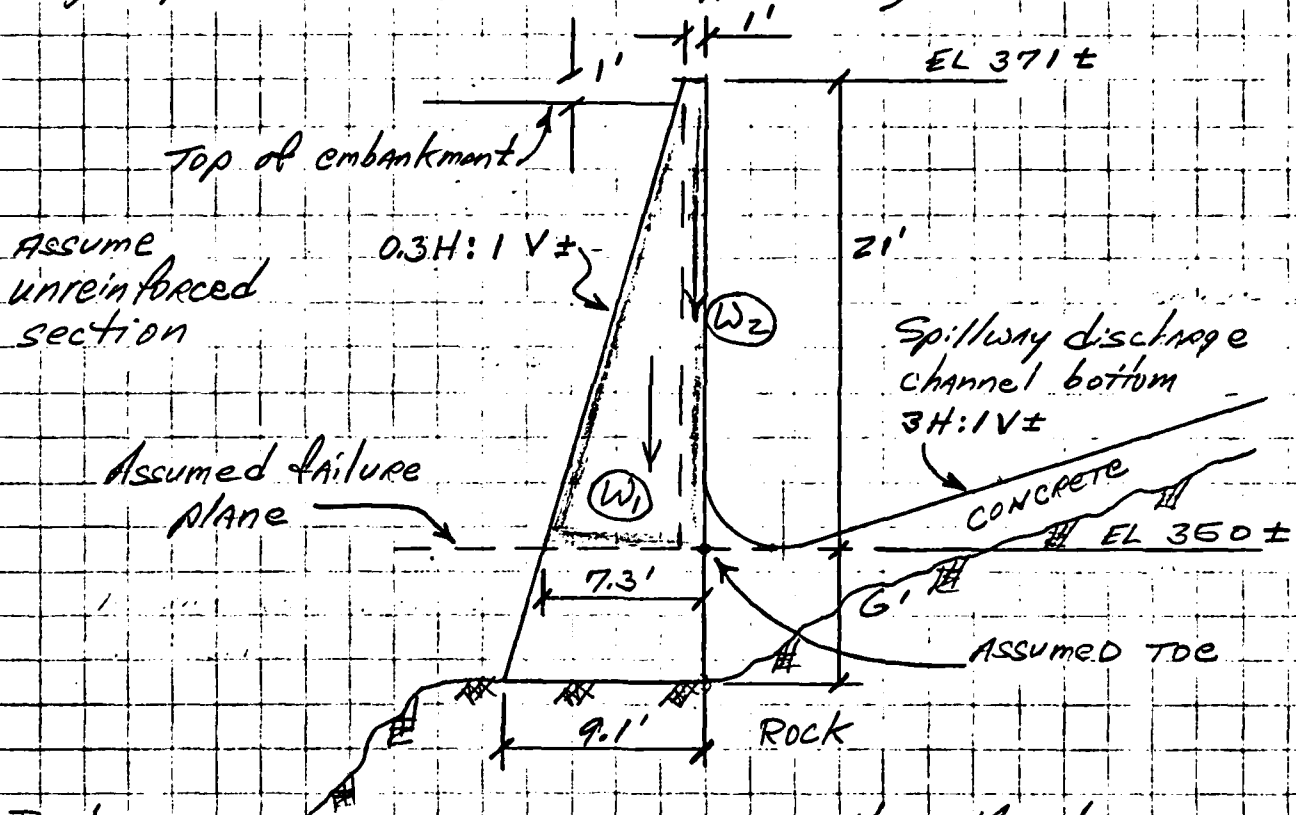
# STABILITY ANALYSIS OF RIGHT TRAINING WALL OF SPILLWAY

CROSS SECTION FOR ANALYSIS (AT MAX. UNSUPPORTED height which occurs just d/s of spillway toe, see dwg. Appendix G-1 & photos Appendix A)
