STRUCTURES NOTE 469

**DISENGAGEMENT OF SAFETY HARNESS BUCKLES**  
**-CT4**

# DISENGAGEMENT OF SAFETY HARNESS BUCKLES —CT4

During the crash of a CT4 Airtrainer in August, 1979 both safety harness buckles disengaged.

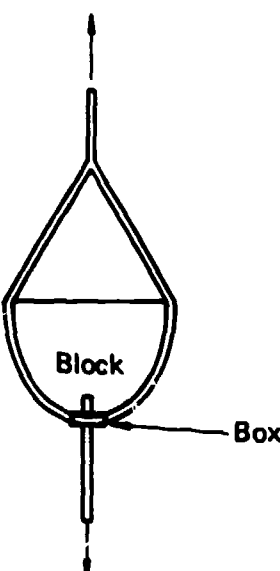
<div style="margin-left: 20px;"> <p>Lap strap with release box was placed around tummy block as sketch, and a 4000 lb. load applied in direction of arrows. No visible distortion or damage to box was apparent.</p> </div> </div> <div style="text-align: right; margin-top: 20px;"> <p>.....</p> <p><b>Chief Inspector</b></p> </div> <div style="text-align: right; margin-top: 30px;"> <p><b>Received 12 Sept. 1979</b></p> </div>

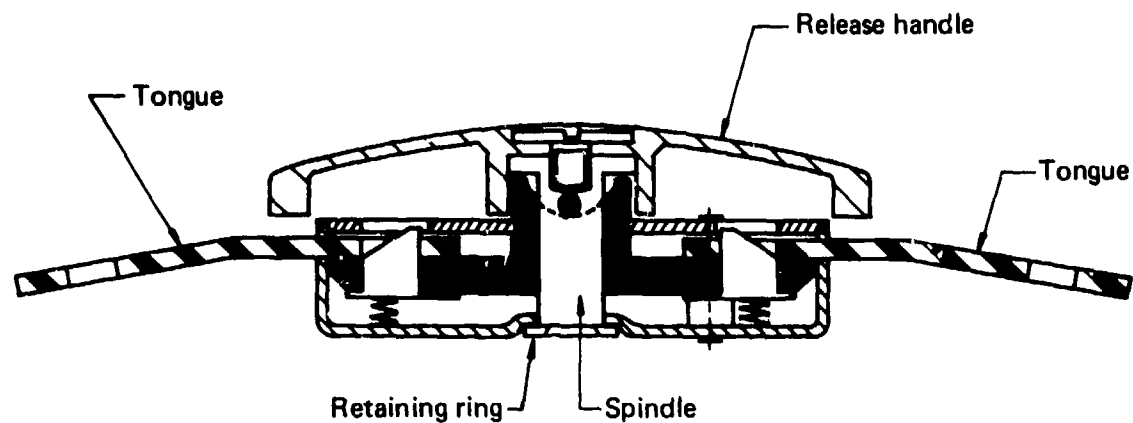
The construction is shown diagrammatically in Figure 2. Tension from the straps is transmitted across the buckle by "tongues", "latch pins" and a "load plate" as shown in Figure 3. The "tongues" are held onto the "latch pins" by the front plate, the sides of the case and shoulders on the studs as shown in Figure 4.

FIG. 2 CONSTRUCTION OF THE BUCKLE.

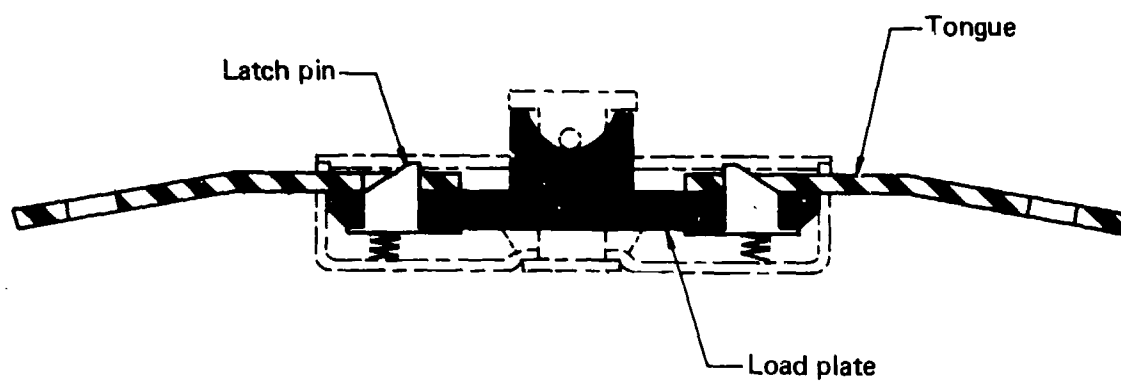
FIG. 3 TRANSMISSION OF TENSION ACROSS THE BUCKLE.

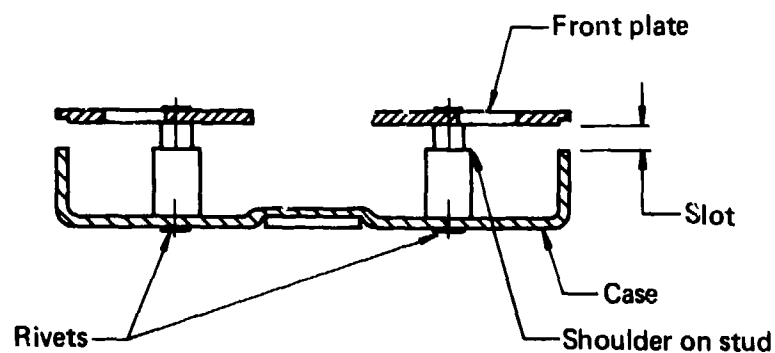
FIG. 4 'SLOTS' FOR LOCATION OF THE TONGUES.

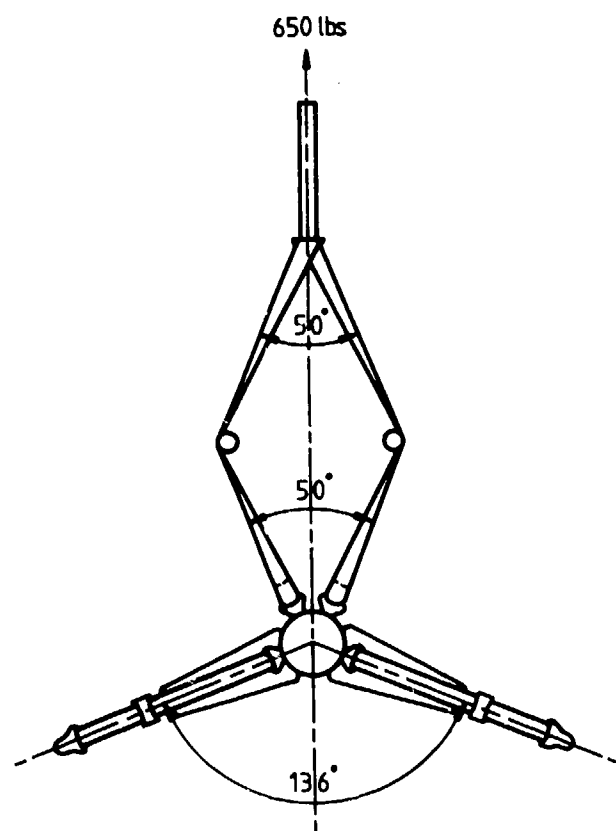
Proof loading diagram

The recommended procedure for proof testing the Teleflex harness (with the Aerolex buckle) arranges all the straps and the buckle in one plane as shown in Figure 7. A certification test for the buckle (reproduced in the appendix) refers to loading the belt and buckle on a "tummy block" but no details of the block are given and only lap straps were used.

FIG. 7 MANUFACTURER'S PROOF LOADING TEST.

amount of misalignment but until research indicates a better value the test procedure of "Pull-back" test A is recommended.
