LOOMIS LAKE DAM

NDI No. PA 00048
PennDER NO. 58-127
Dam Owner: Irving N. Loomis, Sr.

PHASE I INSPECTION REPORT NATIONAL DAM INSPECTION PROGRAM

Loomis Lake Dam, Susquehanna County, Pennsylvania
NDI No. PA 00048, PennDER No. 58-127
Unnamed Tributary to Hop Bottom Creek
Inspected 29 October 1980

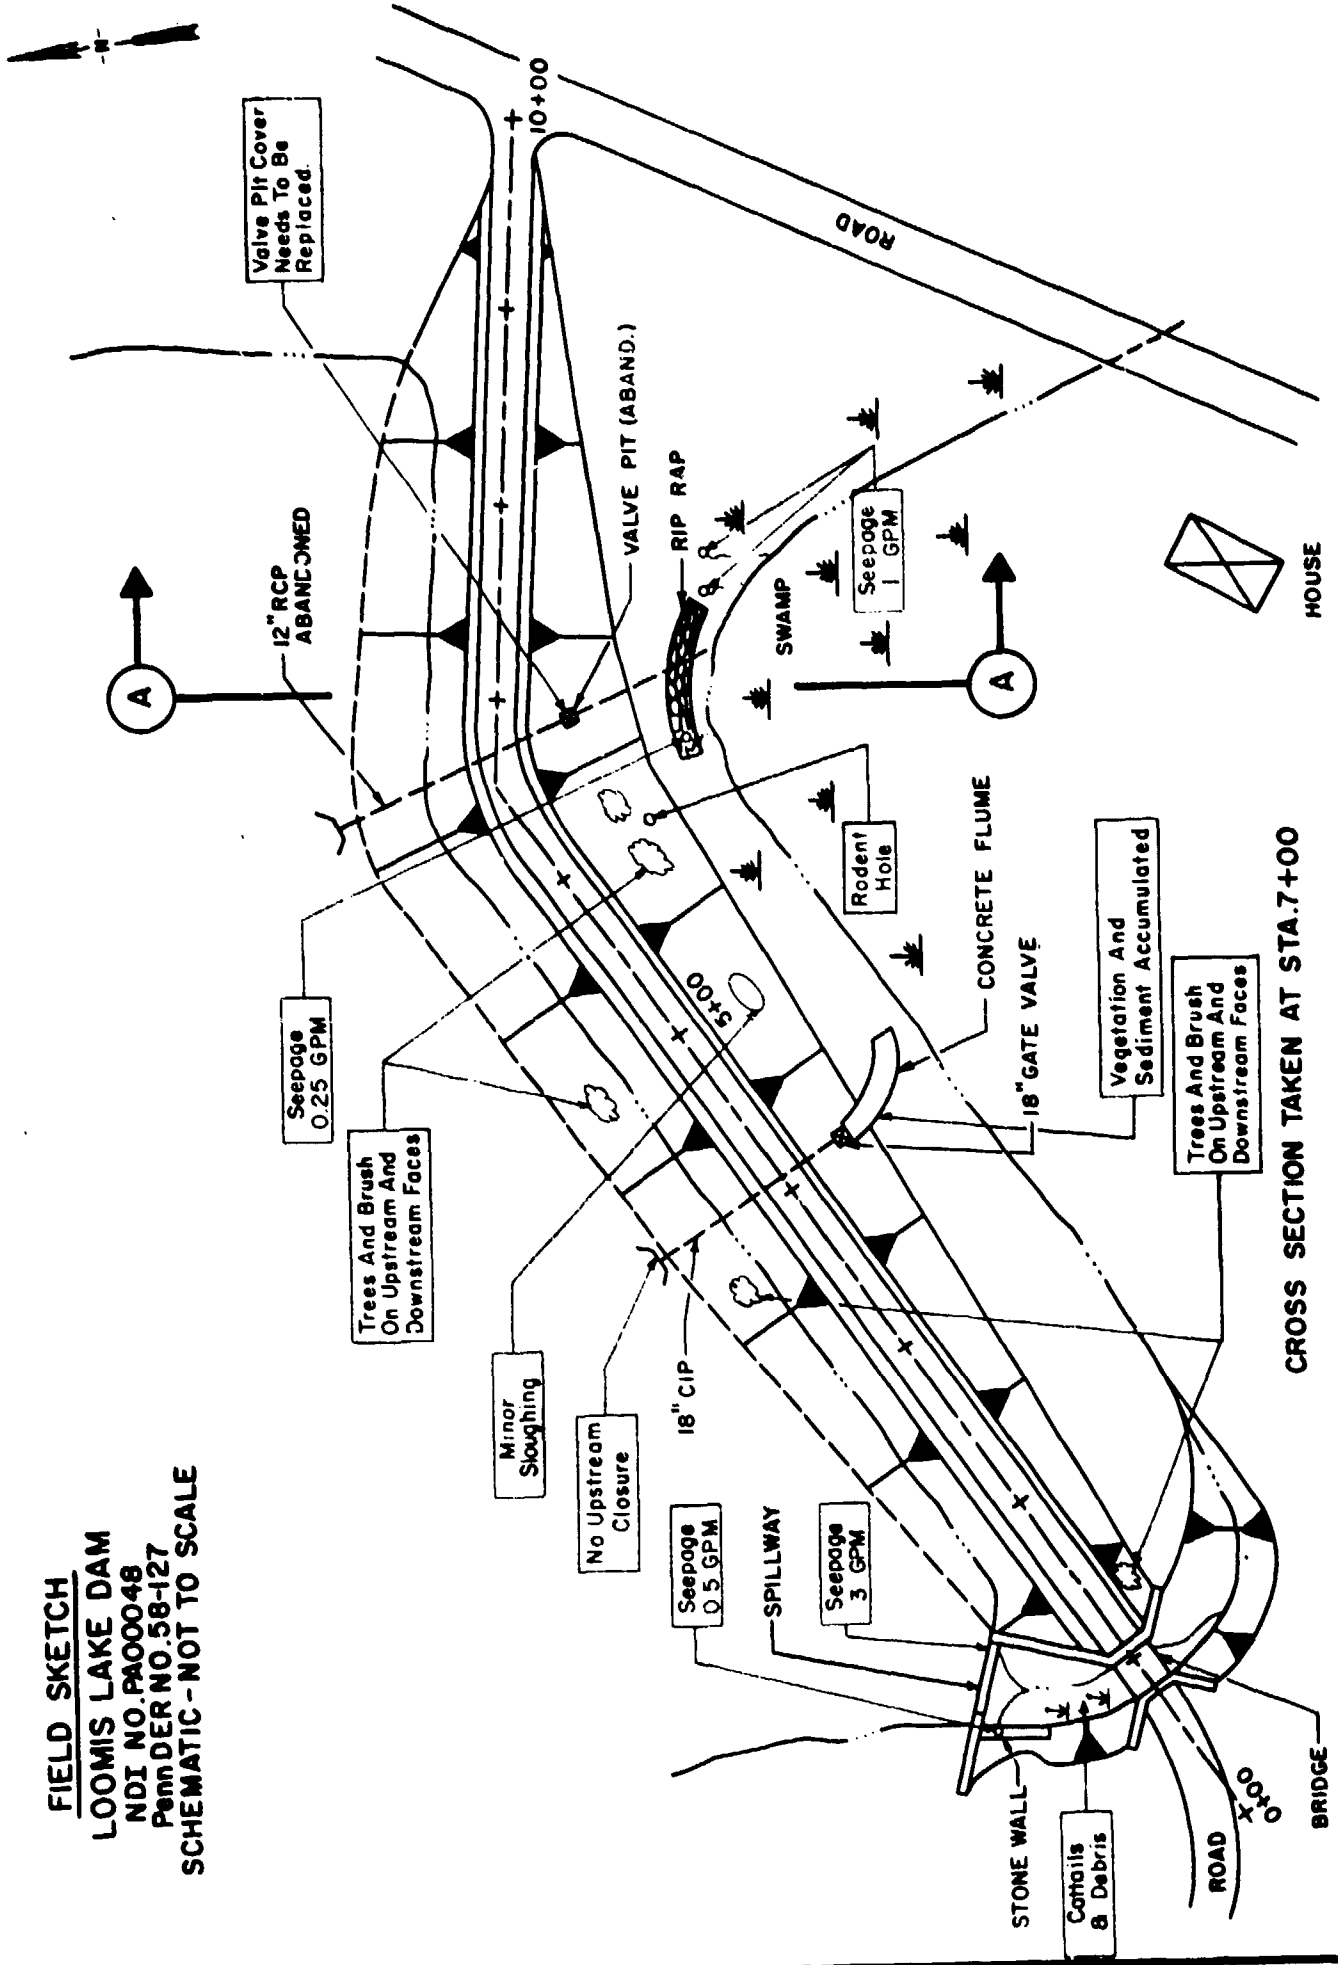
FIELD SKETCH
LOOMIS LAKE DAM
 NDI NO. PA00048
 Penn DER NO. 58-127
SCHEMATIC - NOT TO SCALE

One home and garage 500 ft. downstream
of dam with a township road 600 ft.
downstream.
