DELAWARE RIVER BASIN  
MILLTOWN DAM  
WEST CHESTER AREA MUNICIPAL AUTHORITY

NDI NO. PA-00218  
DER NO. 15-146

PHASE I INSPECTION REPORT  
NATIONAL DAM INSPECTION PROGRAM

Name of Dam: MILLTOWN DAM  
State & State No.: PENNSYLVANIA, 15-146  
County: CHESTER  
Stream: EAST BRANCH CHESTER CREEK  
Date of Inspection: APRIL 9, 1981

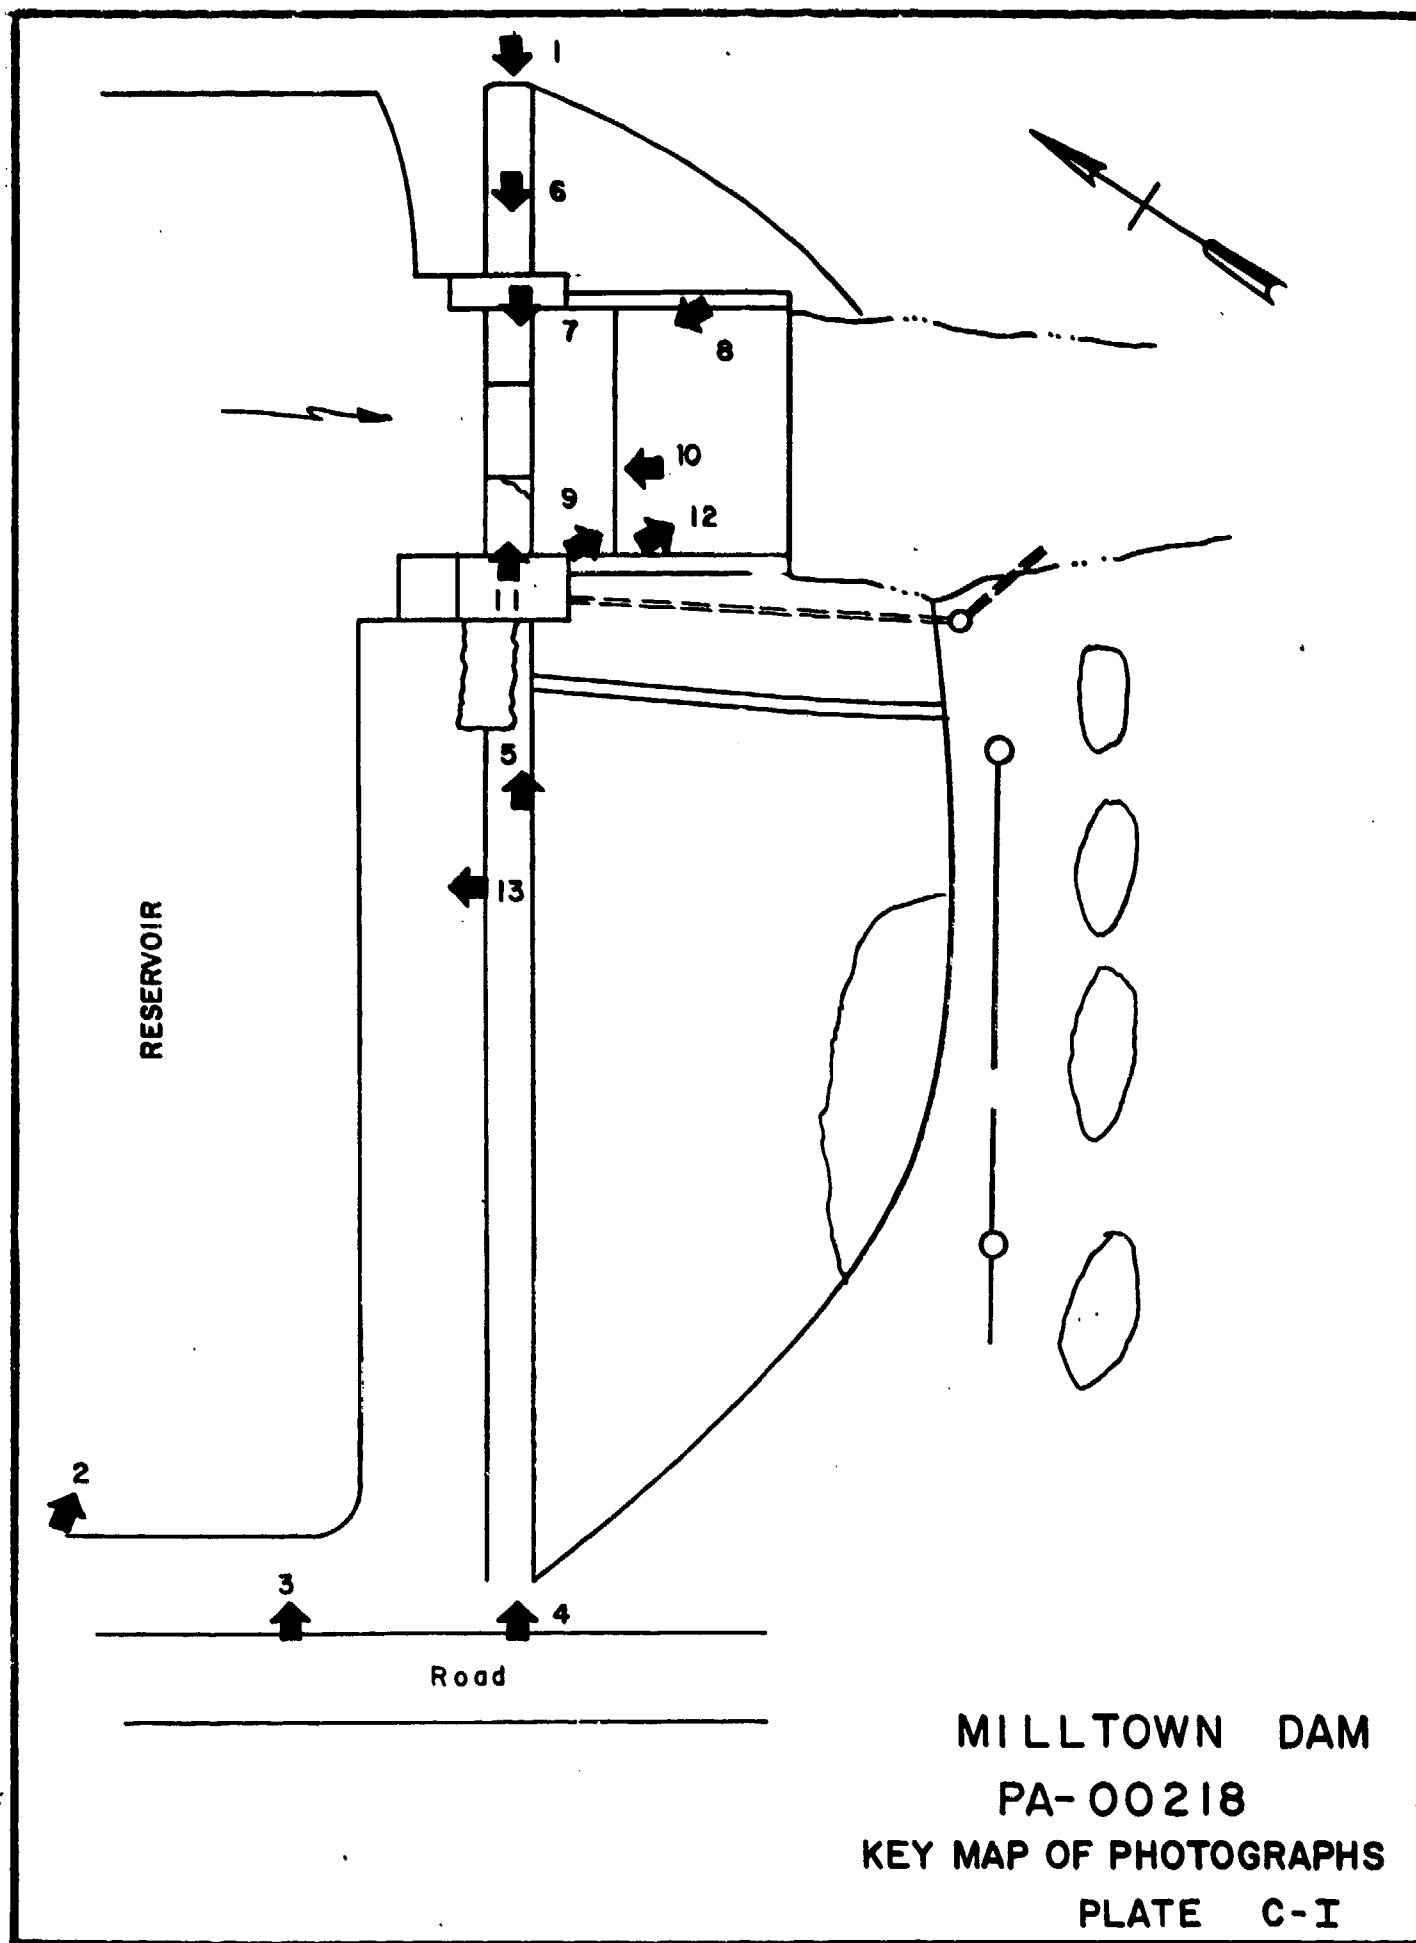
OVERVIEW OF SPILLWAY AND RIGHT EMBANKMENT - NO. 2

The embankment on the left side of the spillway has a low and narrow crest (Photographs No. 1 and No. 6). Several large trees are growing on both the upstream and downstream slopes. The embankment to the right of the spillway has a poor appearance. The crest is below the design elevation and has very little protective cover. The upstream slope is covered with dumped rock with a considerable growth of brush near the normal flow line (Photograph No. 3). The downstream slope has very dense brush over most of its surface, which prevented close observation of the condition of this slope. Rubbish and fill have been dumped on this slope. A steep, bare footpath is located adjacent to the spillway on the downstream slope. A concrete slab has been placed on the crest adjacent to the control structure (Photograph No. 5). A sewer line and several man holes are located immediately downstream of the dam (Plate A-I). Piles of rock, brush, tires, and other debris were dumped in this area.

The overall visual evaluation of Milltown Dam indicates that the dam is in poor condition due to poor maintenance practices. It is recommended that the embankment and the area immediately downstream of the embankment be cleared of all trees, brush and debris. The crest of the embankment and the slopes should be restored to their original design dimensions and be provided with a protective vegetative cover.
