SUN VALLEY DAM

PHASE I INSPECTION REPORT, NATIONAL DAM INSPECTION PROGRAM

POHOPOCO CREEK
SUN VALLEY DAM
MONROE COUNTY, PENNSYLVANIA

NDI NO. PA 00998
DER NO. 45-217

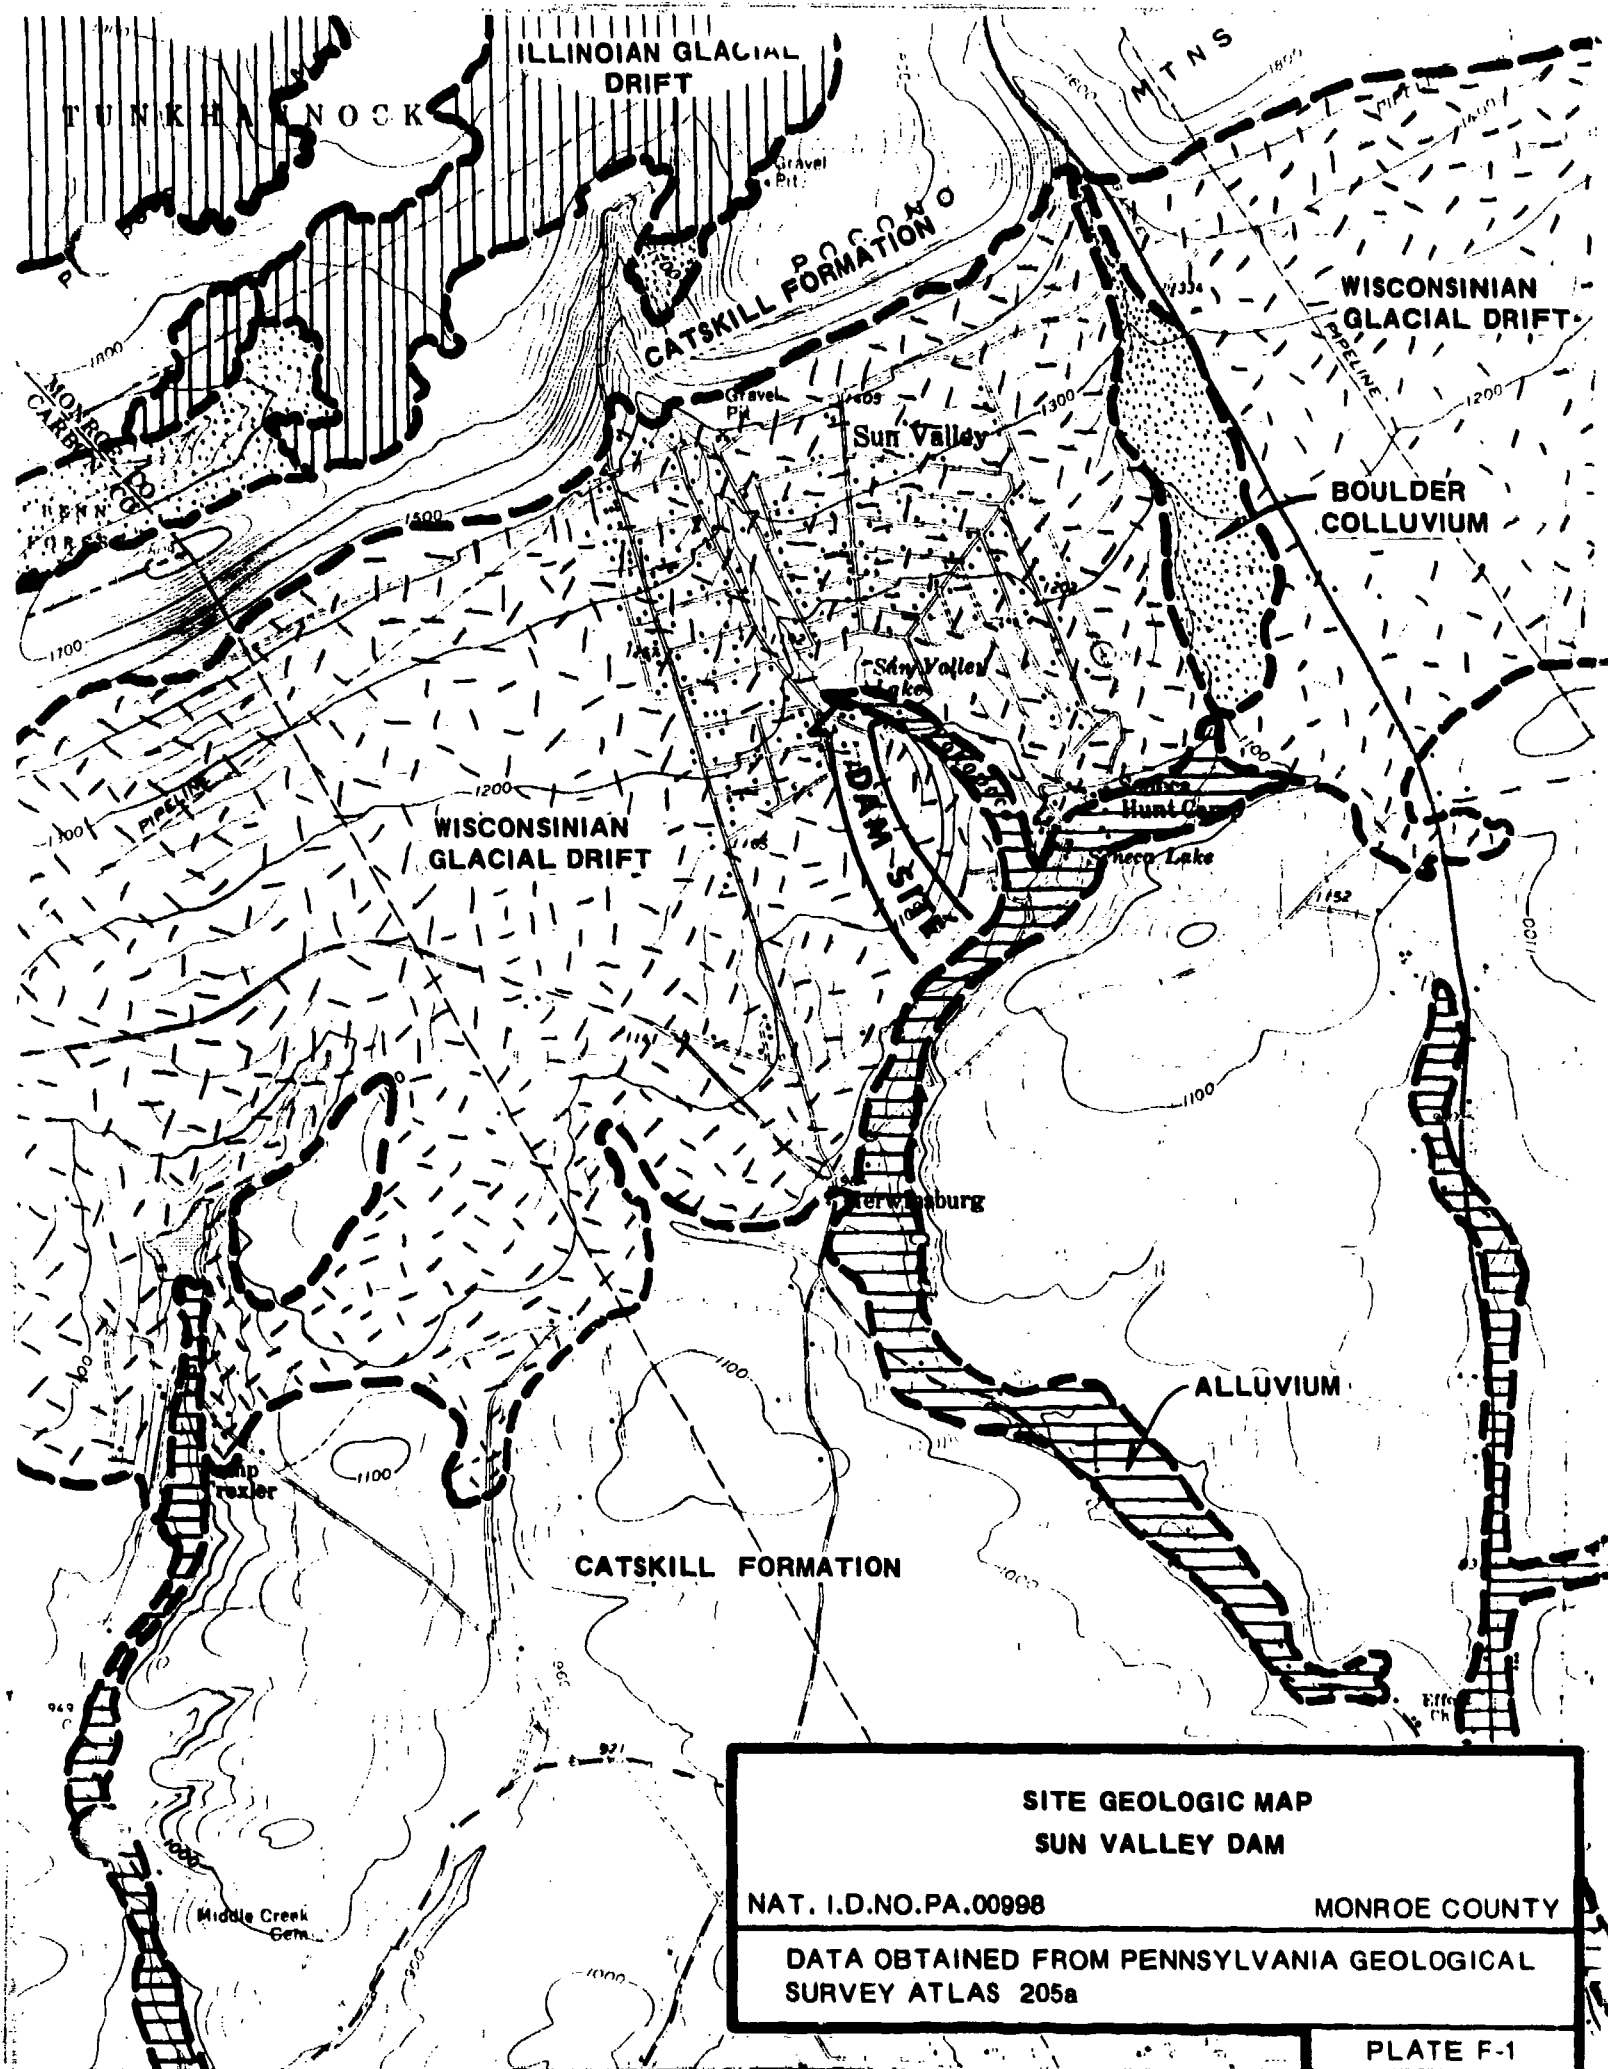
**SITE GEOLOGIC MAP
SUN VALLEY DAM**

Sun Valley Lake Dam is located in the Appalachian Mountain section of the Valley and Ridge physiographic province in an area adjacent to the Pocono Plateau section of the Appalachian Plateaus physiographic province. As shown on Plate F-1, the dam site and much of the surrounding areas are underlain by Pleistocene (Wisconsinian) age glacial drift and alluvium of Recent age. These deposits consist of varying amounts of gravel, sand, silt and clay. A limited exposure of bedrock along Pohopoco Creek downstream of the principal spillway was noted during the field inspection. The rock exposure consists of tan to red-brown siltstone and sandy siltstone of the Long Run Member of the Upper Devonian age Catskill Formation. Bedding strikes approximately N 80° E dipping 73° south (downstream). Jointing strikes N 55° W and N 10° W dipping near vertical.

Consistent with the variable compositional character of glacial deposits, there exists a potential for reservoir seepage through these deposits in addition to seepage along the relatively shallow soil-bedrock interface.
