LARSEN DAM

NDI ID NO. PA-00367

PHASE I INSPECTION REPORT
NATIONAL DAM INSPECTION PROGRAM

JULY 1981

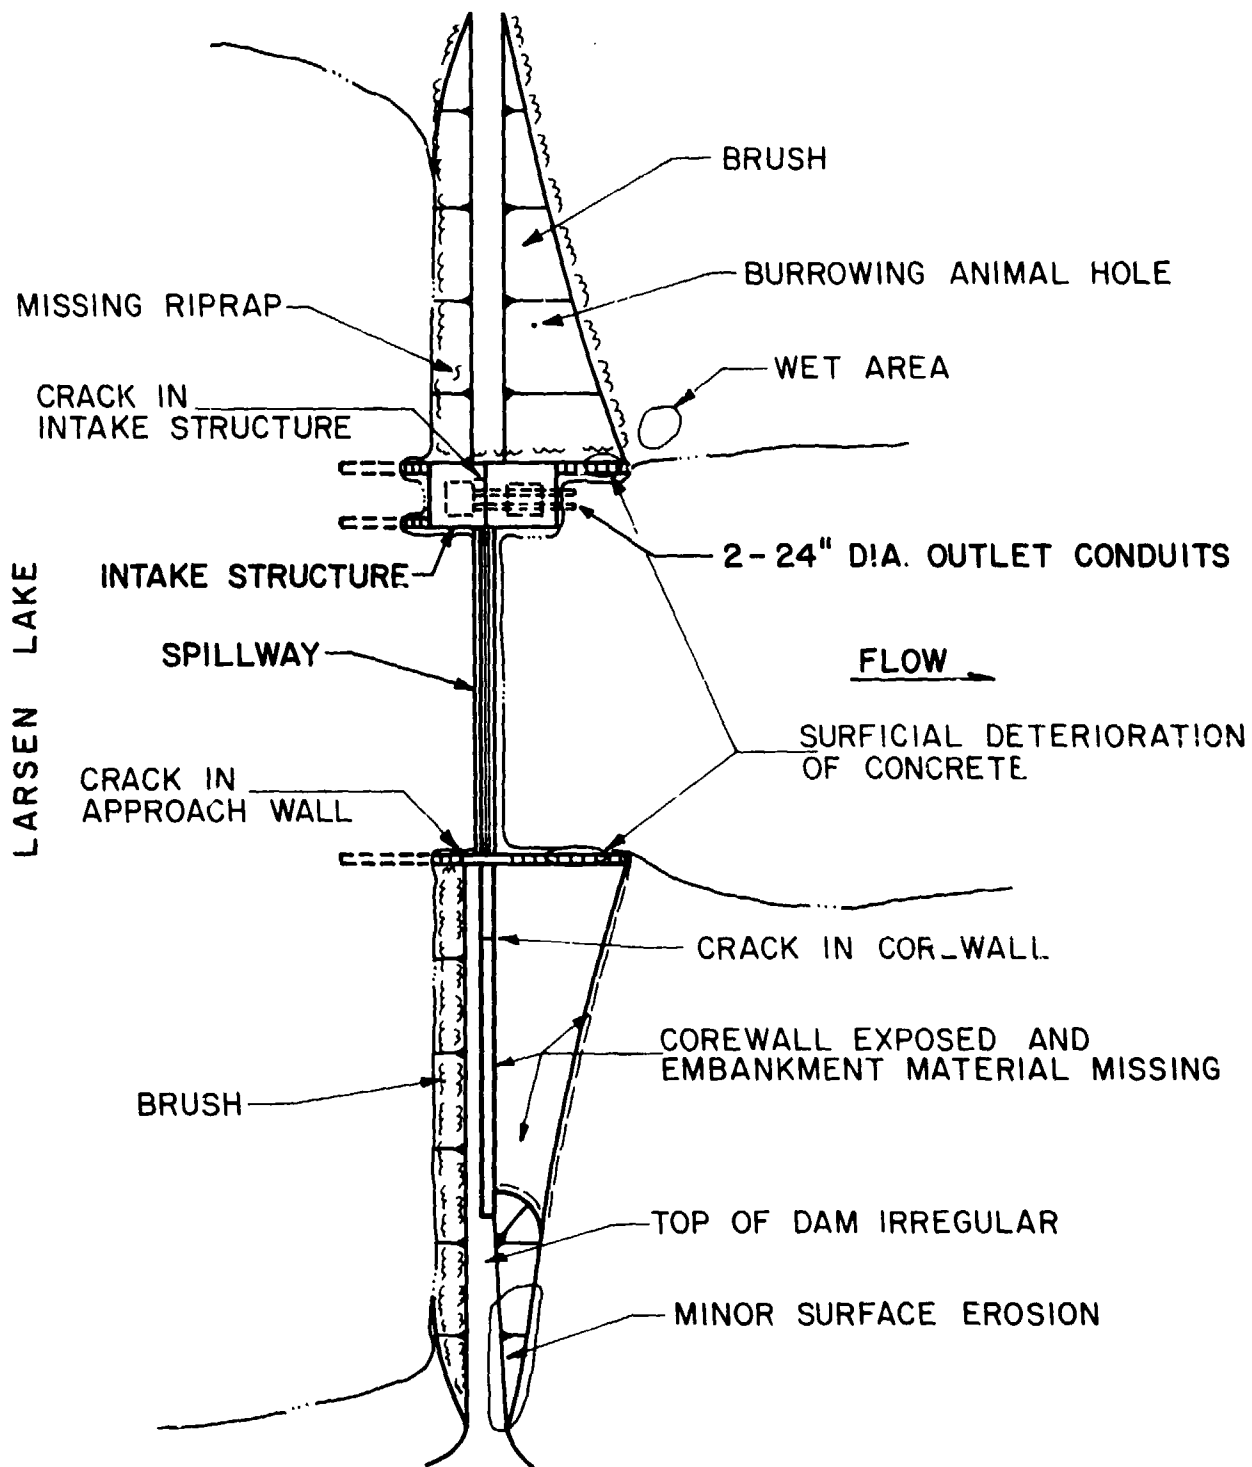
a. General. The overall appearance of the dam is fair. Deficiencies that were observed are noted below. A sketch of the dam with the locations of deficiencies is presented on Exhibit B-1 in Appendix B. Survey information acquired for this report is summarized in Appendix B. Datum used for the survey was the spillway crest level, Elevation 1882.6, as shown on Plate E-2 in Appendix E. On the day of the inspection, the pool was at Elevation 1882.8.
