CRAFT POND DAM

NDI ID NO. PA-01103

PHASE I INSPECTION REPORT  
NATIONAL DAM INSPECTION PROGRAM

JULY 1981

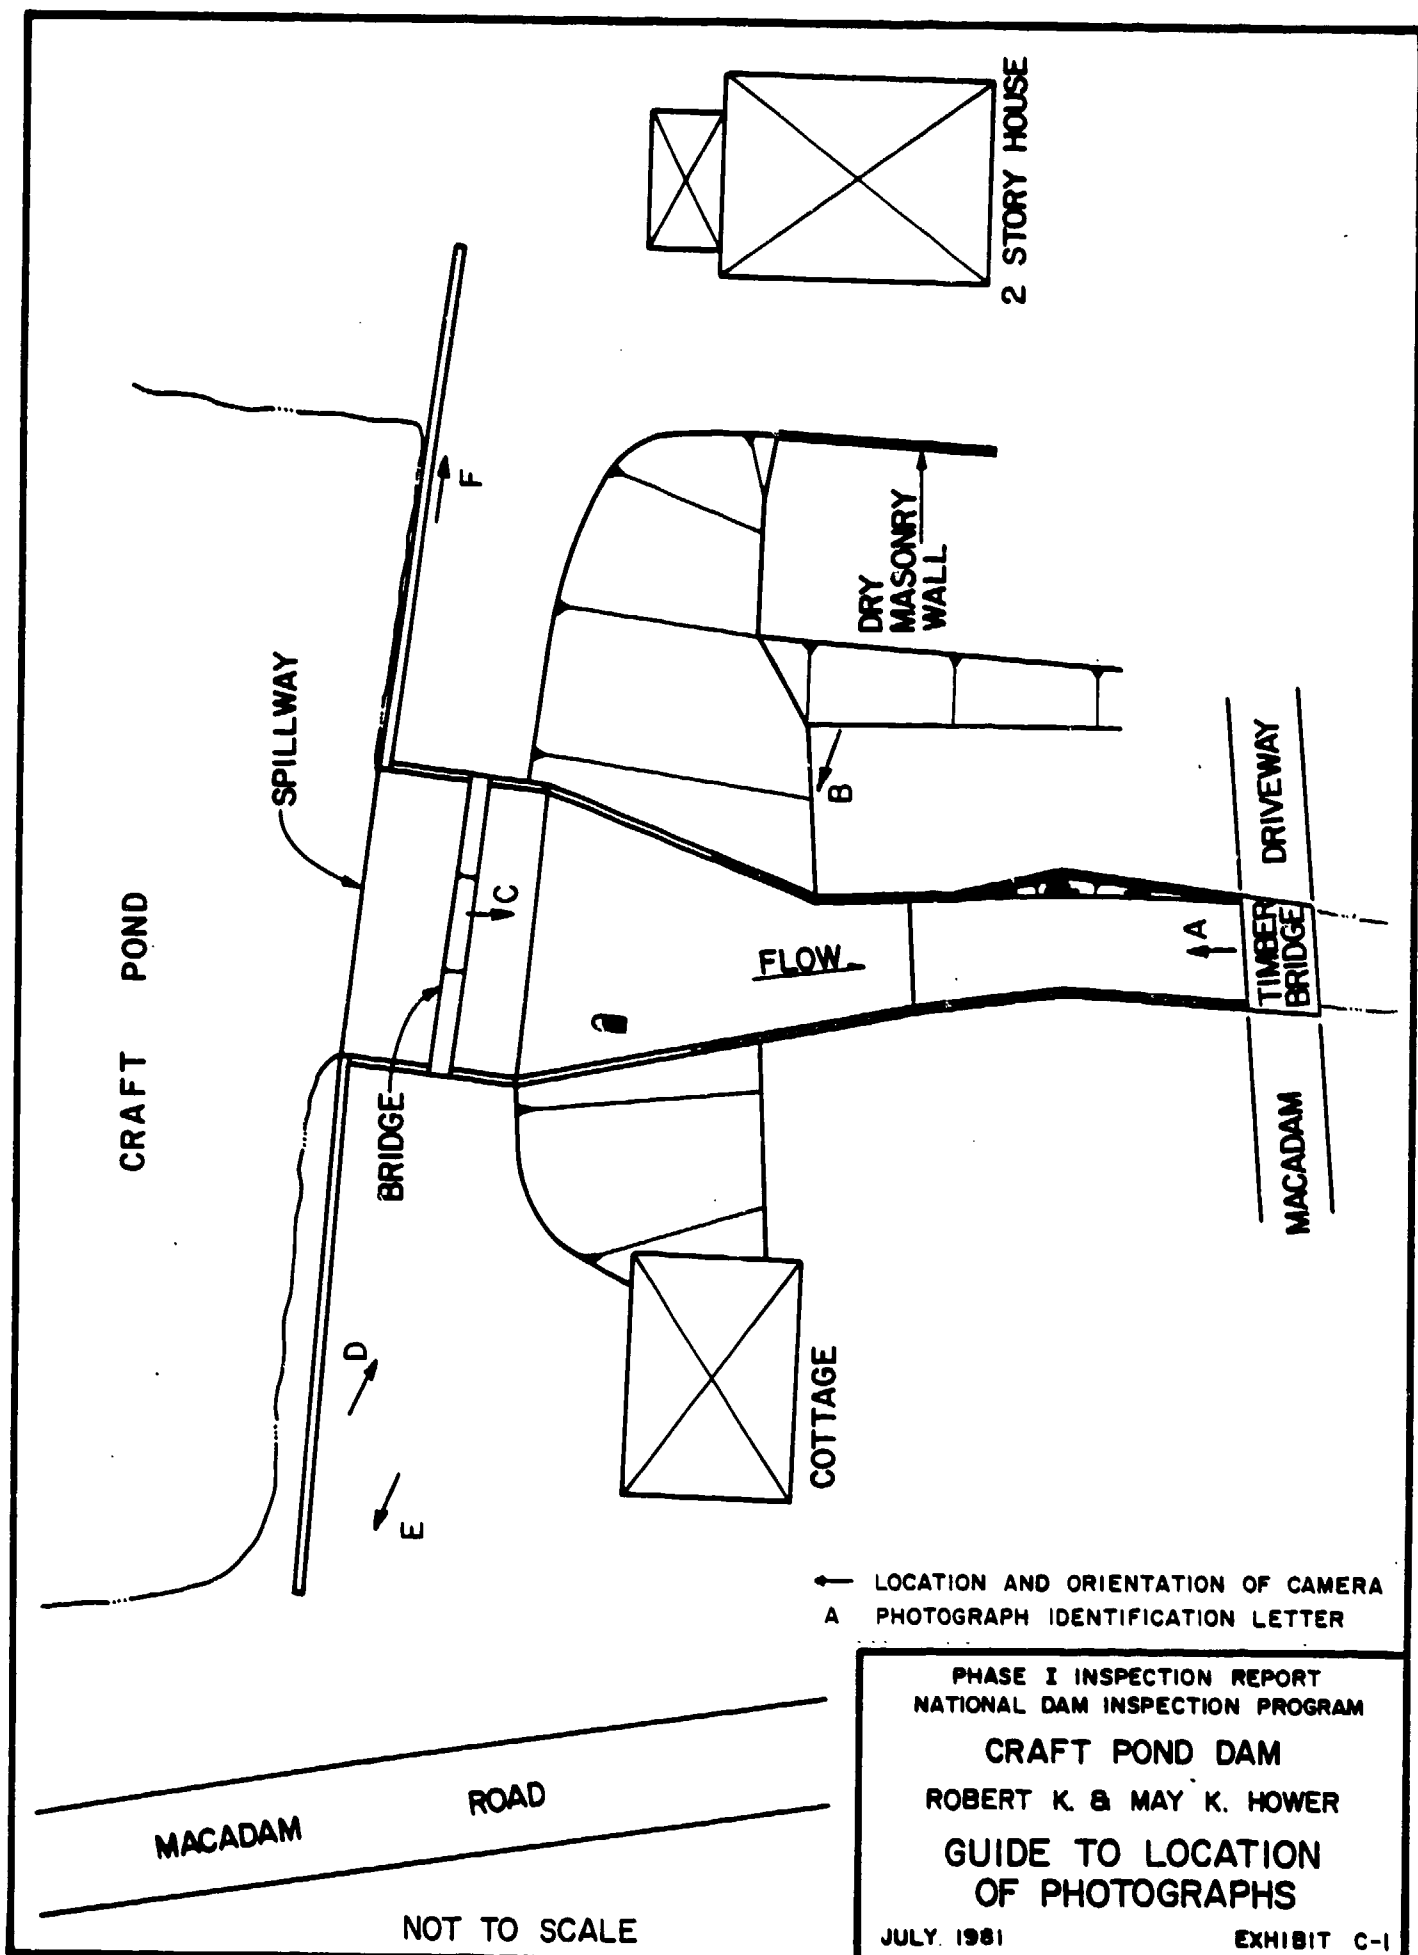
F. Left Abutment

b. Embankment. The embankment is in good condition. The grass covering the embankment is well maintained. There is one mature tree growing on the embankment to the right of the spillway (Photograph D). Two other mature trees are growing at the left abutment (Photograph F). As noted on Exhibit B-1, three burrowing animal holes were observed on the embankment. The Owner reported that two of these holes were dug out to remove snakes and never completely backfilled. There are several shrinkage cracks on the upstream concrete facing. Most of these cracks are repaired with mortar. There is a footing along the upstream concrete face that is sheared off at some locations (Photograph F). No seepage was observed at the dam.
