LAKE IRENA DAM

NDI ID NO. PA-00179
DER ID NO. 40-215

PHASE I INSPECTION REPORT NATIONAL DAM INSPECTION PROGRAM

SEPTEMBER 1981

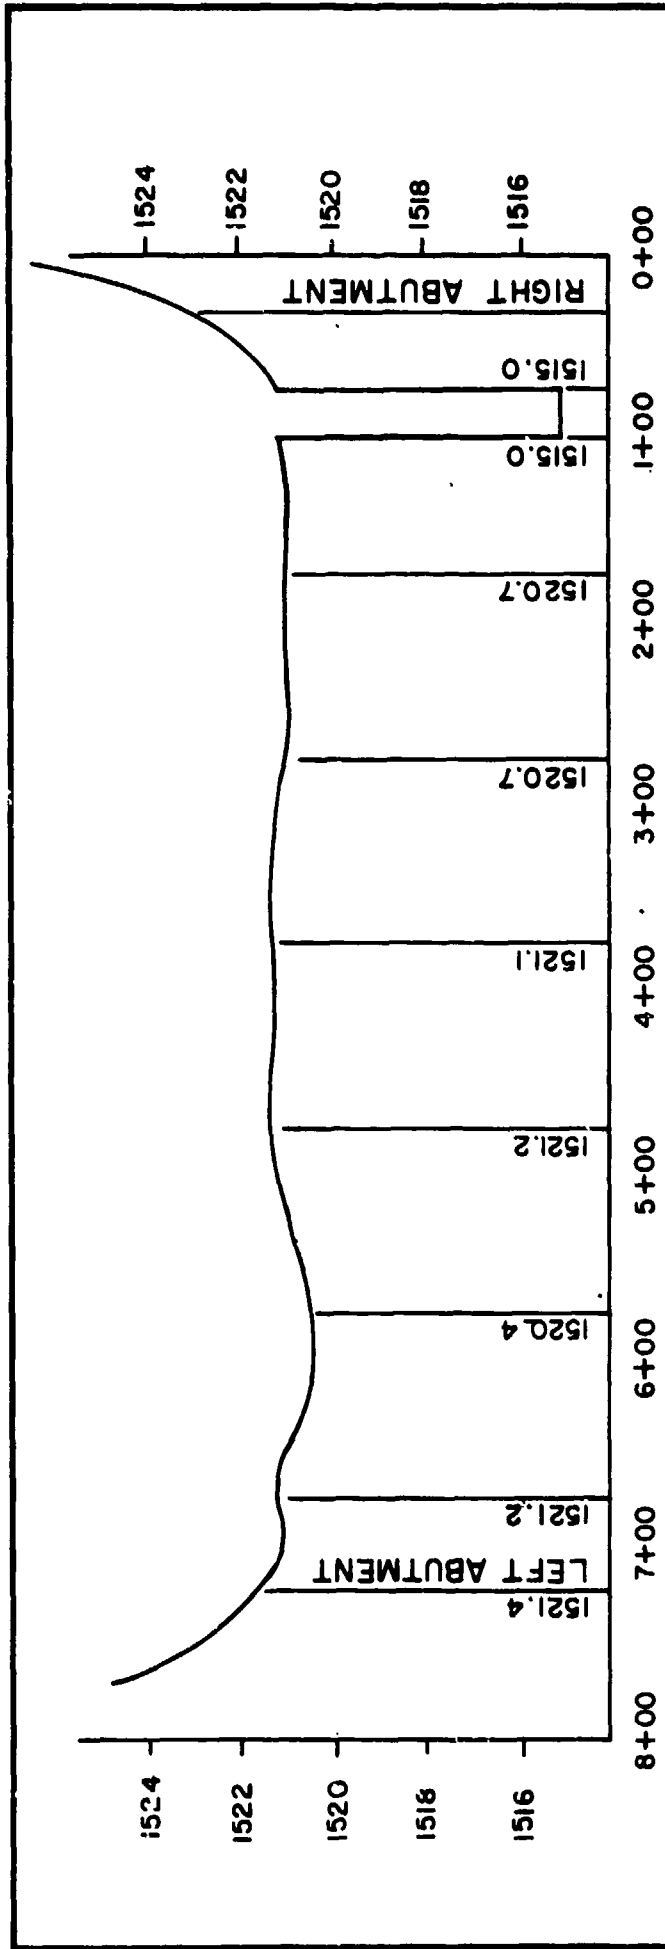
TOP OF DAM - PROFILE

b. Embankment. The vertical alignment of the crest varied about 0.8 foot with a low point occurring approximately 150 feet to the right of the left abutment. No signs of horizontal movement of the crest were observed. Practically the entire 27 foot wide crest was devoid of vegetation. This was apparently due to heavy foot traffic, since the lake is located in a community park and is popular for fishermen. Minor erosion was occurring at the edges of the crest. The upstream face, which is protected by 18-24 inch riprap, has a slope of 1V:2.3H. This stone protection was in good condition and no areas of instability or erosion were observed. Numerous white birch trees are growing near the junction of the crest and upstream slope along the entire length of the dam. The downstream face slopes at 1V:2.5H. Although this face generally supported a good stand of grass, there were areas of localized surficial erosion. The cause was assumed to be the high volume of pedestrian traffic. Scattered trees and brush were growing on this face, mainly near the left and right abutments. Clear seepage was observed flowing from near the toe of a berm which was along the left side of the spillway discharge channel. This area of seepage was determined to be downstream of the junction of the embankment and natural ground. The type of vegetation in the area indicated that this condition has existed for some time. On the day of the review inspection the seepage flow had visibly increased. The location of this seepage with respect to the spillway and the direct correlation between spillway discharge and seepage flows indicates that this flow is caused by spillway discharge passing through the berm. Another wet area exists at and beyond the toe, adjacent to the left half of the dam. No movement or flow was evident in this area. According to photographs taken during construction, a large area downstream of the toe was filled and graded relatively flat. Ponding of surface runoff occurred a short time later.
