# RESERVOIR NO. 7 DAM

NDI ID NO. PA 00090  
DER ID NO. 641

FARVIEW STATE HOSPITAL

## PHASE I INSPECTION REPORT NATIONAL DAM INSPECTION PROGRAM

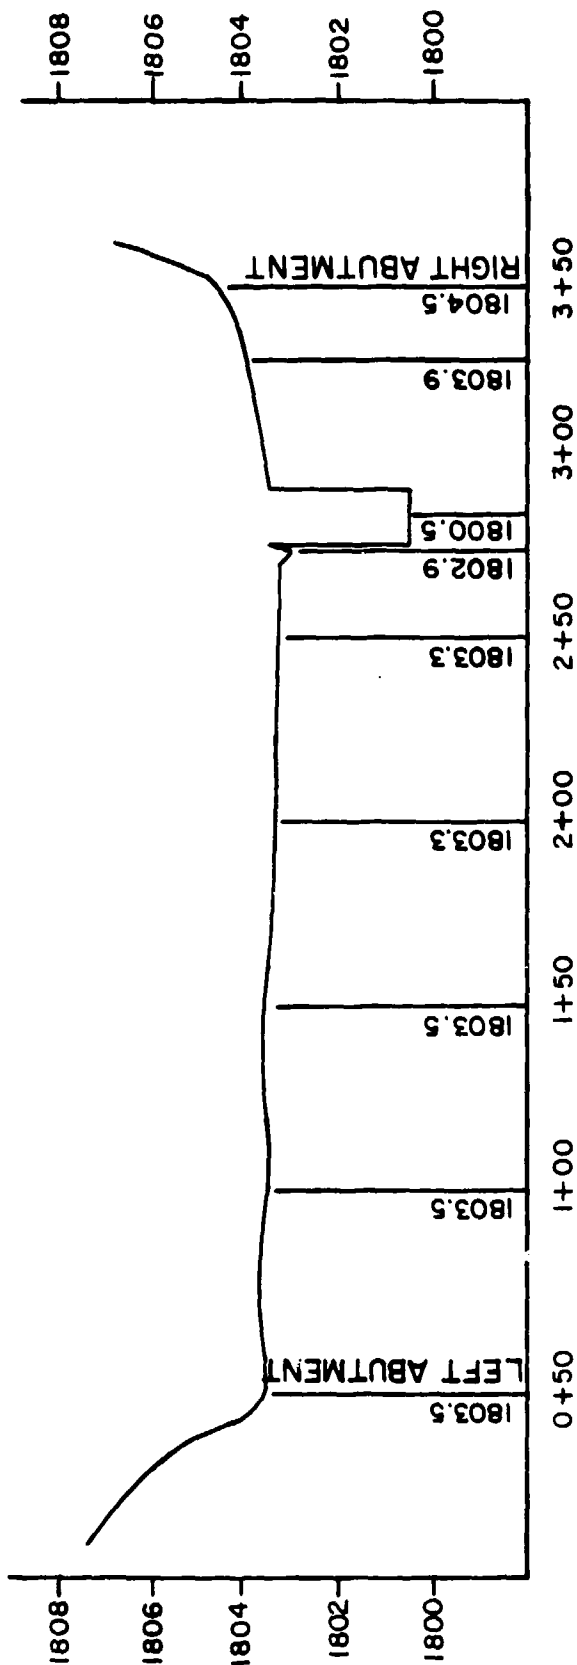
TOP OF DAM - PROFILE  
 HORIZ. 1 IN. = 50 FT.  
 SCALE - VERT. 1 IN. = 4 FT.

b. Embankment. The crest width of this earth embankment varies from 9 feet to the left of the spillway to 14 feet to the right of the spillway. The vertical alignment of the crest varies about 0.4 foot across the majority of the dam with the exception of a low point adjacent to the left spillway wall. This point is 0.6 foot below the top of the spillway wall. The apparent cause of this low area is settlement due to inadequate compaction of the embankment material adjacent to the wall. A well-maintained growth of grass covers the entire crest. The upstream face of the dam slopes at 1V:1.5H for the portion to the left of the spillway and 1V:5H to the right. This slope is protected for its full height by hand-placed riprap, which is in good condition. Some weeds and brush have been allowed to grow to a height of one to two feet near the crest. The downstream face slopes at 1V:2.7H for the portion left of the spillway and 1V:8H to the right. This slope supports a good stand of grass, although weeds are growing in the vicinity of the toe. No signs of instability or seepage were observed. Several trees are growing at the crest and on the slopes at the junction of the embankment with the left abutment. A small natural drainage ditch discharges onto the upstream slope at the right abutment.

f. Evaluation. The deficiencies noted during this inspection are basically maintenance related. The operational condition of the sluice gate and valve on the outlet works conduit should be determined and repairs made. The upstream gate should be closed and the downstream valve left open to prevent pressure within the pipe. The discharge end of the conduit should be cleared of obstructions. The deterioration of the spillway wingwalls and discharge channel walls should be repaired. All debris should be removed from in front of the weir, as well as with all trees in the discharge channel immediately below the concrete chute. In addition, the trees should be removed from the left end of the dam, and the low areas of the embankment should be backfilled to at least elevation 1803.3.

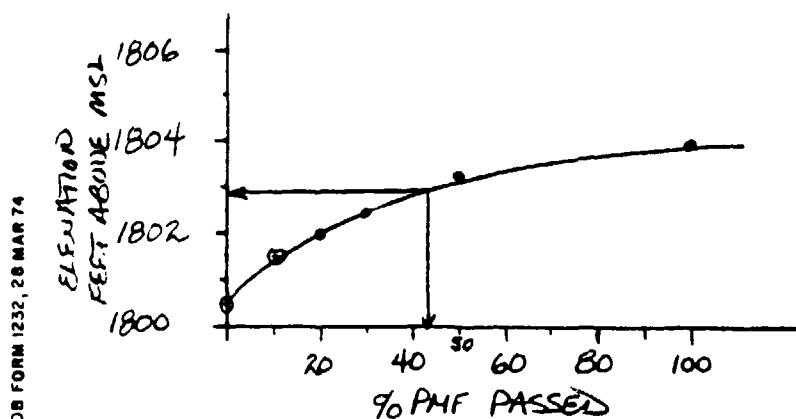
RESULTS OF THE OVERTOPPING ANALYSIS:EXISTING CONDITIONS - SPILLWAY AS ISFROM PAGE D-19, THE FOLLOWING CURVE CAN BE  
DRAWN FROM THE SUMMARY TABLE IN THIS APPENDIX

TOP OF DAM ELEVATION - 1802.9

RESERVOIR NO. 7 DAM CAN  
PASS 42% OF THE PMF PRIOR  
TO OVERTOPPING THE EMBANKMENT

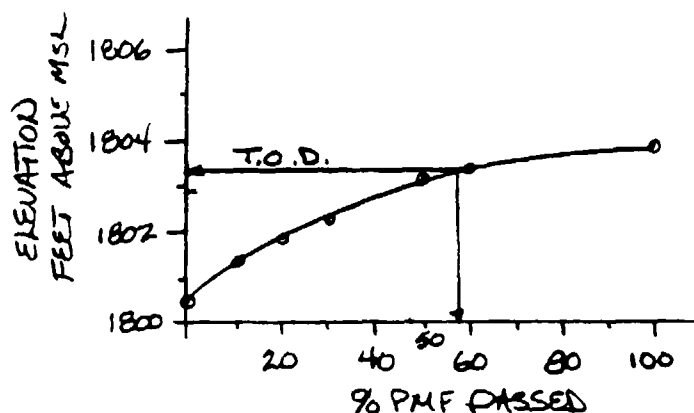
MODIFIED, RESERVOIR NO. 7 DAM CAN PASS 58% OF THE PMF PRIOR TO OVERTOPPING THE EMBANKMENT.

NOTE: TOP OF DAM AT 1803.3

REMOVAL OF THE DEBRIS IN THE ENTRANCE OF THE SHARPCREST WEIR WOULD RESULT IN THE FOLLOWING. IN ADDITION THE LOW AREA ADJACENT TO THE LEFT SPILLWAY WALL WOULD BE FILLED IN.
