NATIONAL DAM SAFETY PROGRAM, CHAZY LAKE DAM (INVENTORY NUMBER N--ETC(U))

CHAZY LAKE DAM

PHASE I INSPECTION REPORT
NATIONAL DAM SAFETY PROGRAM

AUGUST 1981

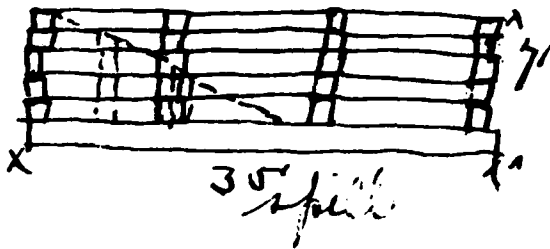
*spill all washed out.
new dam needed.*
