SSI 8115-4

Testing of Shelter Design and Industrial Hardening Concepts at the Mill Race Event

Contract No. EMW-C-0611
Work Unit 1128D

SCIENTIFIC SERVICE, INC.

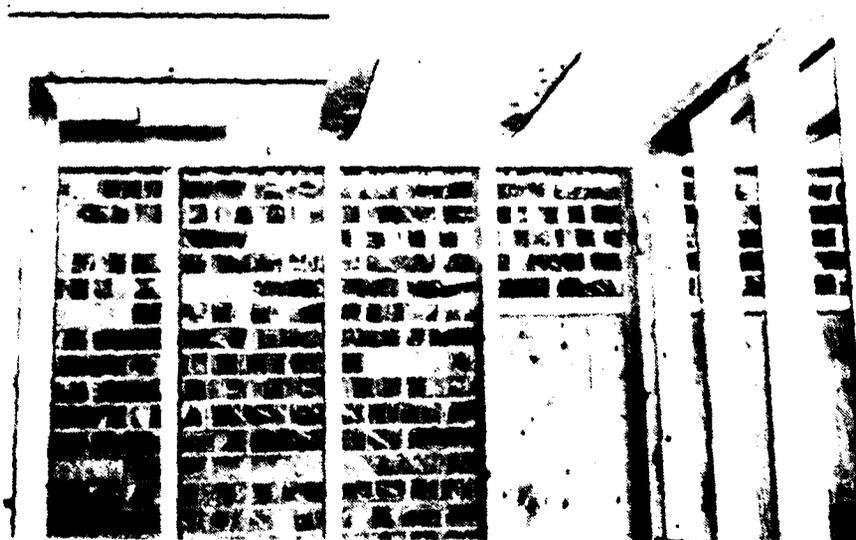
Six days after the test, one end wall of the building was cleared of earth and a door exposed. Figure 3-12 shows this exposed end wall with the door closure partially removed. An examination of the interior of the building did not indicate any structural distress in the building or the shores. No cracks were noted in either the brick or block walls, or in the concrete slab ceiling. The interior was clean and free of debris. Figure 3-13 is an interior view of the building after test, showing the ceiling slabs, wall bracing, and stud wall shoring.

Fig. 3-13. Interior View of Building, Posttest.

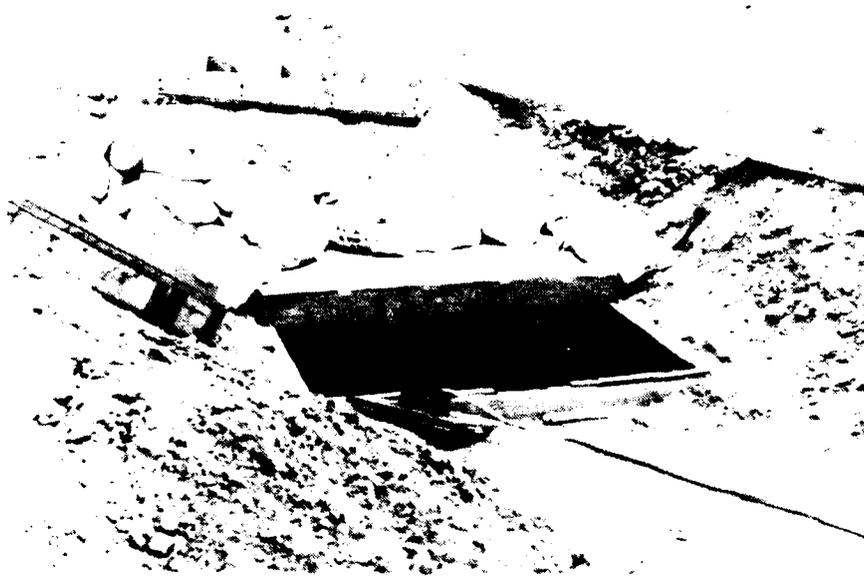
Fig. 4-11. Hatch Cover Partially in Place, Pretest.

The closure over the hatch was not secured adequately to resist the positive interior pressure created by the failure of the adjacent bay. As in many of the experiments, this hatch was expedient and designed to permit ease of access immediately prior to the test. In order to perform as a viable shelter, it would be necessary to secure the hatch from the inside, as well as close off the doorway to the unshored bay.

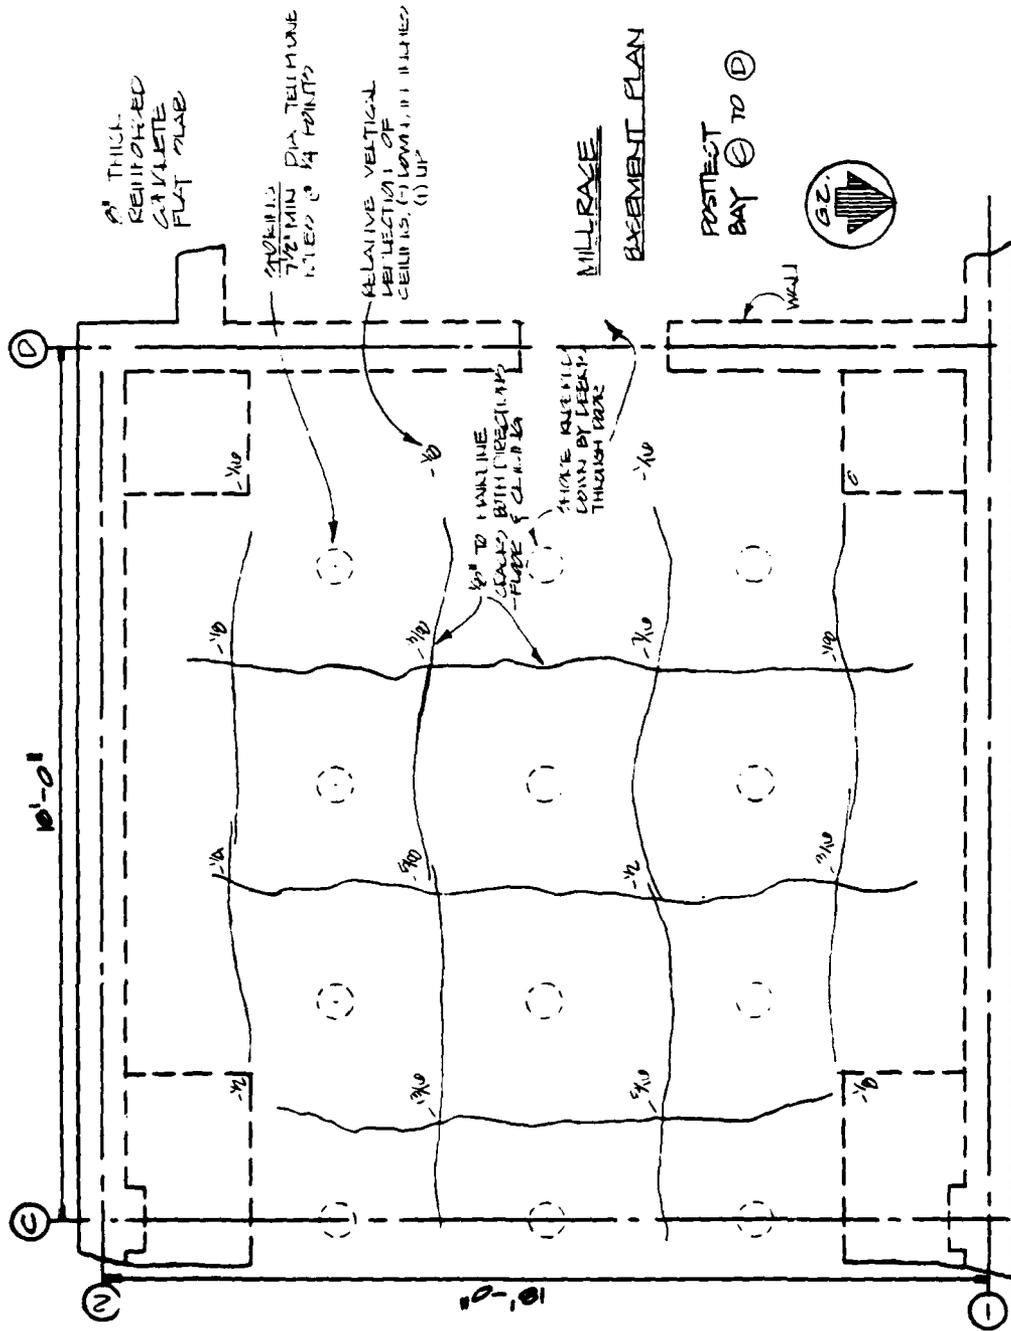
Both the floor and ceiling slabs in all three bays exhibited cracking in both directions midway between the shoring. The maximum vertical deflection of the ceiling in these bays was $5/8$ in. in a downward direction. Figures 5-28, 5-29, and 5-30 show the location of the cracks and the recorded ceiling deflections. Figure 5-31 is an interior view of these three bays looking toward line A from line C, and shows the timber pole shores in the foreground, and one of the steel tube shores in the background. Figure 5-32 is a closeup of the steel tube shores, and shows a load cell in location on top of the shore.

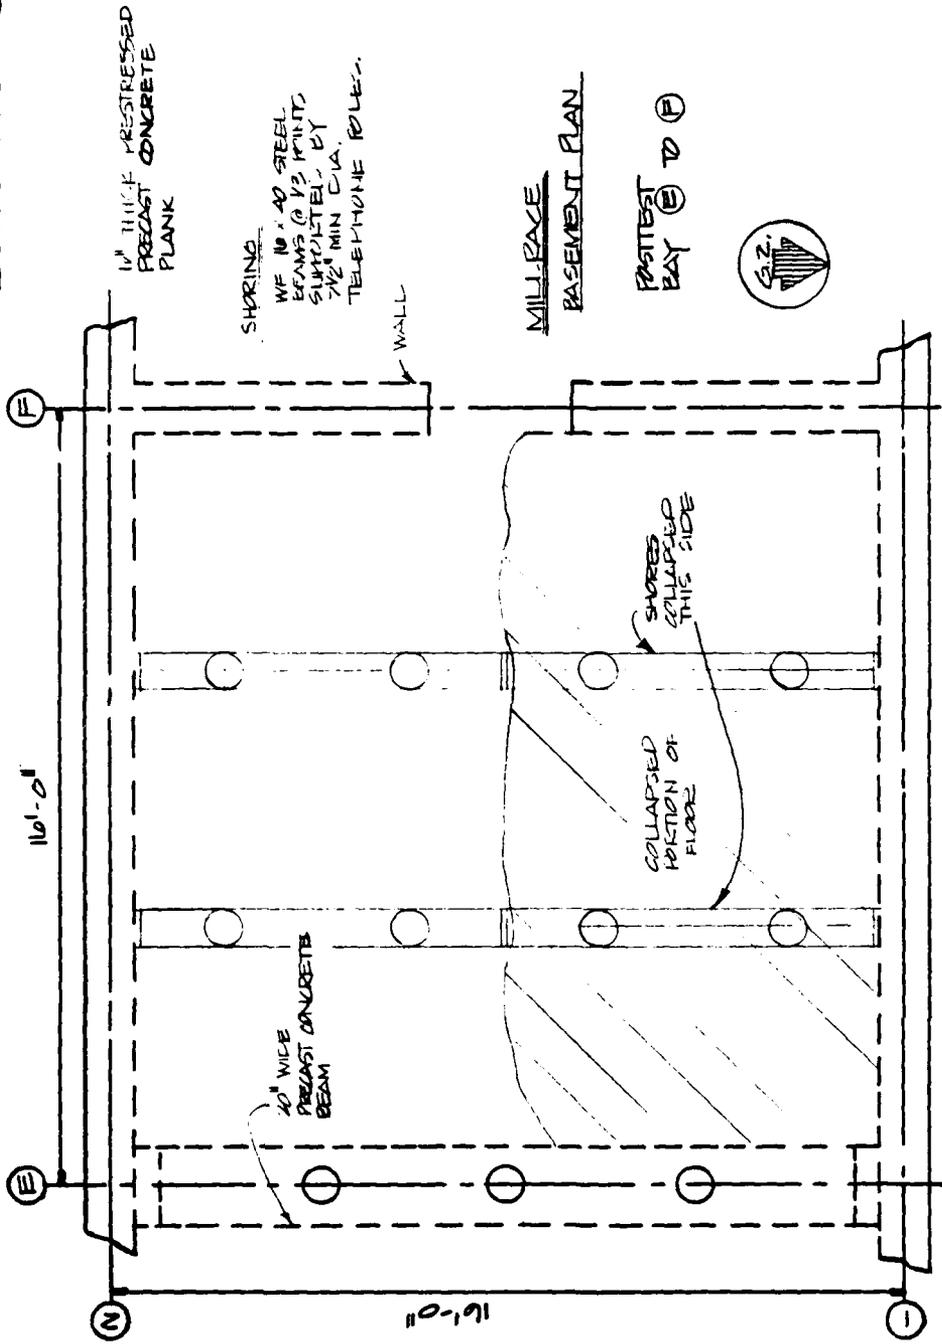
Fig. 5-37. Location of Shoring and Damage to Precast Plank Floor, Bay E to F, Area No. 2.

The double line of shoring in bay E to F would be expected to upgrade the floor to withstand loading of approximately 25 psi, and the performance was as anticipated. The appearance of the failed planks was nearly identical to those tested in the laboratory and reported in Ref. 7. The partial collapse of this bay underscored the importance of laterally bracing the shores to each other and to

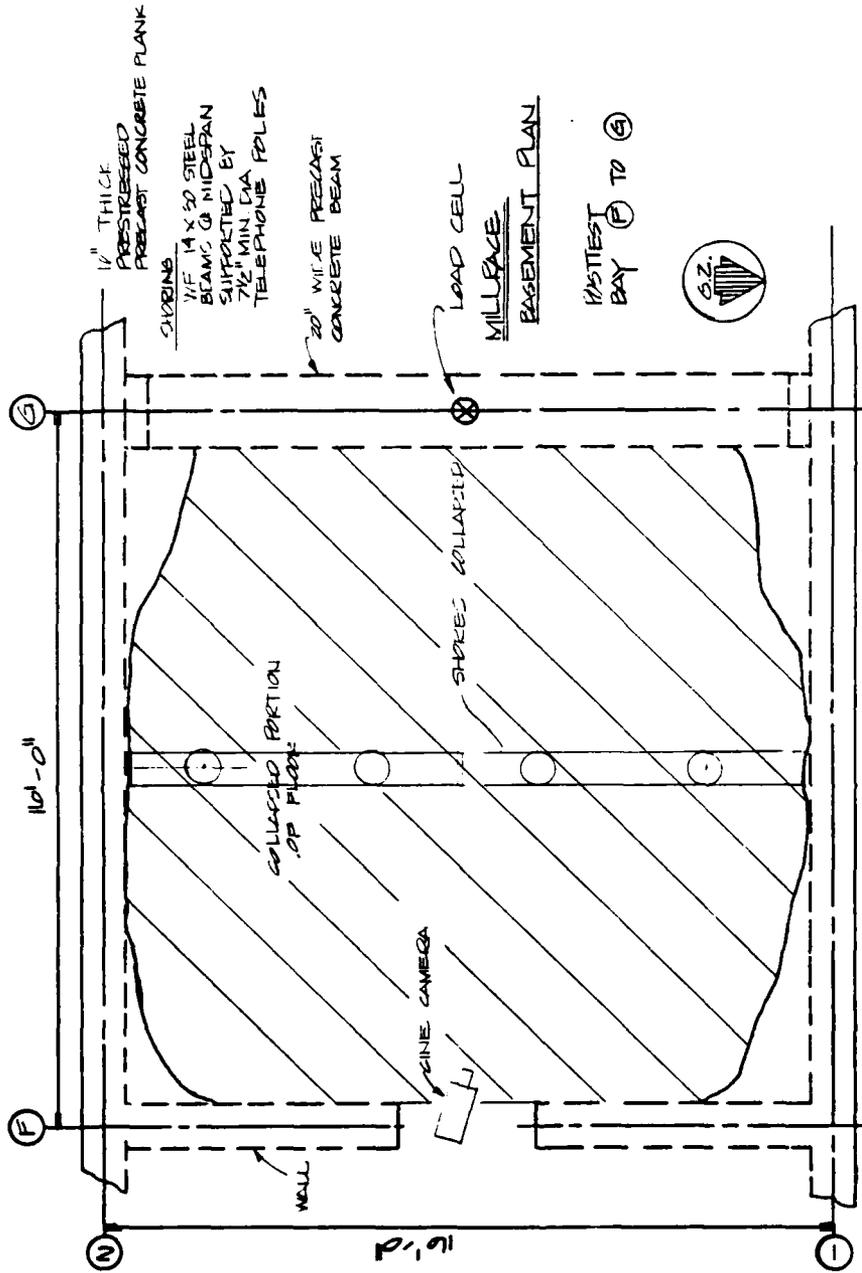
Fig. 5-39. Location of Shoring, Instrumentation, and Damage in Bay F to G, Area No. 3.

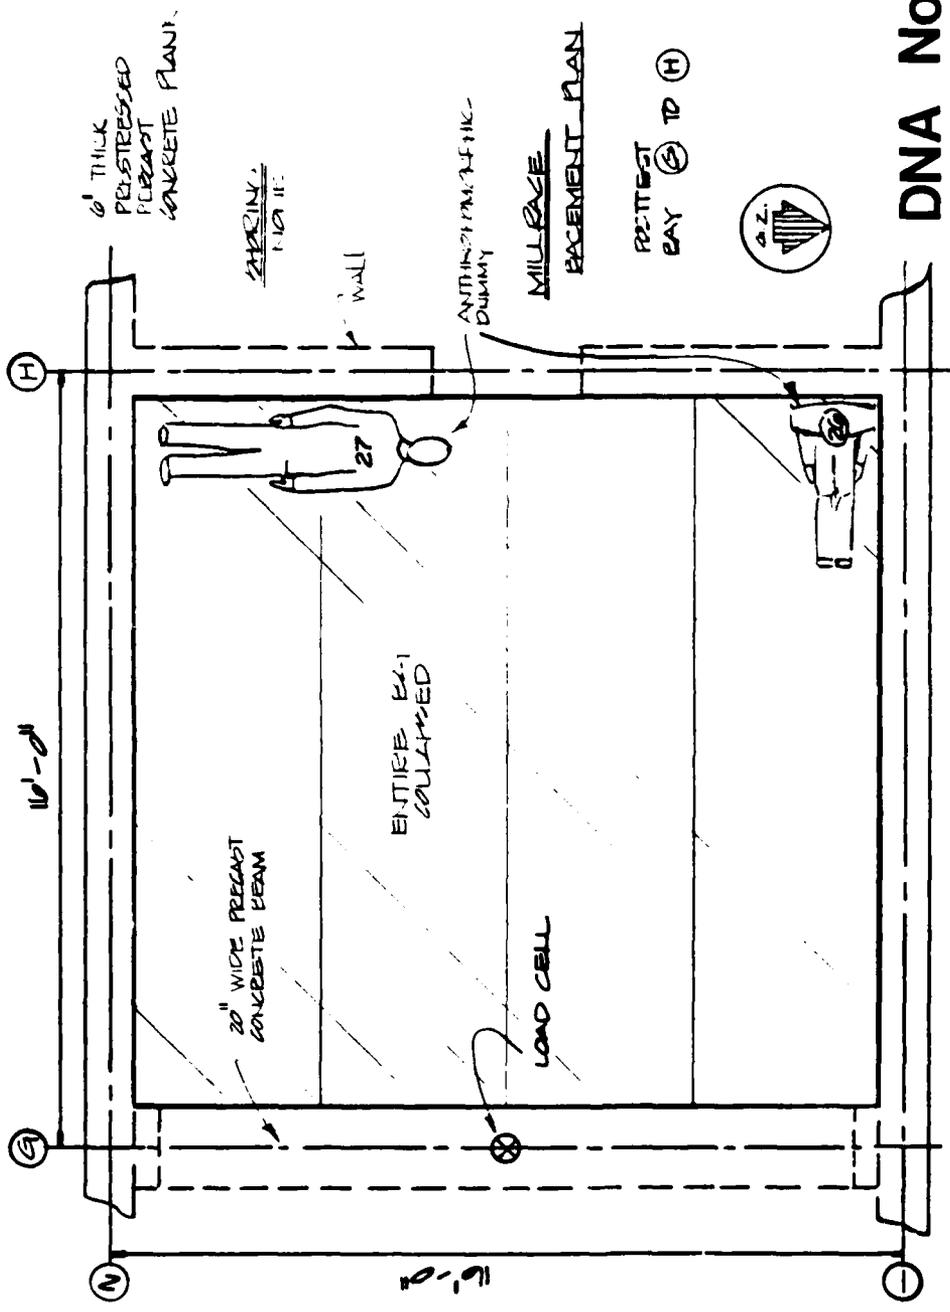
The ceiling of the bay from lines G to H (Figures 5-1, 5-5, and 5-19), again constructed of precast prestressed concrete plank, was unshored and completely collapsed (see Figure 5-44). The collapse in this bay was total, filling all areas of the bay along the walls and in the corners with concrete debris and earth. Figures 5-45 and 5-46 are two different views looking down into the bay toward line H. The cine camera seen located in the doorway in these figures is oriented toward lines J and K.

Fig. 5-44. Location of Instrumentation and Damage in Bay G to H, Area No. 3.

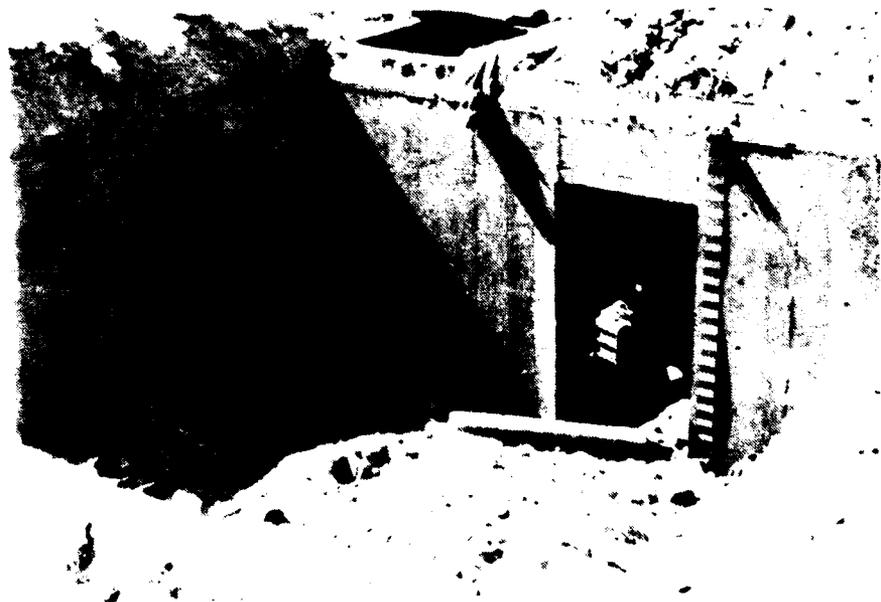
Figure 5-46 shows the posttest location of the dummy (27) that was originally located in the supine position along the wall on line H, and has been completely covered with 2 ft of earth and roof materials. Its location was the same as pretest, and a 500-lb concrete fragment was found in the area over the left thigh. The dummy sustained multiple tears in clothing, one each deep laceration on the head and face, left arm torn from shoulder and shoulder joint broken, and deep lacerations of thorax, left hip, and left thigh. There were no readings recorded on the accelerometers of either dummy (26 and 27).

Fig. 5-46. View of Bay G to H, Area No. 3, Posttest.

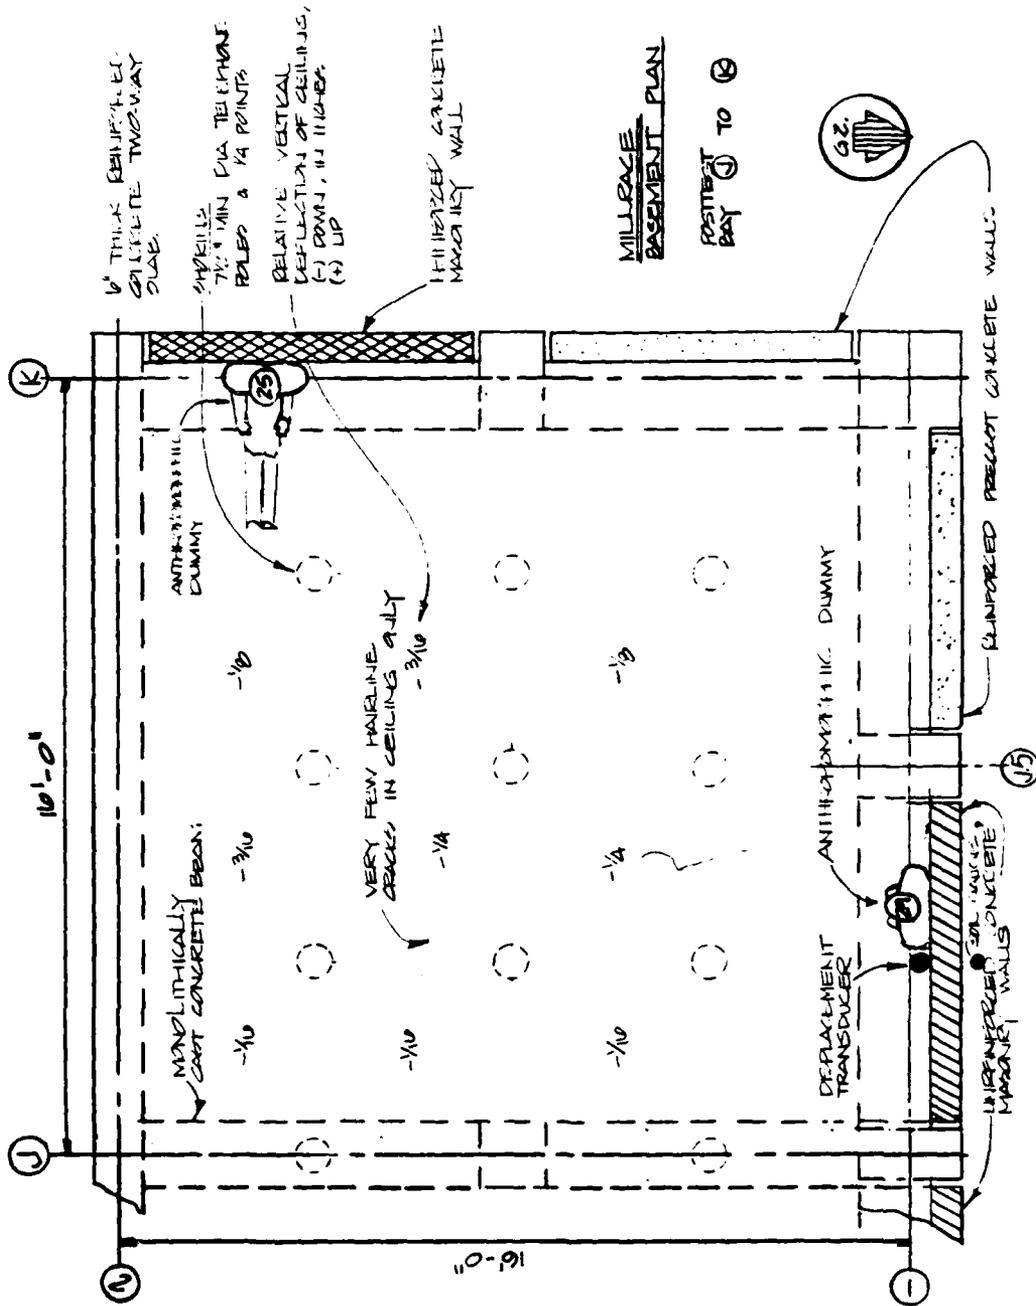
The two bays between lines H and K (Figure 5-1, 5-6, and 5-19), of 6-in. thick reinforced concrete two-way slab construction, sustained very little damage. Both bays were shored at the one-quarter points with timber telephone poles, and were expected to perform well in the 40 psi range. No cracks were found in the floor slabs in either bay, and only relatively short hairline width cracks were noted in the ceiling. The ceiling cracks ran in both directions, midway between the shores. Figures 5-48 and 5-49 show the locations of these cracks. The maximum vertical deflection found in the ceiling was 15/16 in. The deflections recorded for both bays are shown in Figures 5-48 and 5-49.

Fig. 5-49. Location of Shoring, Instrumentation, and Damage to Two-Way Slab, Bay J to K, Area No. 4.

The dummy that was standing against the wall along line 1 in bay J to K (see Figure 5-49 for location) is shown in Figure 5-54. The head on this dummy had moved 1 in. to the right and had fallen forward on the chest, the left foot had moved 0.5 in. to the left, and the right foot had moved 0.25 in. to the left. No damage had been sustained by the dummy. The reading on the accelerometer was 10 g.

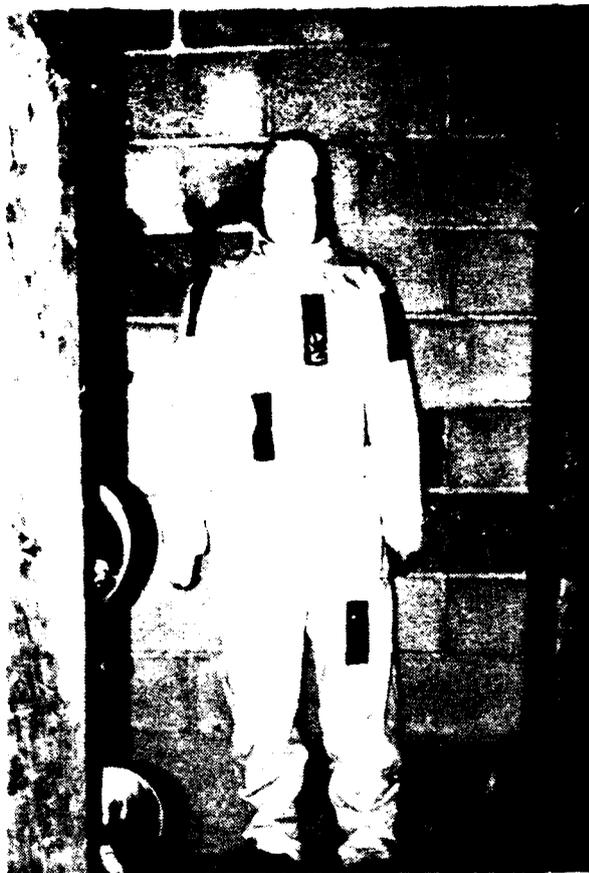
Fig. 5-54. Dummy No. 29 After Test.

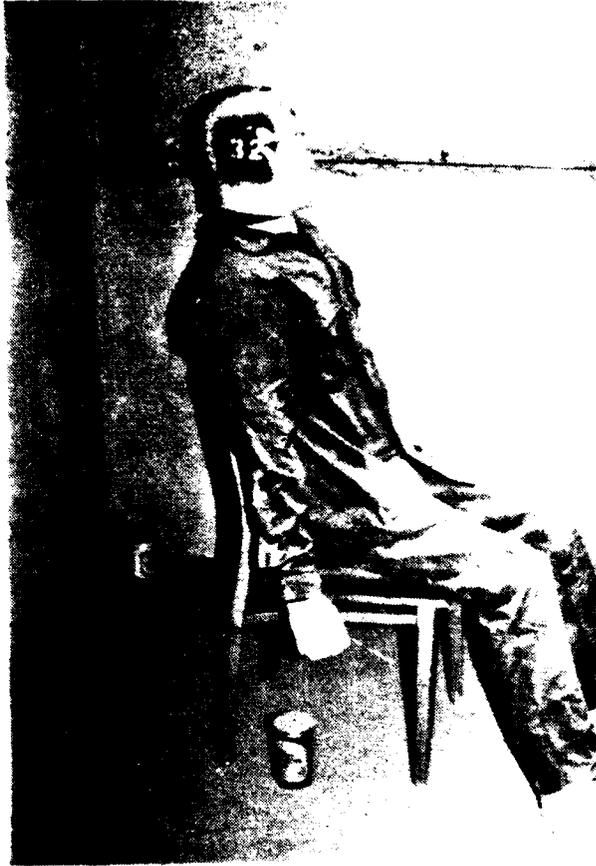
At the 20 psi ground range, the sandbags from the closure were displaced slightly, about two inches (though the displacement would have been greater for a larger weapon), and the logs were still in place. (There was no pressure gauge in this vault; the gauge originally scheduled was relocated between the two berms where one of the 5102 experiments was conducted.) The posttest environment inside the vault was similar to that in the vault at 40 psi, excepting there was a thinner layer of dust over all surfaces (Figure 6-11). No relative displacements appeared to have taken place, and there was no indication of motion of either the anthropomorphic dummy or the glass jar passive gauges. Neither were there signs of cracks or permanent deformations in the vault, despite the fact that no structural upgrading options (shores, or roof cover of expanded polystyrene) were installed.

Thus, it appears this vault installation without upgrading would be certain to survive at 10 psi in the same condition, even from a multimegaton weapon, and the failure rating without upgrading could be much higher. To establish the rating more exactly, or just what the performance might be in other soil materials, additional tests would be required, including one, or more, to failure.

Fig. 6-11. Posttest View of 20 psi Vault Interior.

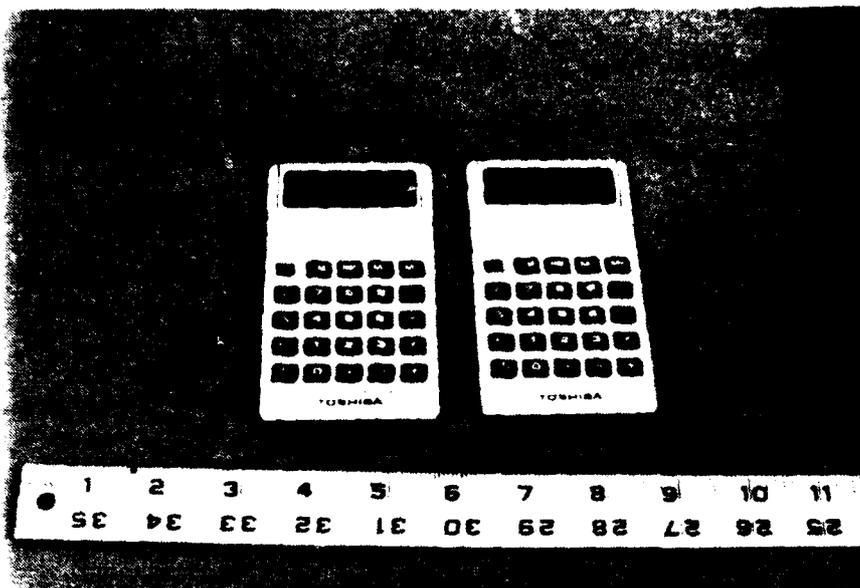
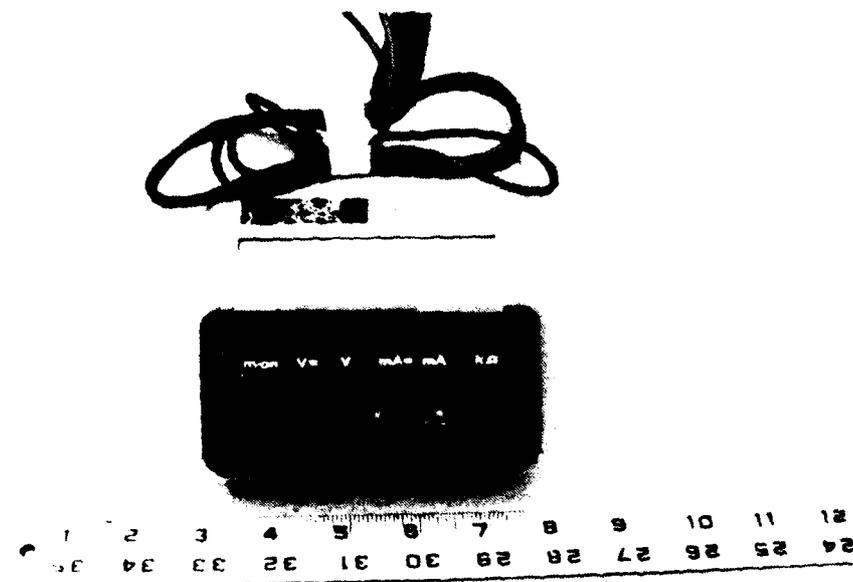
Fig. 7-16. Posttest Photographs of Electronic Equipment, Area I.

Figure 7-16 showed photographs of the calculator and the digital ohmmeter, posttest. Neither was seriously damaged and both were immediately serviceable -- principally because both were protected from missile damage, and neither package could undergo much volume change when the pressure pulse hit.

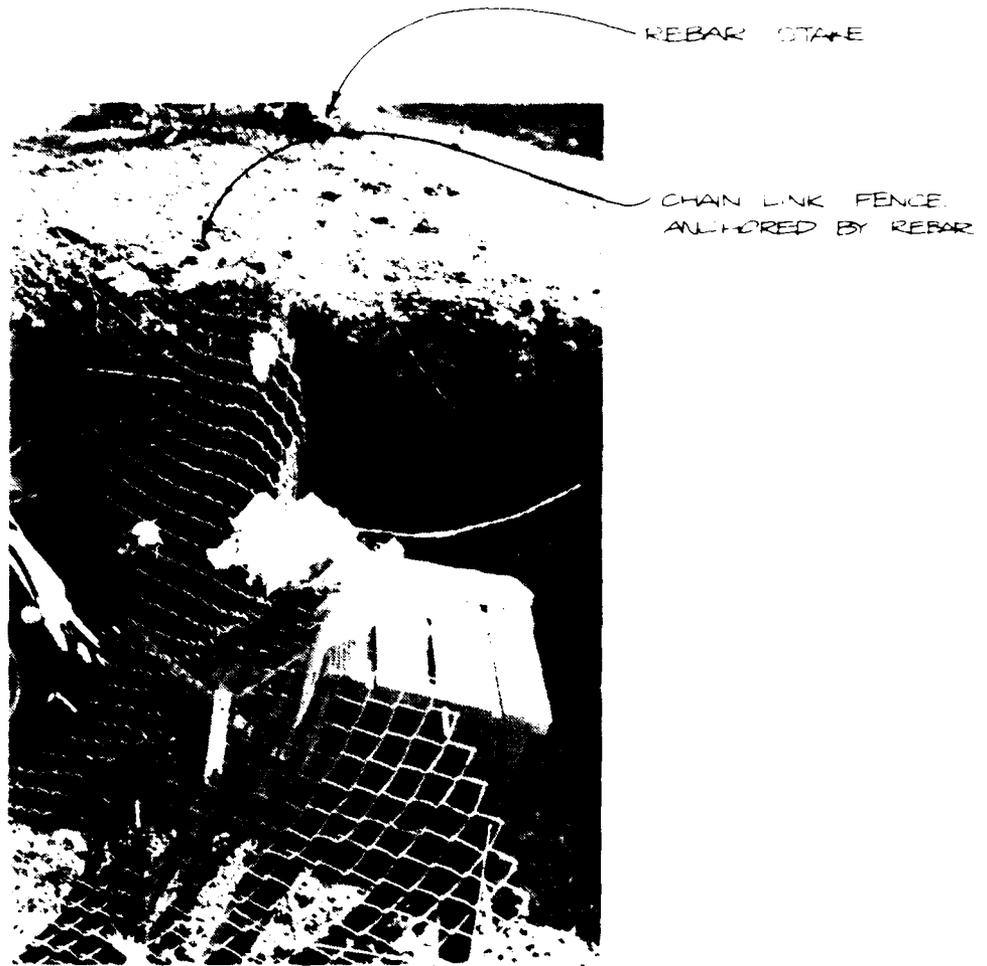
Area 1 (5102) - In the trench (Figure 7-1), one table saw and two band saws survived with minor damage; one table saw received major damage; the empty, sealed drum was moderately crushed; the partially filled, open drum and its contents were apparently unaffected; the electronic equipment in this area (Figure 7-16) survived - the checkbook style hand calculator was scarred, but operable; and the digital ohmmeter, which had been submerged in isopropyl alcohol, was unmarked and operable. Posttest photographs of the trench area and artifacts are shown in Figures 7-17 and 7-18.

Fig. 7-18. Posttest Photograph of Area I Trench.

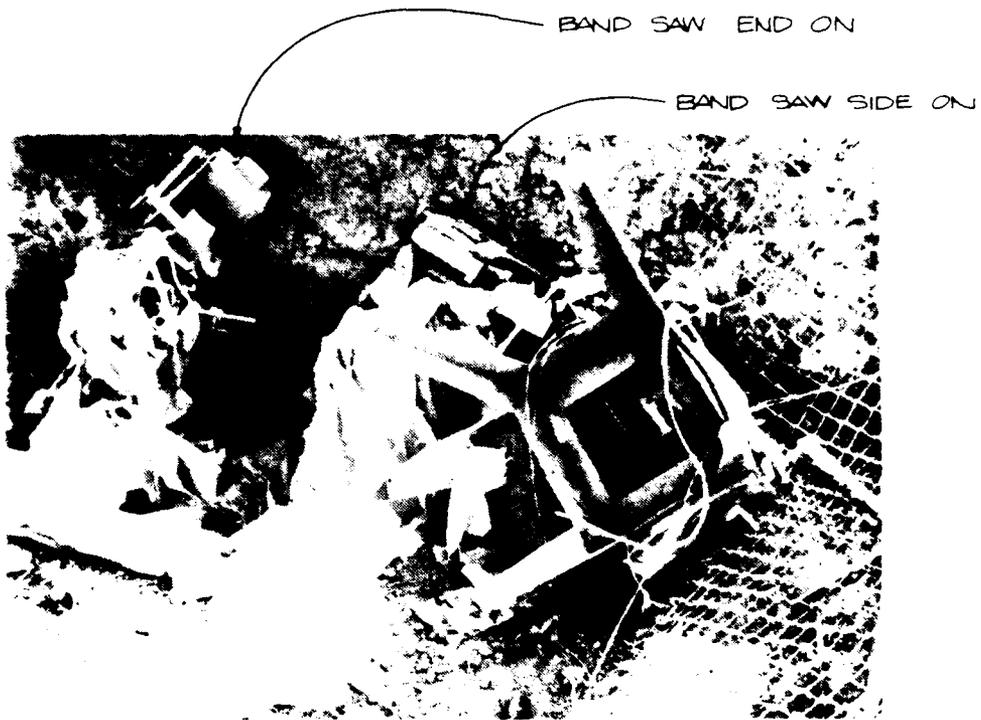
Fig. 7-19. Band Saws in Trench, Area 1, Posttest.

The band saw that was oriented end-on to the blast (Figure 7-19, and see Figure 7-1) lost the pulley cover but otherwise suffered little serious damage. The other band saw, oriented side-on in the trench, was tilted into the trench wall, but suffered little damage (Figure 7-19). Both band saws had the bottom plate that makes up the leg-assembly dished upward by the pressure pulse when the pulse reflected off the bottom of the trench.

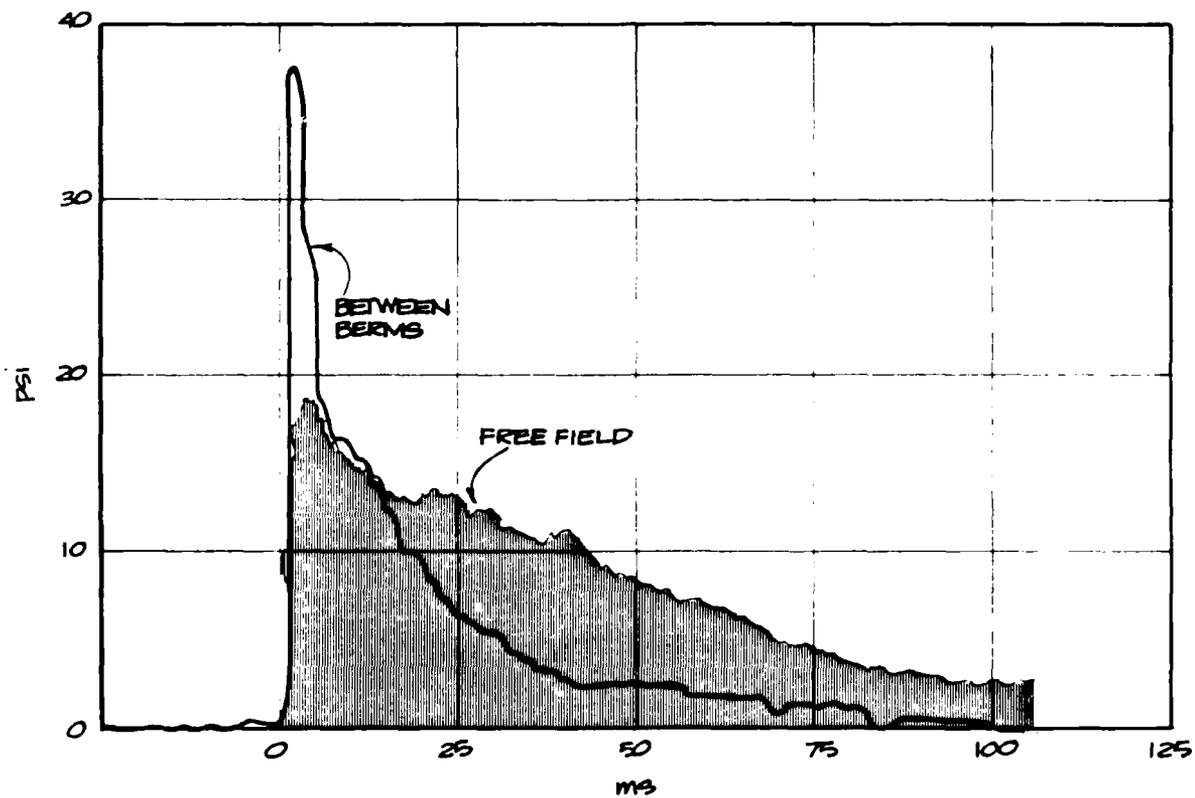
The peak overpressure recorded between the berms was a 1 to 2 ms spike, roughly twice the magnitude of the free-field overpressure (Figure 7-21). The spike was expected, the objective of the berms was not to reduce the overpressure (which is not the major problem), but rather the drag force.

Fig. 7-21. Peak Overpressure Between Berms Compared With Free-Field Overpressure.

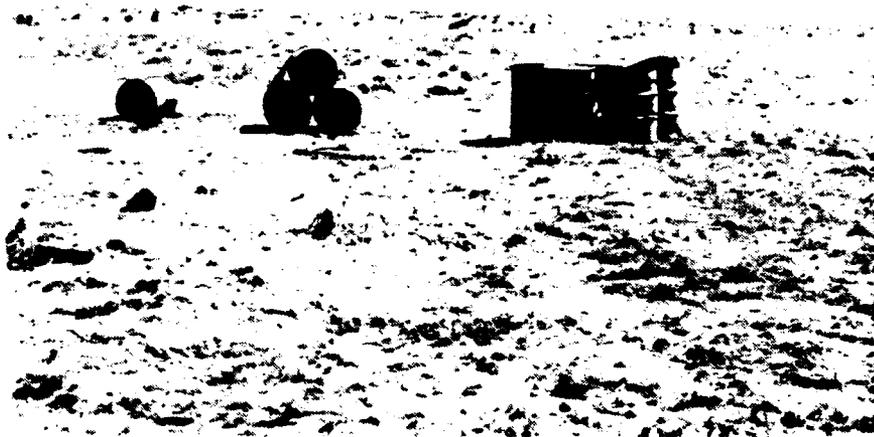
Area 3 (5102) - In the open area where the natural soil was undisturbed, the three-barrel arrays and the single reference barrels, at both scales, were overturned; the stability of the seven-barrel arrays at both scales was sufficient to prevent overturning (Figures 7-22 and 7-23).

Fig. 7-22. Full-Scale Barrels, Area 3, After Test.

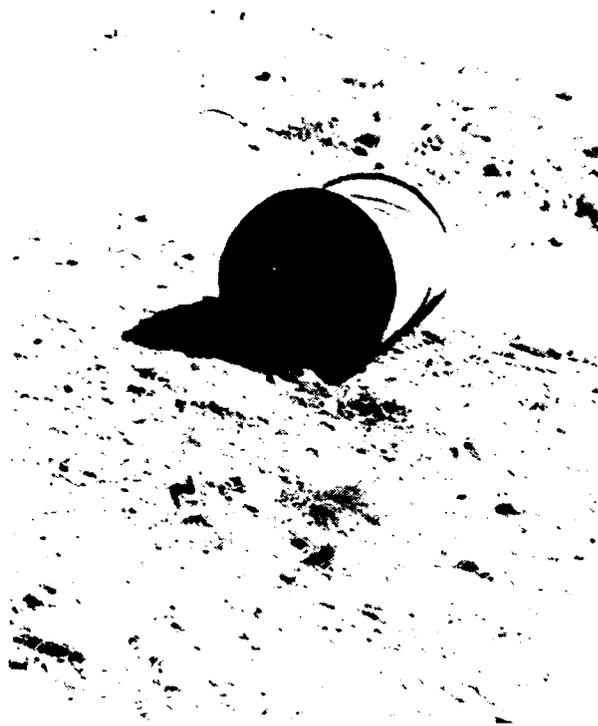
The bung had been left open on the single barrel, which was found nearly empty posttest and with its center section compressed somewhat (Figure 7-24). In addition, the barrel had been translated a total distance of 4 ft (two barrel diameters) where it was found overturned.

Fig. 7-24. Single Barrel, Area 3, After Test.

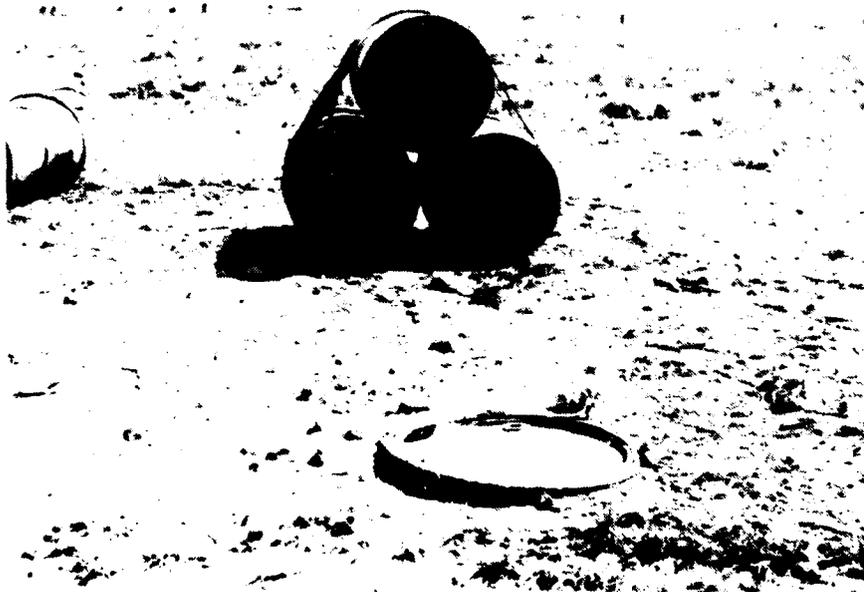
The three-barrel array also translated a total distance of 4 ft (one array diameter) and was overturned, but the array remained intact, all the lids remained firmly affixed and all the contents were still inside the barrels (Figure 7-25).

Fig. 7-25. Three-Barrel Array, Area 3, After Test.

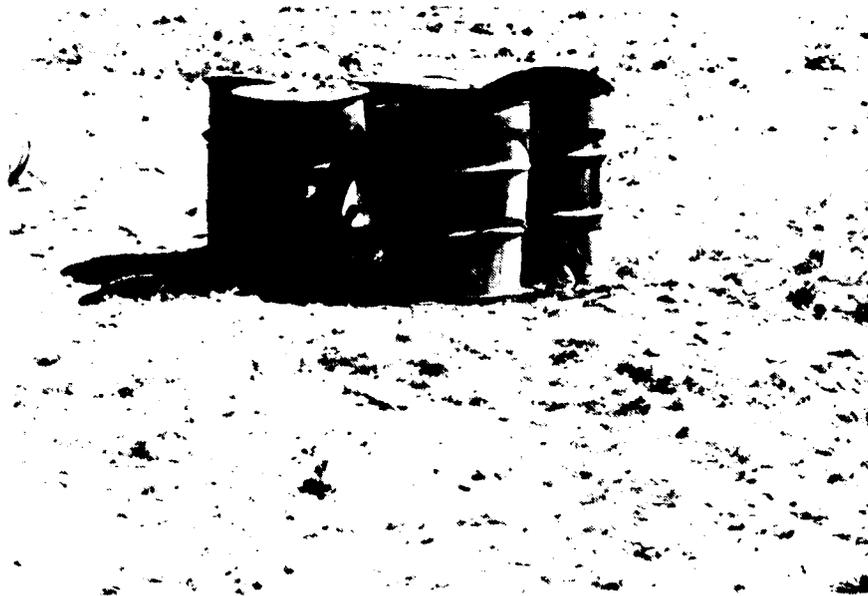
The seven-barrel array translated a total distance of 1 ft (0.16 array diameters). Some of the lids on these full-scale barrels did not seal well (the barrels were used/recycled) so that one lid was blown off entirely and two were blown partly off (Figure 7-26). About 15% of the contents of the barrel that lost the lid was also missing.

Fig. 7-26. Seven-Barrel Array, After Test.

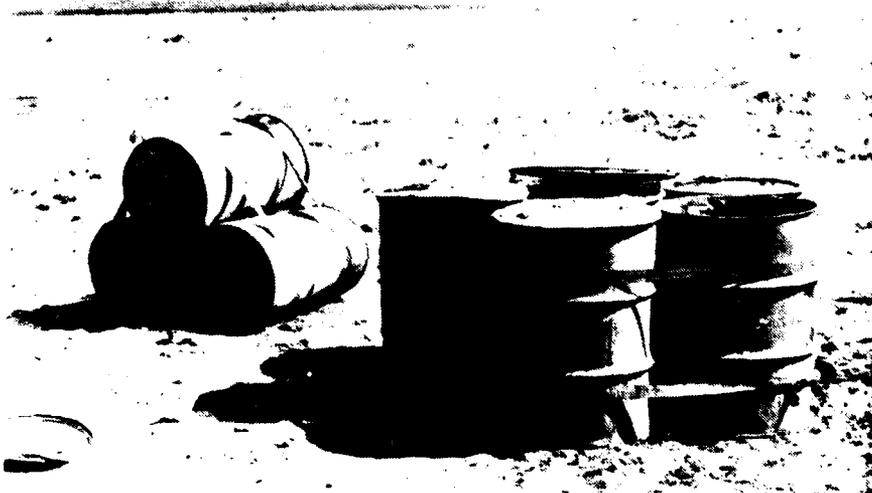
Area 5 (5103) - In the area where the soil was graded level, the ten water-filled drums in the group that duplicated the three- and seven-barrel arrays in Area 3 also duplicated the response observed in Area 3 (Figure 7-34). Most of the eleven-barrel group that had been partially filled with water suffered from crushing, and the lids and half or more of the contents were missing (Figure 7-35). The two band saws protected by the lumber package were undamaged and immediately

Fig. 7-34. Area 5, Three- and Seven-Barrel Arrays After Test.

The seven-barrel array visible in Figure 7-34 translated a total distance of one-third of a foot in the direction of the blast wave. Two lids came off altogether and one was partially lifted off, but there was little distortion in any of the drums. The lidless drum clearly visible in the figure lost 40% of its contents and the other lidless drum lost 25% of its contents, not unlike the events in Area 3.

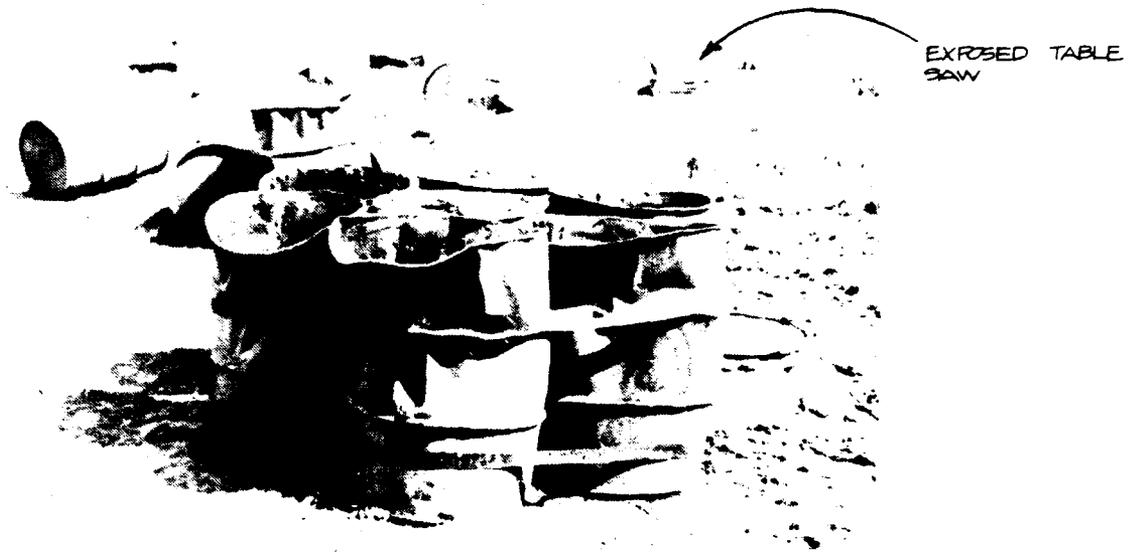
Fig. 7-35. Posttest Photograph of Partially Filled Barrels, Area 5.

The seven-barrel array translated one half a foot. Five of the seven barrels lost their lids and half their contents (leaving them about 1/4th full) and these barrels were severely crushed. The center barrel, which retained its lid and contents, was sufficiently protected that it was not crushed. And the remaining barrel that retained its lid and contents was crushed at the top, by the tension in the webbing that crossed it there (Figure 7-35).

The table saw that was located in the free field was translated 25 ft downstream and overturned (see Figure 7-35), but only the on/off switch was damaged - apparently because this saw did not impact at any time on the vulnerable mounting appendage for the safety fence. The switch was readily repaired, and the saw was operable in a matter of minutes.

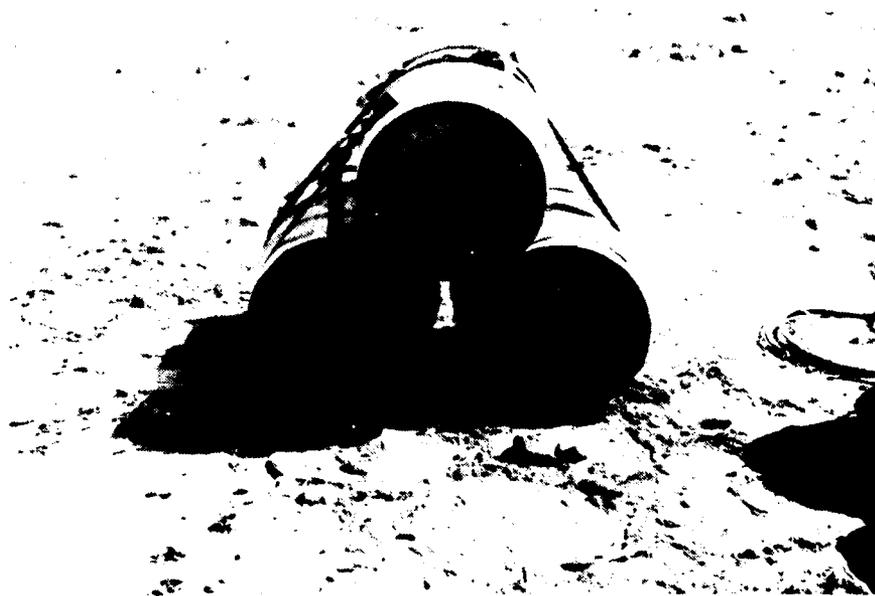
Fig. 7-36. Posttest Photograph of Three-Barrel Array, Area 5.

There was no single barrel in the ten-barrel group of water-filled drums. The three-barrel array translated a total distance of 4 ft (one array diameter) and overturned. The lid came off one of these drums, the one on the bottom right side of the array (Figure 7-36), and all the fluid spilled, but the other two drums maintained their integrity and contents. The results essentially duplicated those in Area 3.

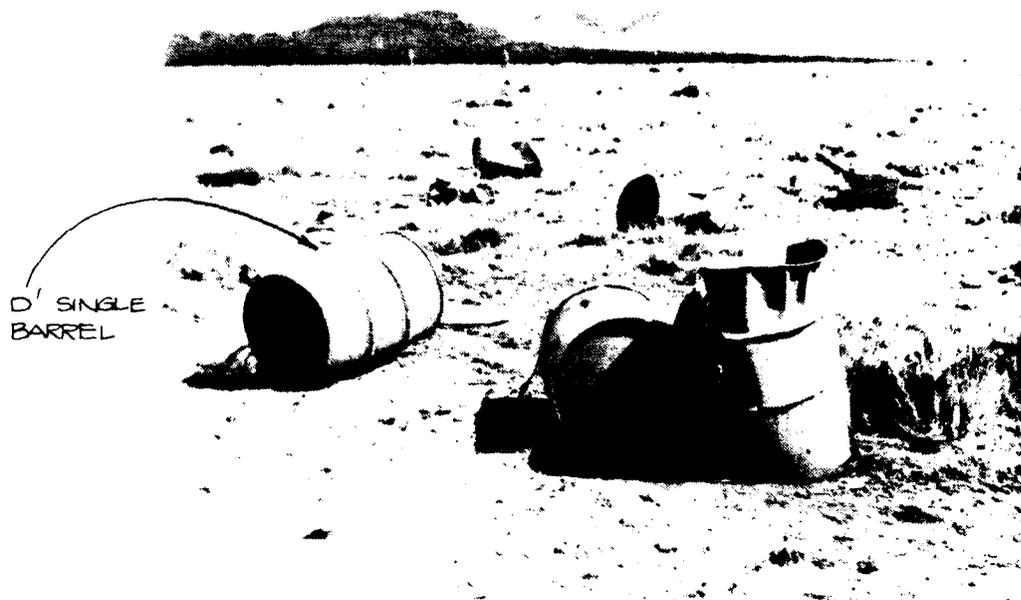
Among the barrels in the group that was partially filled, the single barrel translated about the same total distance as the single barrels that were completely full, i.e., 4 ft, and it also overturned. In addition, it lost both its lid and contents and became slightly crushed in the middle, but not at the ends (the barrel marked D' in Figure 7-37).

Fig. 7-37. Area 5, Partially Filled Barrels After Test.

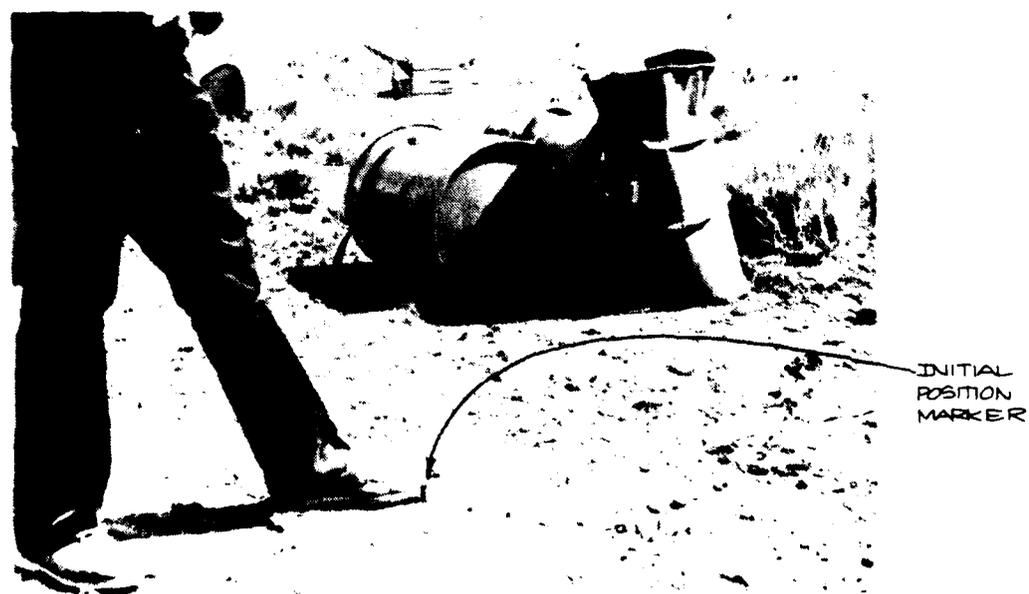
The three-barrel array in this group translated a total distance of six feet (Figure 7-38 - which also shows the benchmark that indicates the array's initial position), and the array came apart. Two of the drums were overturned but maintained their integrity and contents, while one of the drums lost its lid and most of its contents and was severely distorted, but remained upright.

Fig. 7-38. Area 5, Three-Barrel Array After Test.

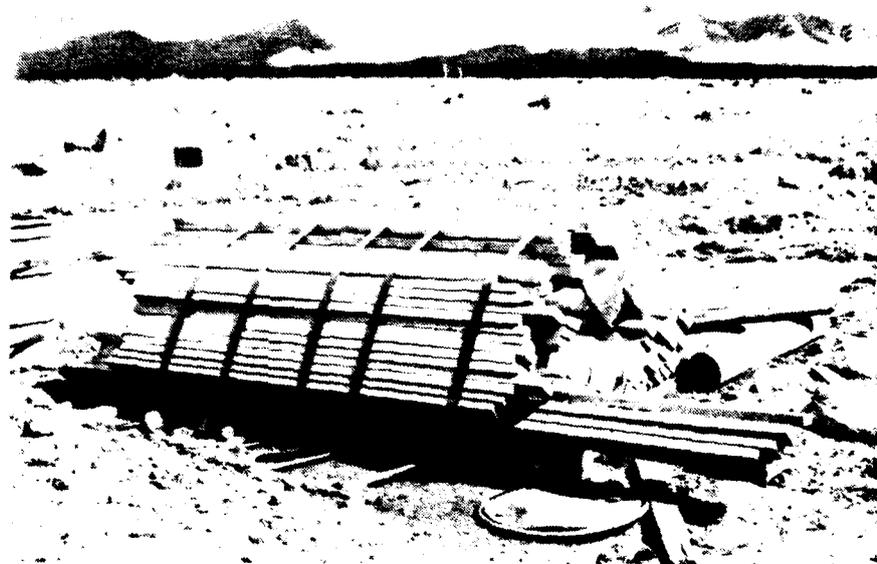
The lumber stack used to protect two band saws was partially overturned (Figure 7-39), but maintained its integrity and remained anchored. Partial overturning occurred because only the bottom half of the package was stabilized by logs piled behind it. The total load on the package, which was oriented to provide the maximum drag, was slightly over 30,000 pounds. Thus, the load per anchor and the tension in the webbing corresponded to, roughly, 5,000 pounds. The effects of this tension can be seen in Figure 7-40 where the webbing cut into the lumber along the junction of the bottom and front faces of the package. The band saws recovered from inside the package suffered no apparent damage and were immediately operable.

Fig. 7-39. Area 5, Lumber-Protected Equipment Package After Test.

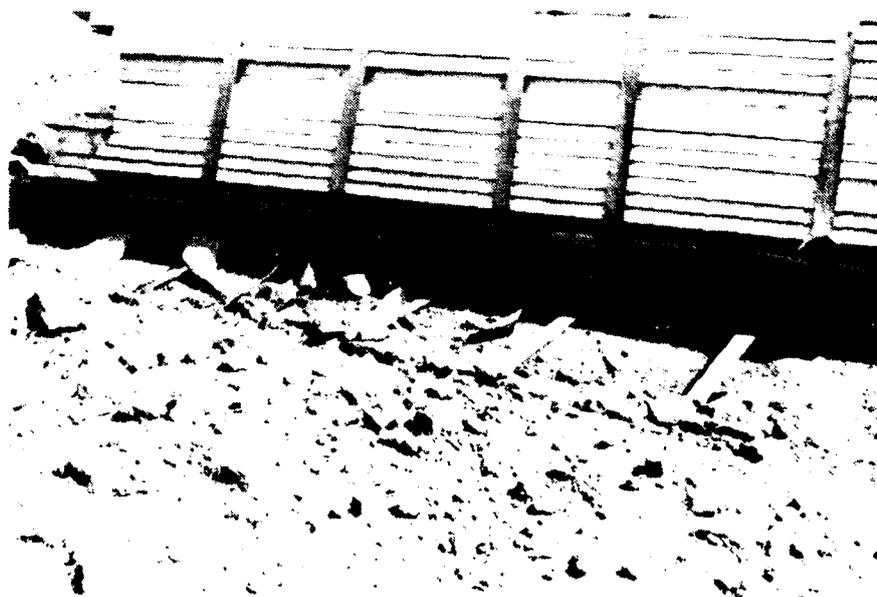
Fig. 7-40. Closeup Photograph of Lumber Stack Showing Cuts Caused by Webbing.
