SSI 8115-4

Testing of Shelter Design and Industrial Hardening Concepts at the Mill Race Event

Contract No. EMW-C-0611
Work Unit 1128D

SCIENTIFIC SERVICE, INC.

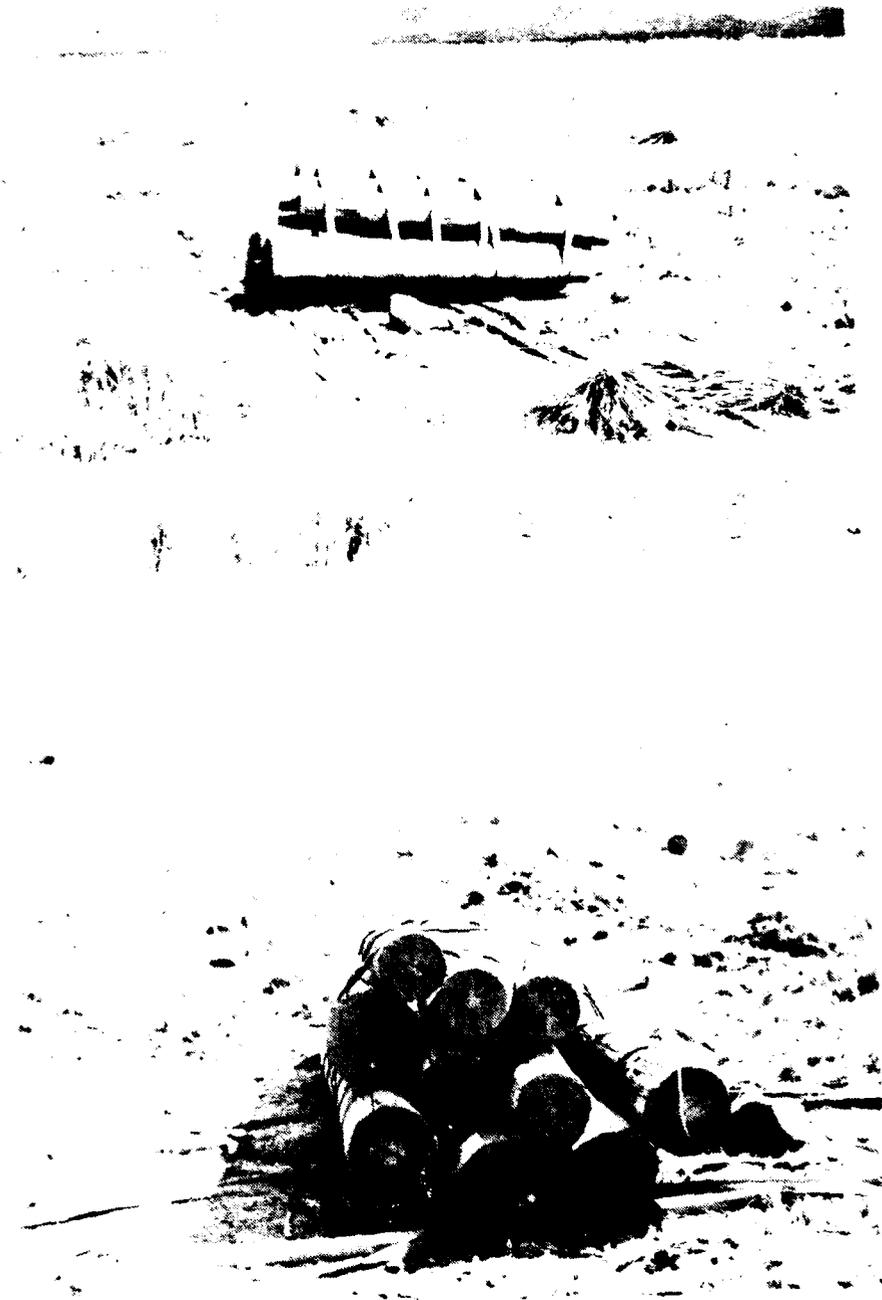
The stack of logs packaged and anchored so as to be exposed end-on to the blast with the anchoring force at right angles to it (Figure 7-15) remained anchored, but there was some minor rearrangement of the logs (Figure 7-44). It appears the lead expedient anchor was pulled loose (Figure 7-45, right-hand bottom corner, and center foreground in Figure 7-46).

Fig. 7-44. Posttest Photographs of Anchored Log Package
(compare Figure 7-15).

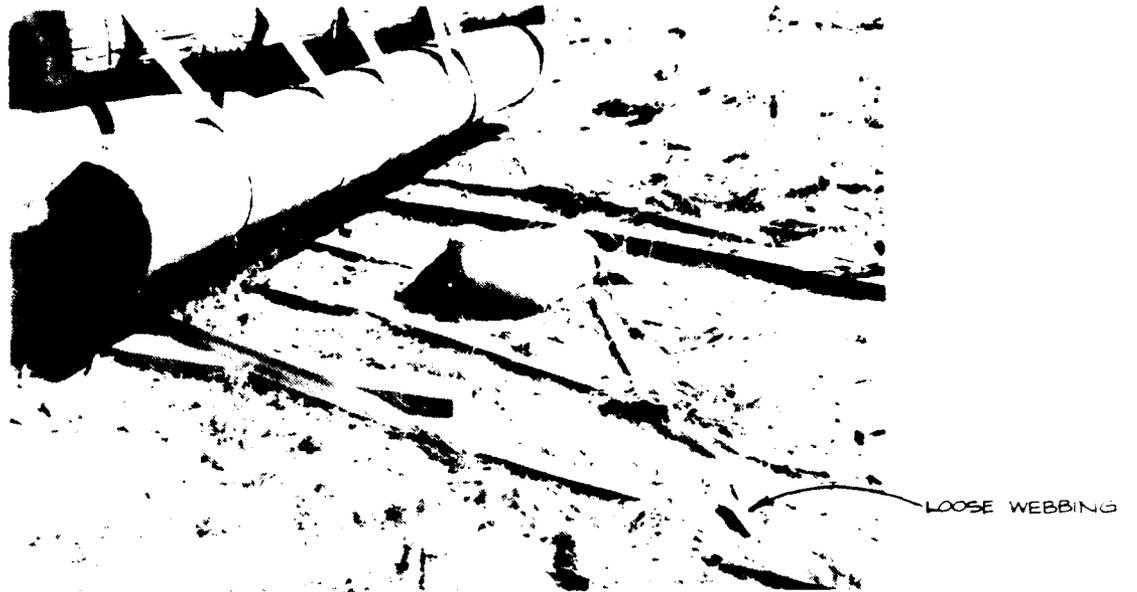
Fig. 7-45. Closeup Photograph of Log Package Anchoring.

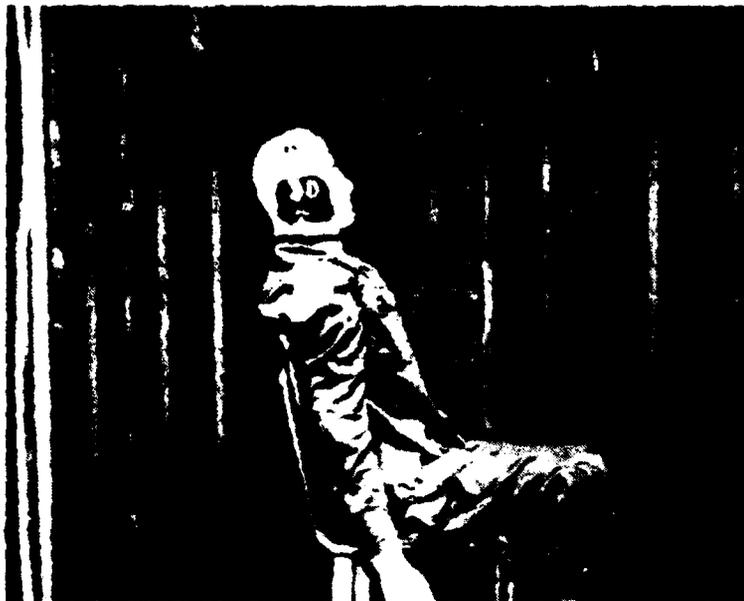
The inside of the shelter did not indicate any structural distress, but a significant amount of dust and earth was present. Figure 8-17 shows a view of the inside of the shelter, and shows the anthropomorphic dummy (30) in its original position. Figure 8-18 is a closeup of the dummy, and shows the amount of dust and earth present in the interior of the shelter. A posttest examination of the dummy indicated that it was in the same position as pretest, and the chair had not moved. It sustained no damage, and no reading was recorded on the accelerometer.

Fig. 8-17. Interior of Shelter After Test.
