REPORT OF FLOOD
14-16 MARCH 1978
CHAGRIN AND GRAND RIVERS
OHIO

U.S. ARMY ENGINEER DISTRICT, BUFFALO

JUNE 1978

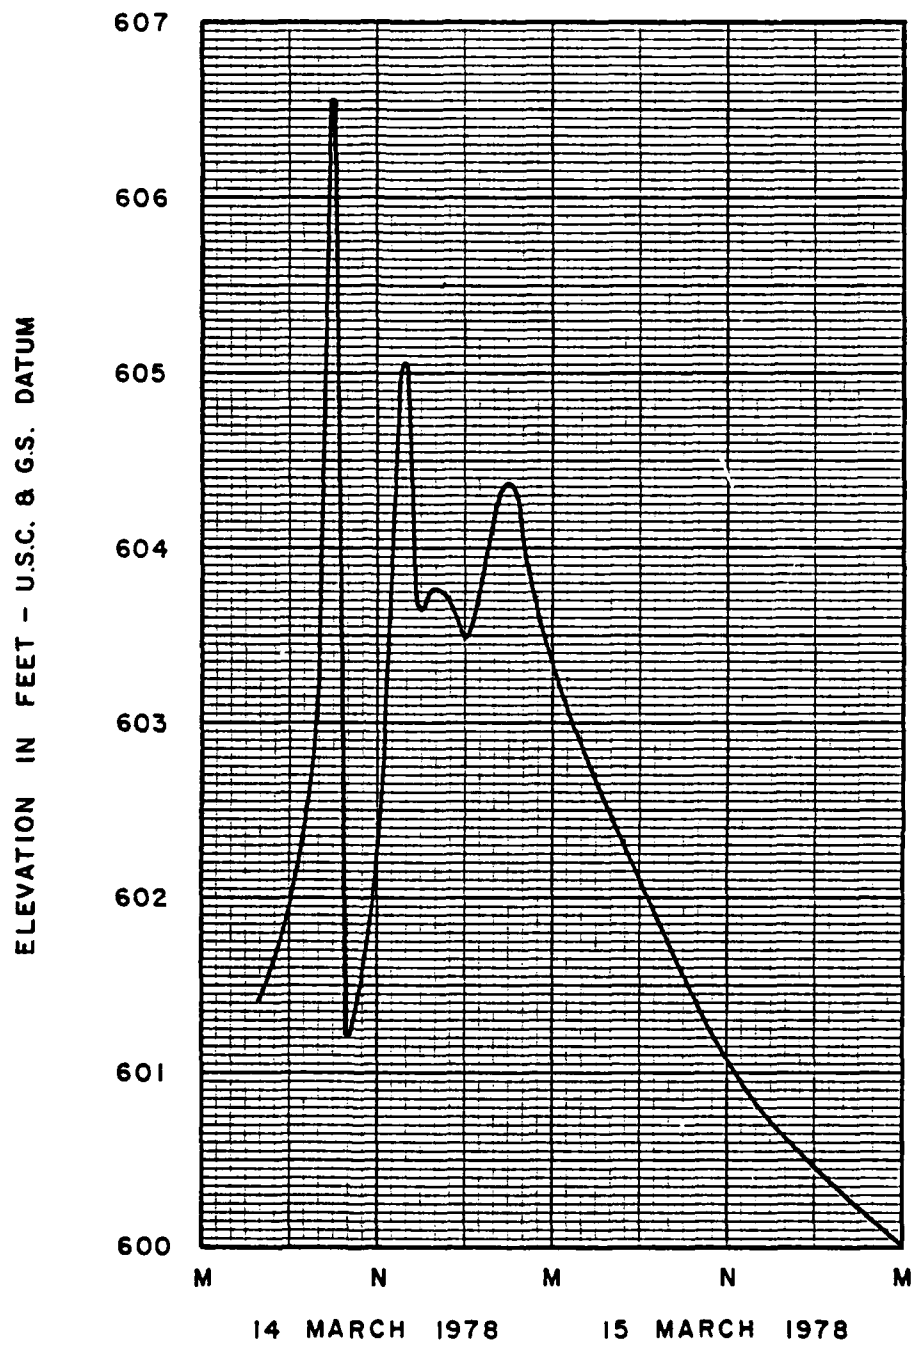
REPORT OF FLOOD 14-16 MARCH 1978
CHAGRIN RIVER BASIN
STAGE HYDROGRAPHS

1. ZERO OF GAGE IS EL. 594.57 USC. & G.S. DATUM.
2. DRAINAGE AREA IS 246 SQUARE MILES.
3. STAGE AFFECTED BY ICE JAMS.
4. M DENOTES MIDNIGHT.
5. N DENOTES NOON.

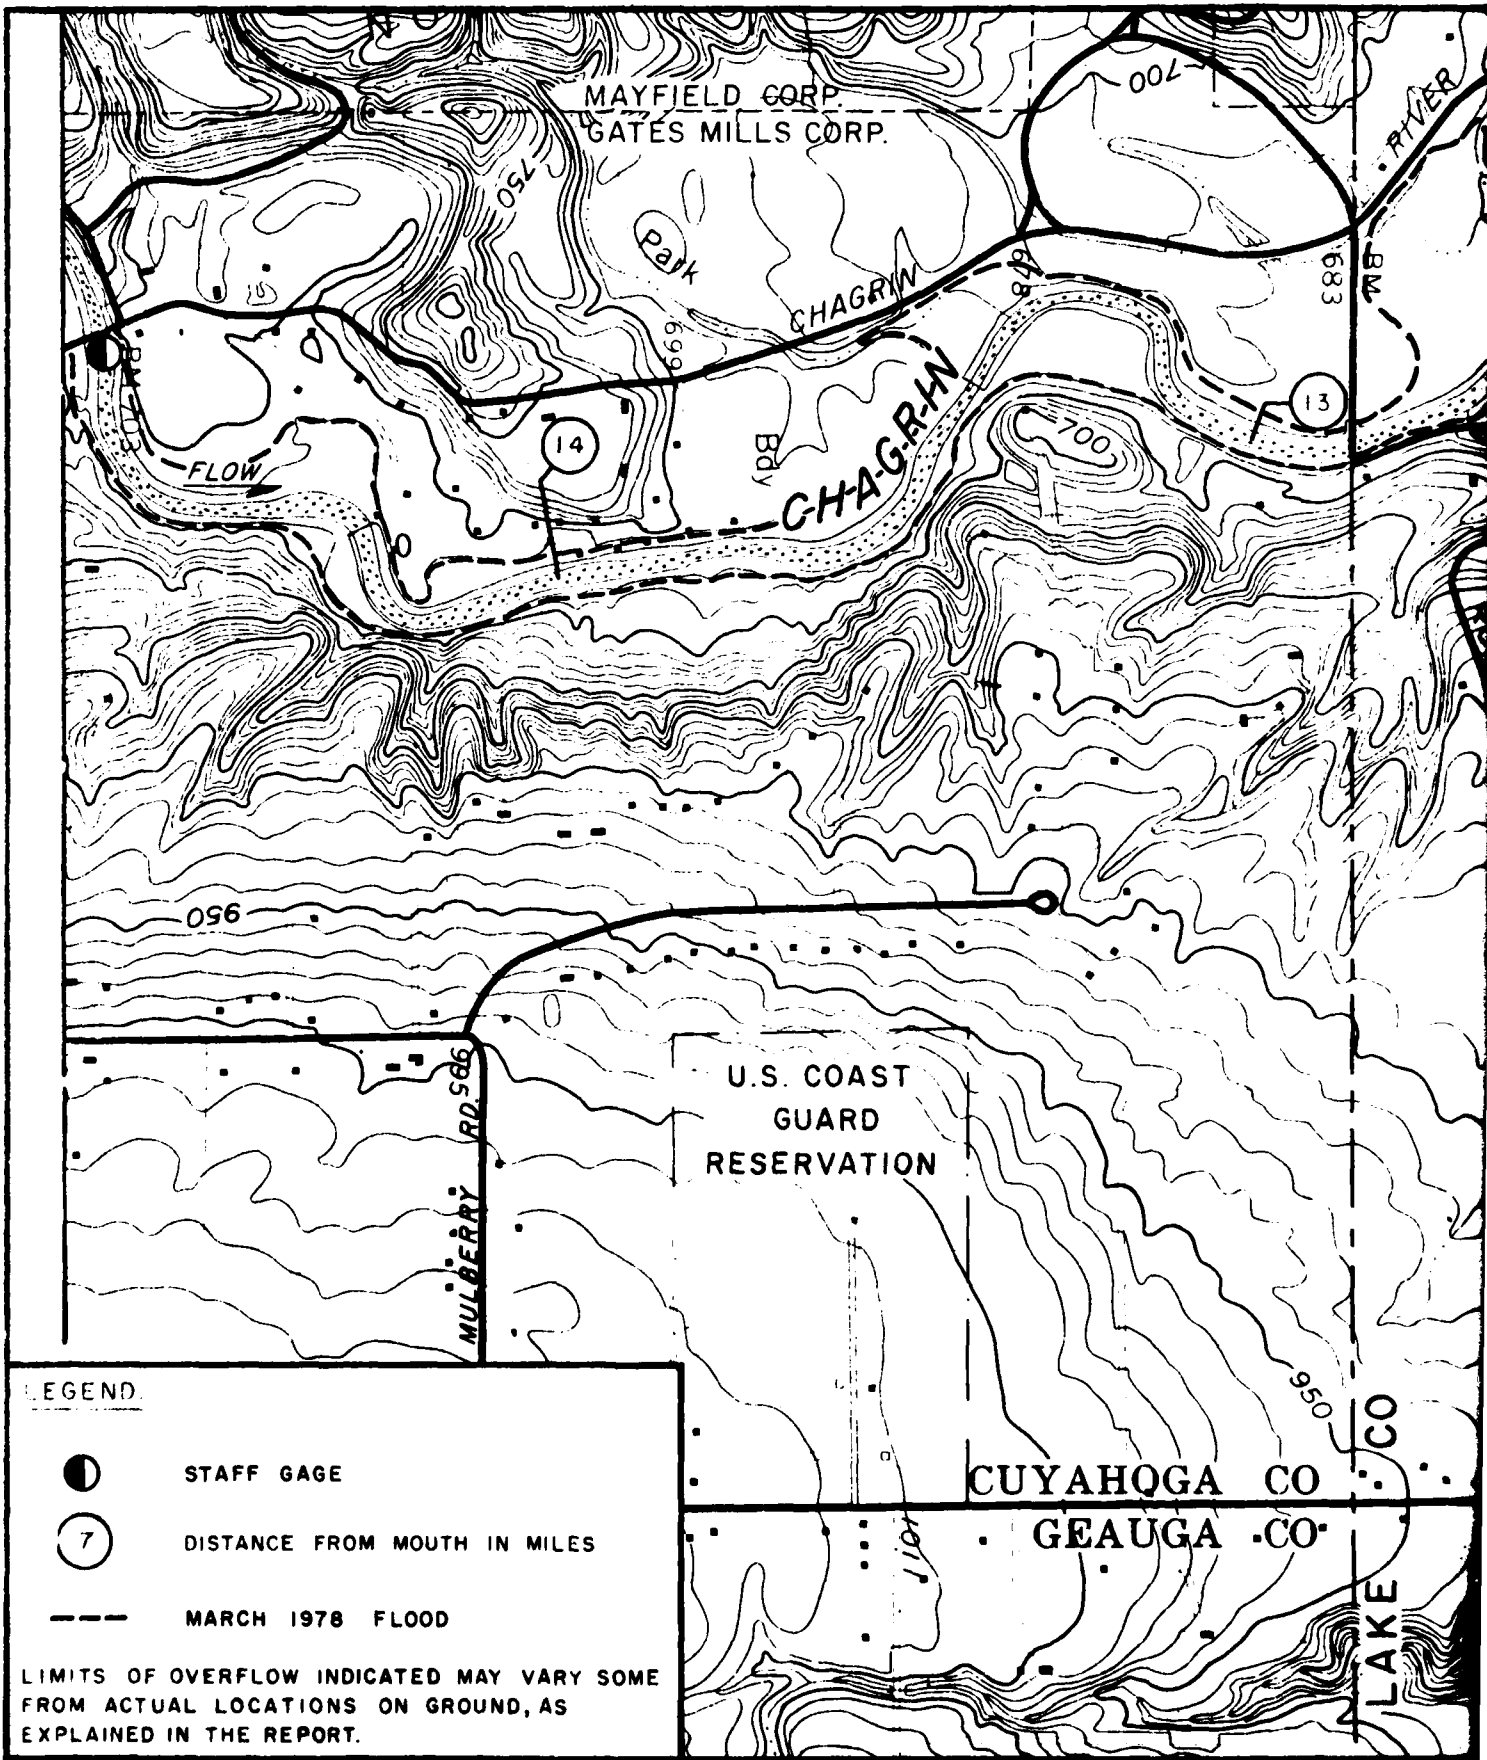
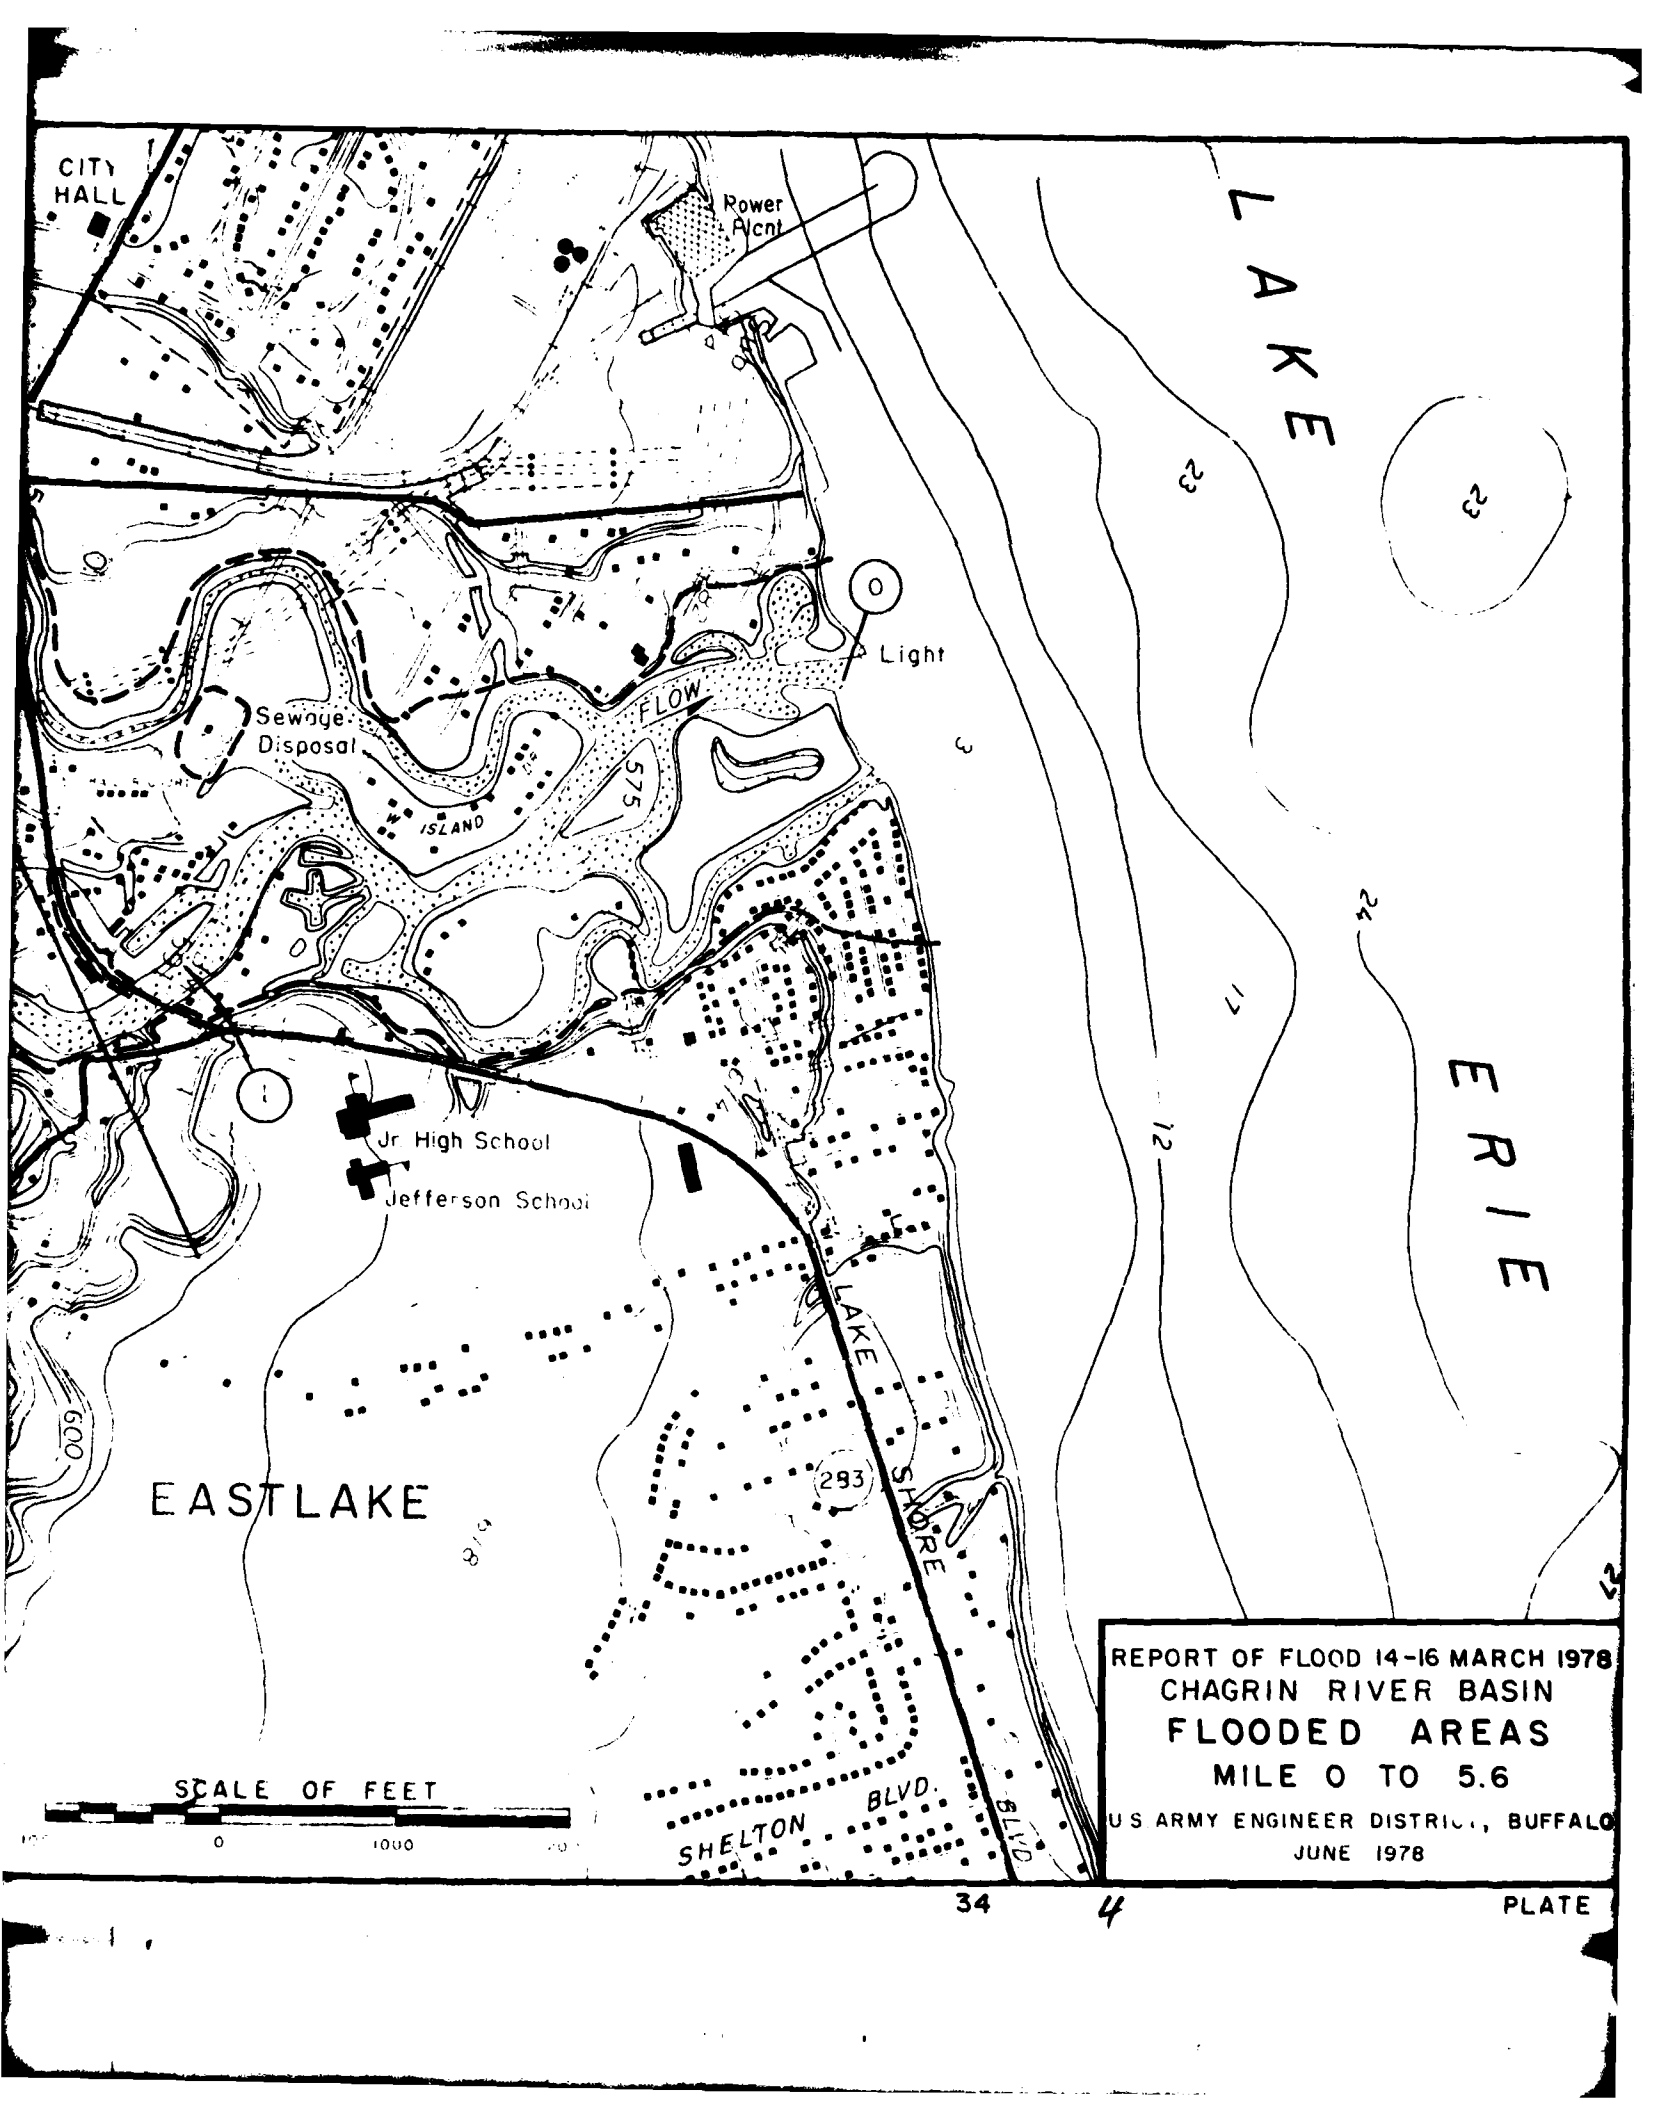
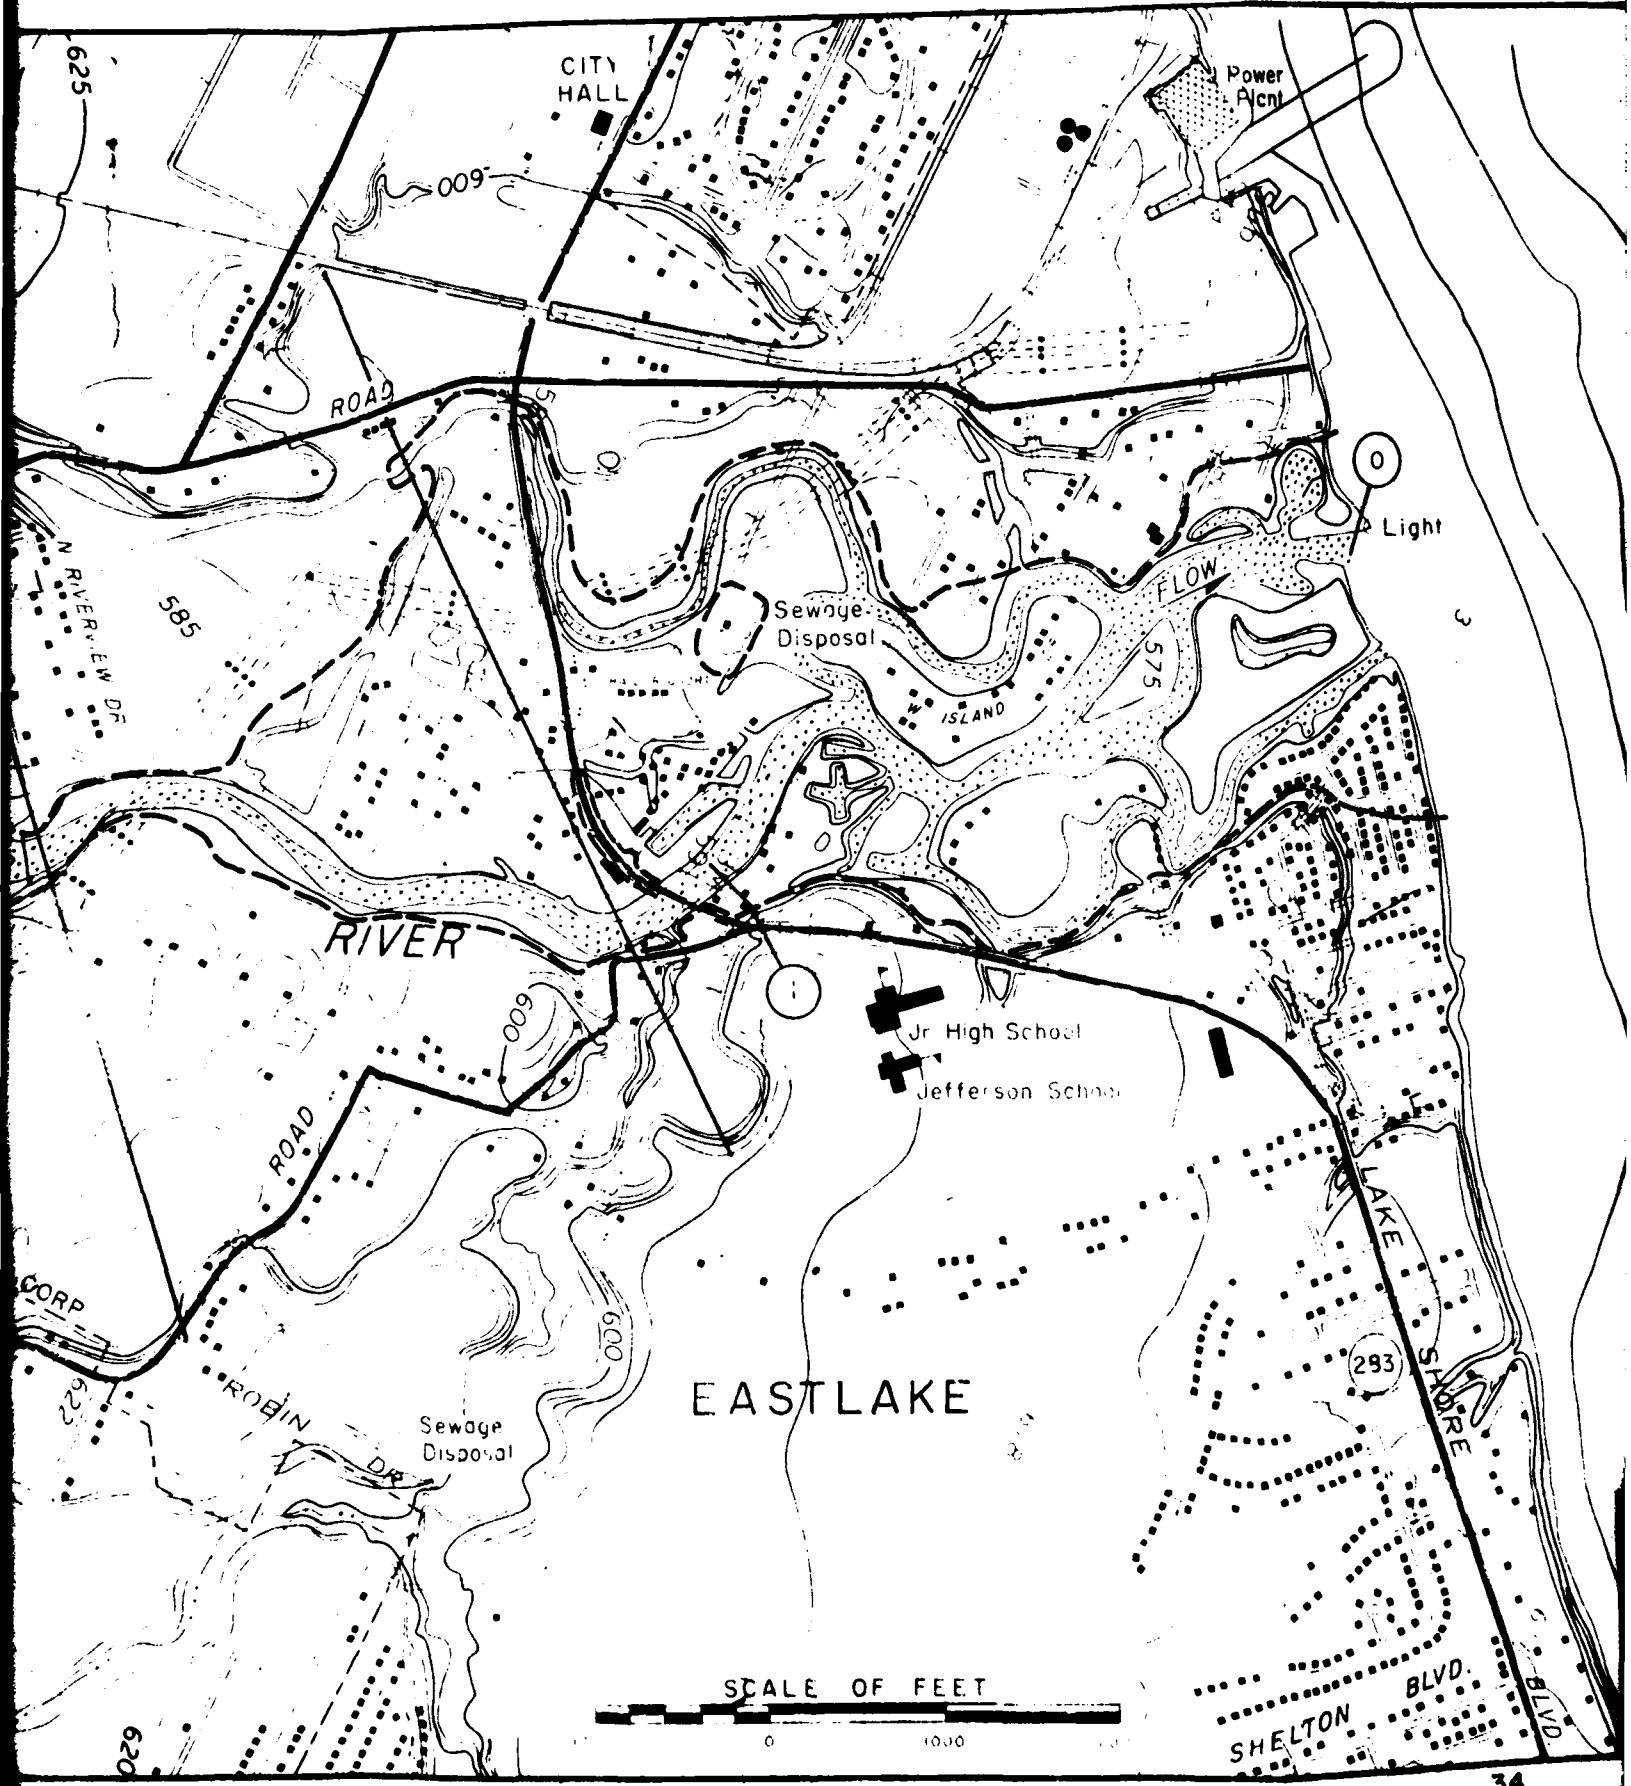
REPORT OF FLOOD 14-16 MARCH 1978
CHAGRIN RIVER BASIN
FLOODED AREAS
MILE 0 TO 5.6
U.S. ARMY ENGINEER DISTRICT, BUFFALO
JUNE 1978
