USAAEFA PROJECT NO. 81-18

UH-60A LIGHT ICING ENVELOPE EVALUATION WITH THE BLADE DEICING KIT INSTALLED BUT INOPERATIVE

FINAL REPORT

JUNE 1982

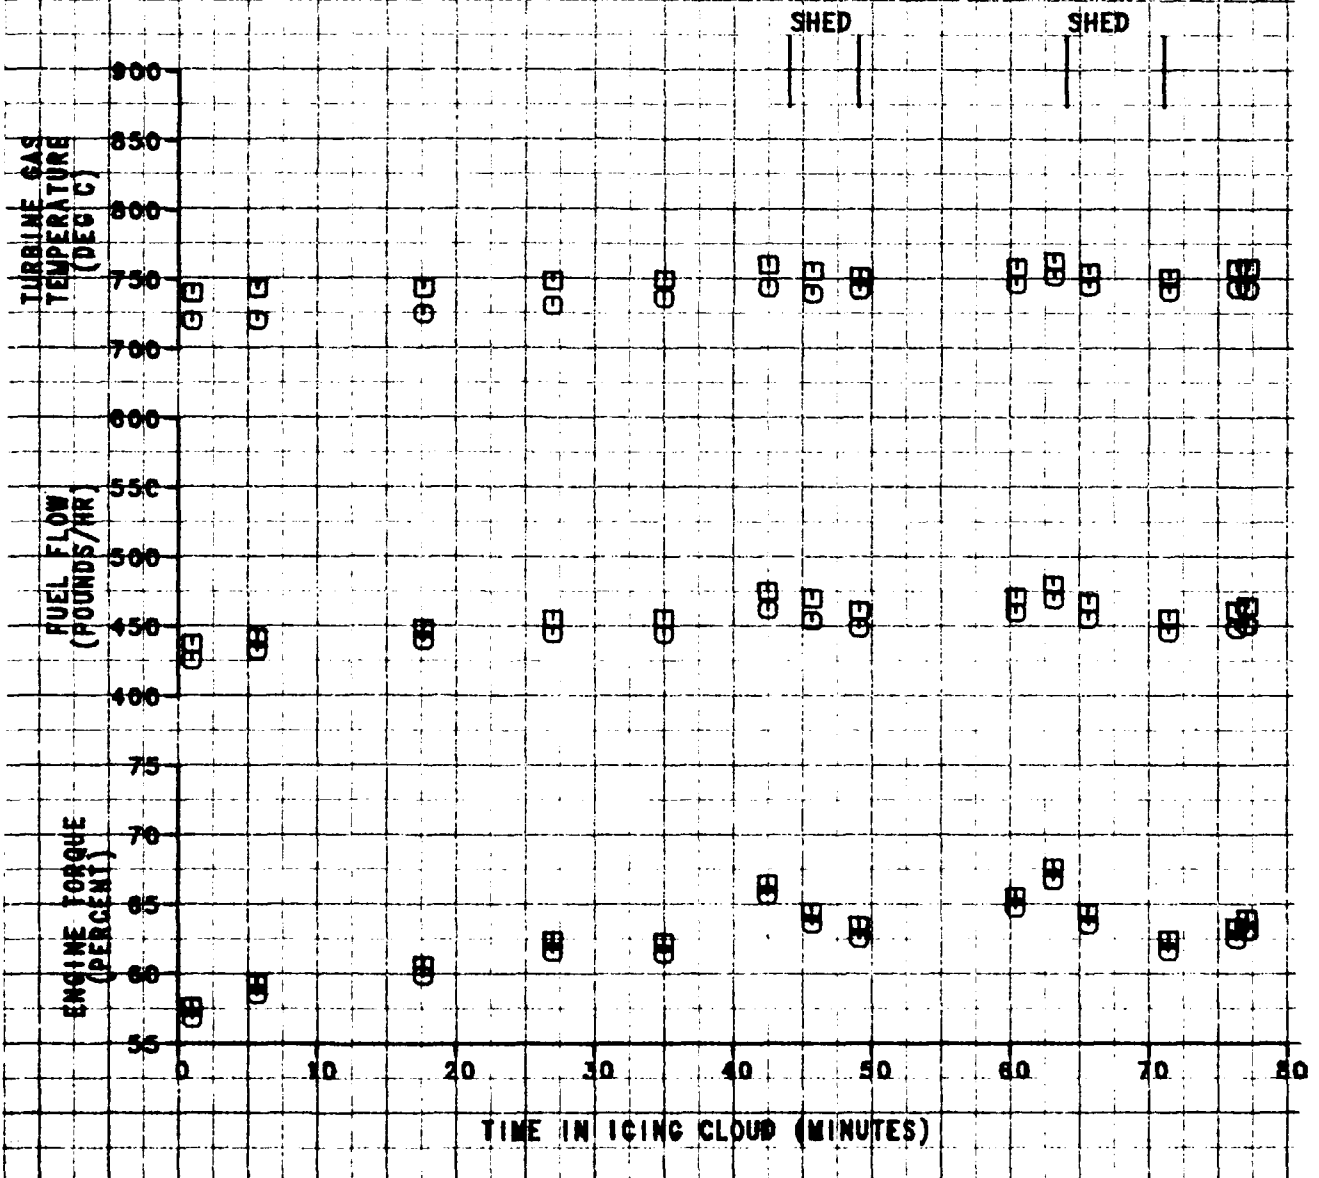
FIGURE 3
TORQUE RISE IN NATURAL ICING CONDITIONS
 UH-60A USA S/N 77-22976

10. Main rotor ice sheds occurred in both the artificial and natural icing environments. The ice accretion and shedding characteristics of the main rotor blades was independent of leading edge surface condition. A typical time history of engine torque rise during rotor system ice accretion in natural icing conditions is presented in figure 3, appendix F. The first ice shed during a flight typically occurred from 17 to 52 minutes after entering the icing environment with random and more frequent sheds occurring thereafter. The time required for the first shed to occur and the frequency of subsequent sheds appeared to be a function of the LWC and ambient outside air temperature. Photos 1 through 5, (app G), taken during flight in artificial icing conditions, and photos 6 and 7 (app G), taken after landing, show representative characteristics of main rotor ice accretion and shedding.

NOTE : 1. CIRCLES DENOTE THE LEFT ENGINE SQUARES DENOTE THE RIGHT
 2. DATA TAKEN WITH A FIXED COLLECTIVE POSITION.
 3. A MAIN ROTOR ICE SHED WAS OBSERVED BY THE FLIGHT CREW FROM 44 THRU 49 AND 64 THRU 72 MINUTES.

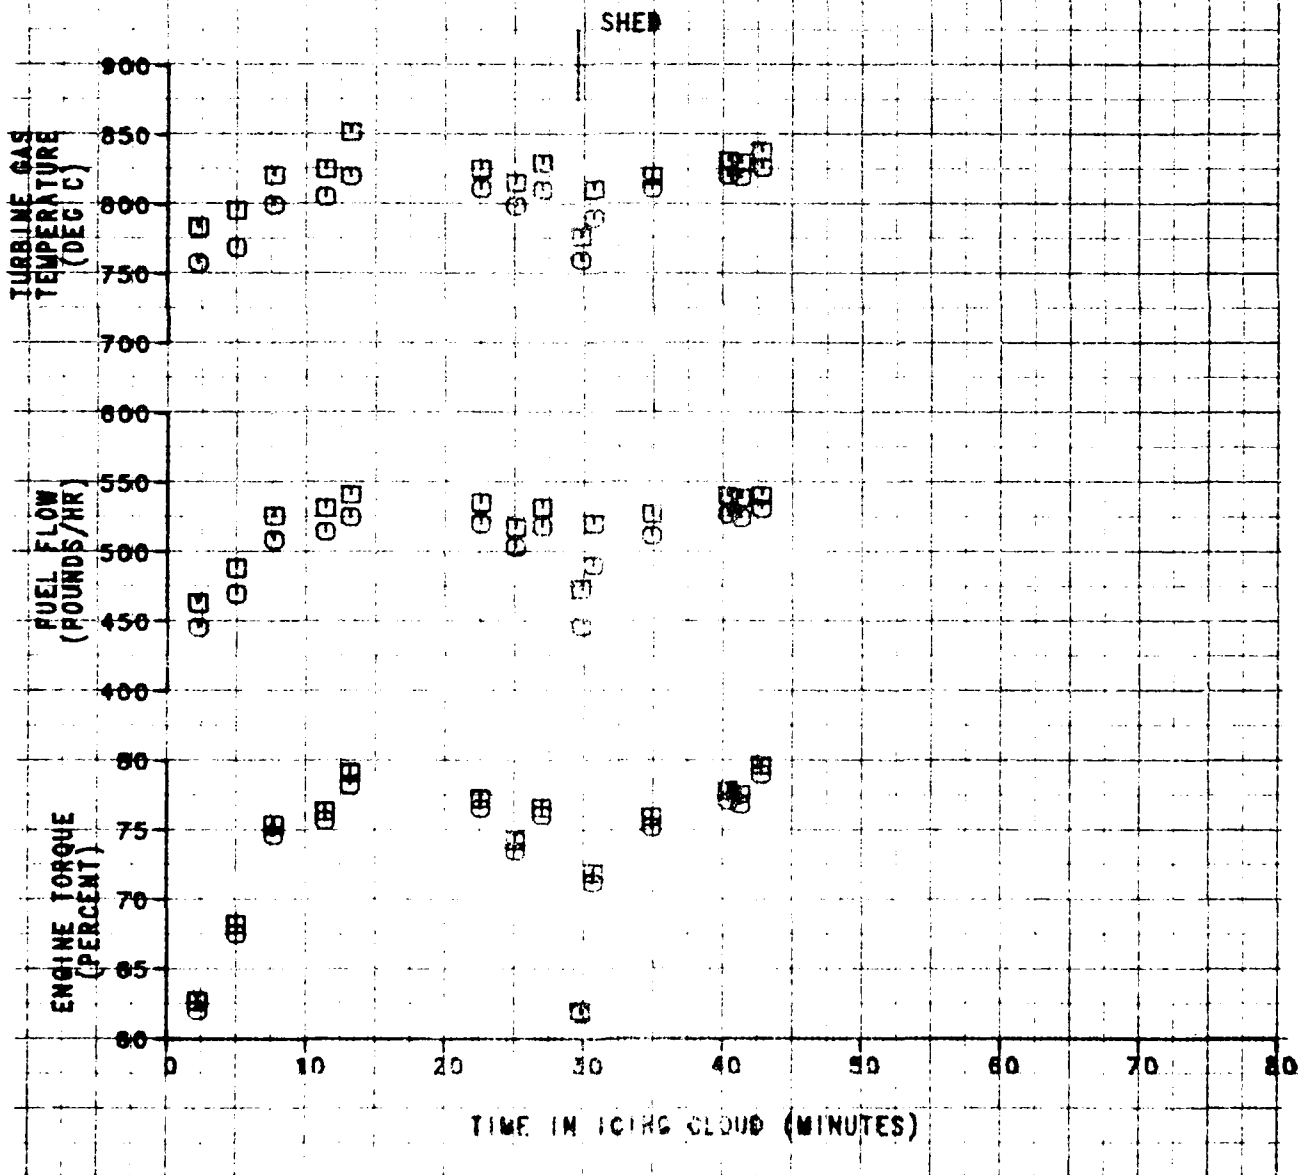
FIGURE 4
TORQUE RISE IN NATURAL ICING CONDITIONS

- NOTE : 1. CIRCLES DENOTE THE LEFT ENGINE SQUARES DENOTE THE RIGHT
 2. DATA TAKEN WITH A FIXED COLLECTIVE POSITION.
 3. A MAIN ROTOR ICE SHED WAS OBSERVED BY THE FLIGHT CREW
 AT 29 MINUTES.

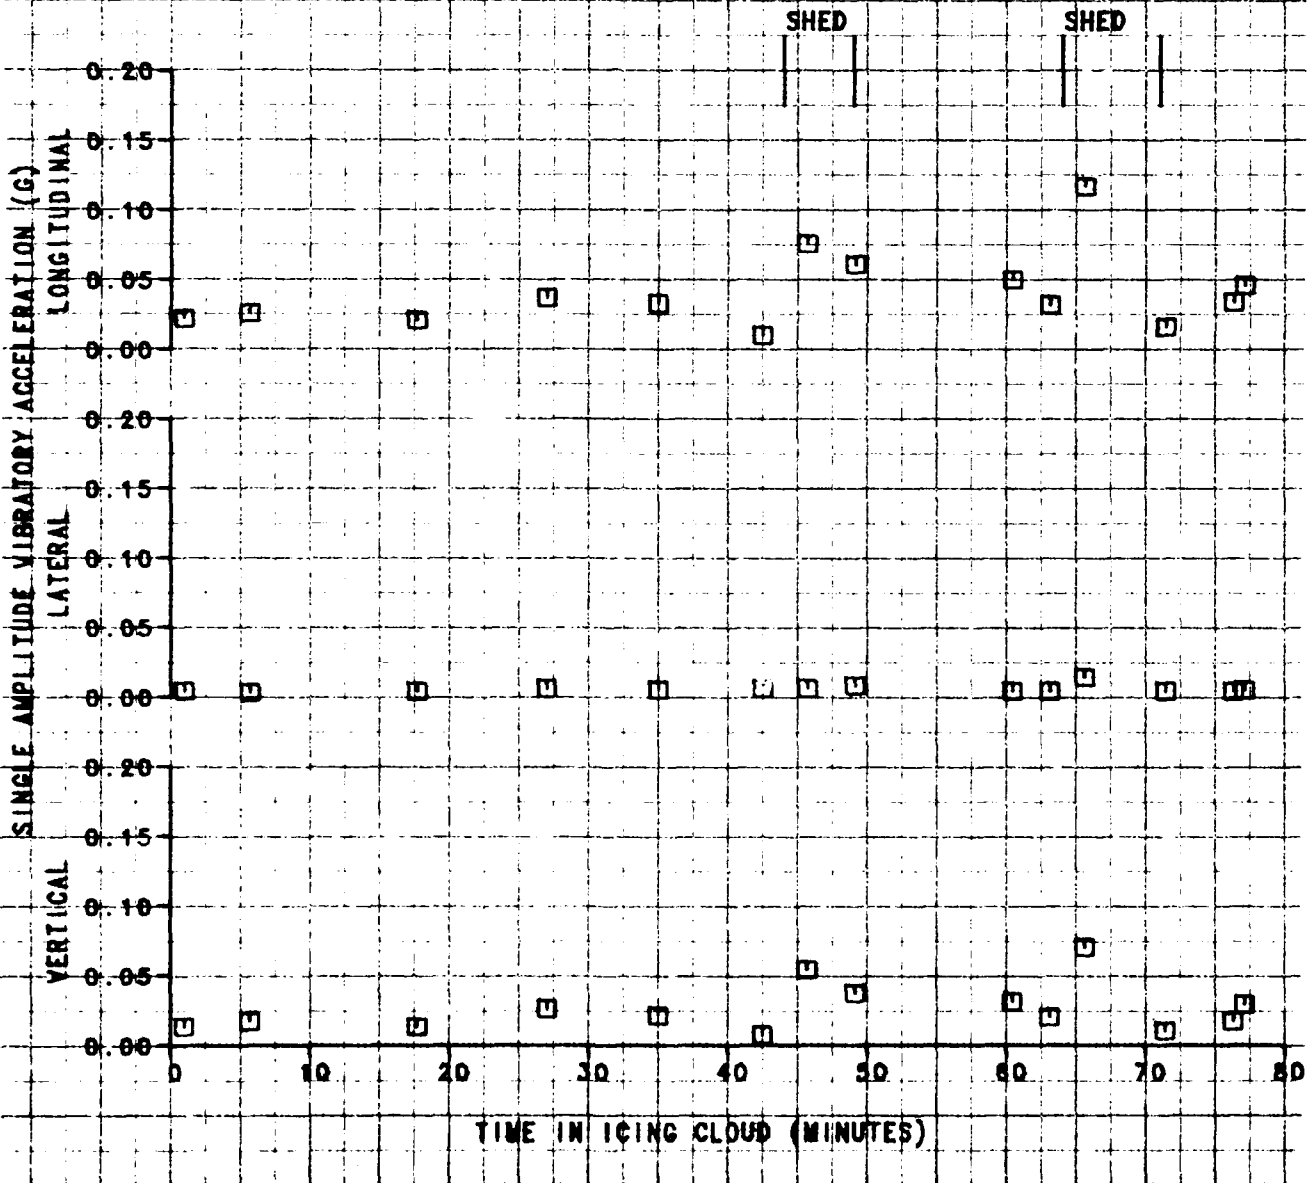
FIGURE 5
VIBRATION CHARACTERISTICS IN NATURAL ICING CONDITIONS

14. Visual observation of the tail rotor blades after icing encounters revealed no significant ice accretions. A high frequency vibration was felt in the cockpit after exiting the natural icing conditions of 0.1 to 0.2 gm/m³ LWC and -15.0 °C. This vibration was apparent to the crew but did not increase their workload over the short period of time the vibration occurred (VRS 4). A comparison of tail rotor gear box vibrations before and during the high frequency vibration is presented in figure 5, appendix F. The ice accretion and shedding characteristics of the unprotected tail rotor blades appear satisfactory.

NOTE : 1. CIRCLES DENOTE THE LEFT ENGINE SQUARES DENOTE THE RIGHT
 2. DATA TAKEN WITH A FIXED COLLECTIVE POSITION.
 3. A MAIN ROTOR ICE SHED WAS OBSERVED BY THE FLIGHT CREW FROM 44 THRU 49 AND 64 THRU 72 MINUTES.

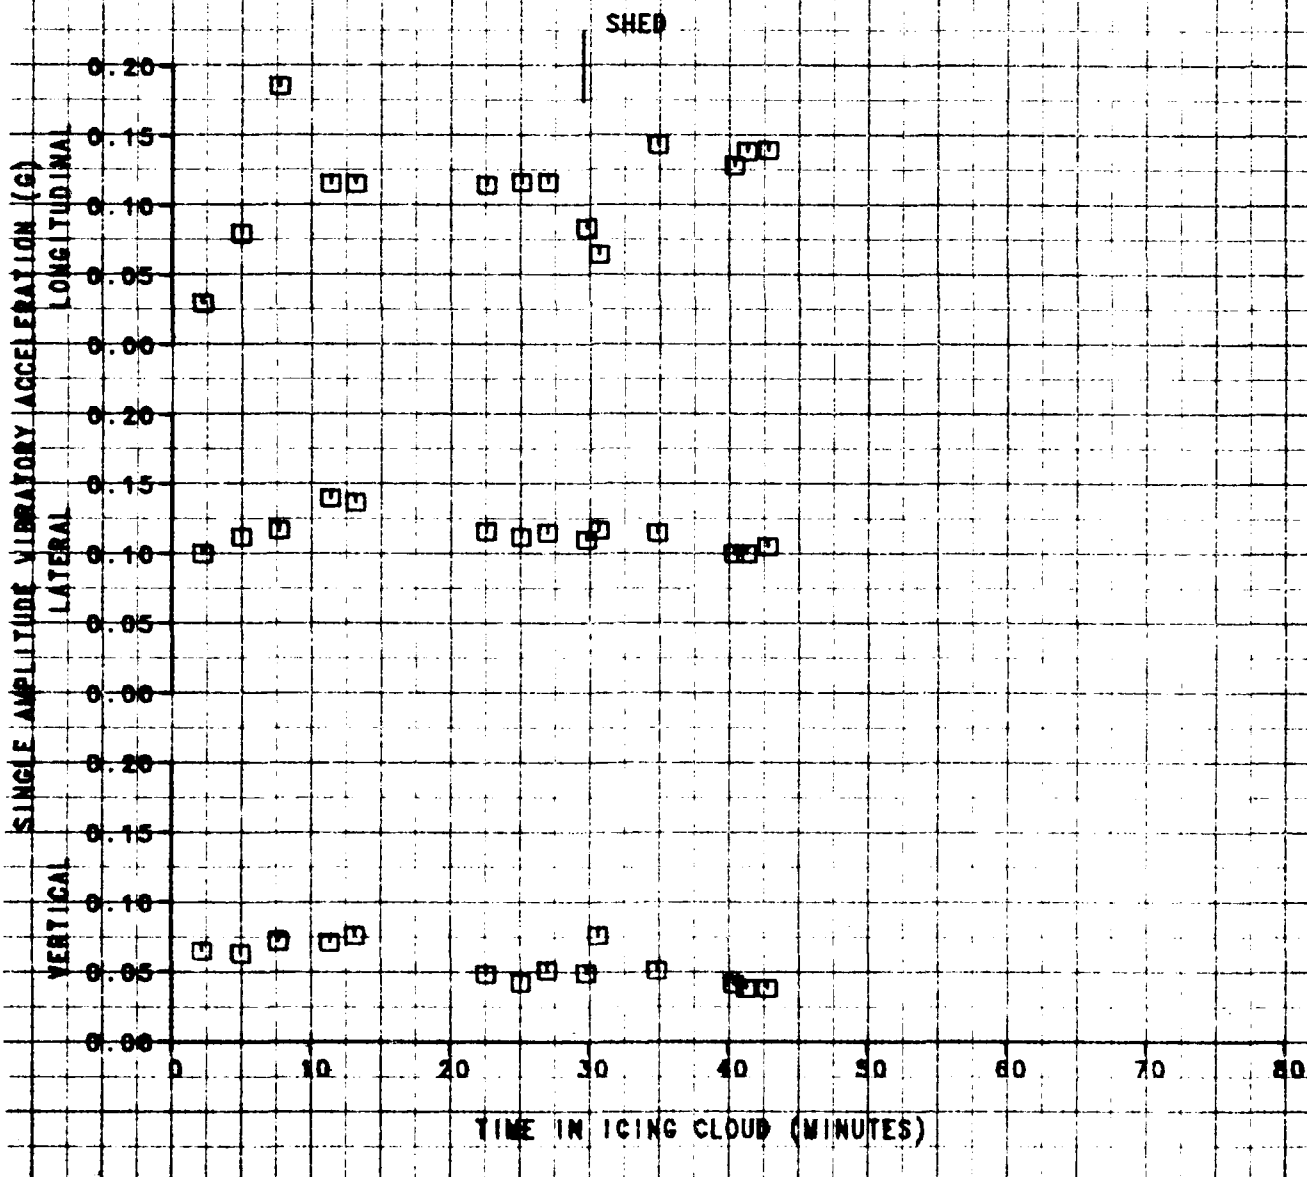
FIGURE 6
VIBRATION CHARACTERISTICS IN NATURAL ICING CONDITIONS

17. The final test flight was in natural icing conditions of 0.5 gm/m^3 LWC and $-4.0 \text{ }^\circ\text{C}$. Vibration data from this flight, which is typical of other flights, indicate larger increases in longitudinal vibrations than in the other axes (fig. 6, app F). Photos 22 and 23, appendix G depict the ice formations at these conditions. A 17 percent torque rise per engine occurred after the aircraft had been in the icing environment 13 minutes (fig. 4, app F). At 29 minutes, a main rotor ice shed occurred and torque decreased to the pre-immersion trim power required

- NOTE : 1. CIRCLES DENOTE THE LEFT ENGINE SQUARES DENOTE THE RIGHT
 2. DATA TAKEN WITH A FIXED COLLECTIVE POSITION.
 3. A MAIN ROTOR ICE SHED WAS OBSERVED BY THE FLIGHT CREW
 AT 29 MINUTES.
