MODIFICATION AND LABORATORY EVALUATION OF A SHIPBOARD
MULTIFUNCTIONAL MAS... (U) NAVAL SURFACE WEAPONS CENTER
DAHLGREN VA J A BYRNE ET AL. MAY 82 NSWC/TR-82-71

4. TITLE (and Subtitle) MODIFICATION AND LABORATORY EVALUATION OF A SHIPBOARD MULTIFUNCTIONAL WASTE INCINERATOR (MFI), PHASE II	5. TYPE OF REPORT & PERIOD COVERED Final

6. PERFORMING ORG. REPORT NUMBER	
7. AUTHOR(s) J. A. Byrne W. W. Jones	8. CONTRACT OR GRANT NUMBER(s)	
9. PERFORMING ORGANIZATION NAME AND ADDRESS Naval Surface Weapons Center (G51) Dahlgren, VA 22448	10. PROGRAM ELEMENT, PROJECT, TASK AREA & WORK UNIT NUMBERS 63721N 21484

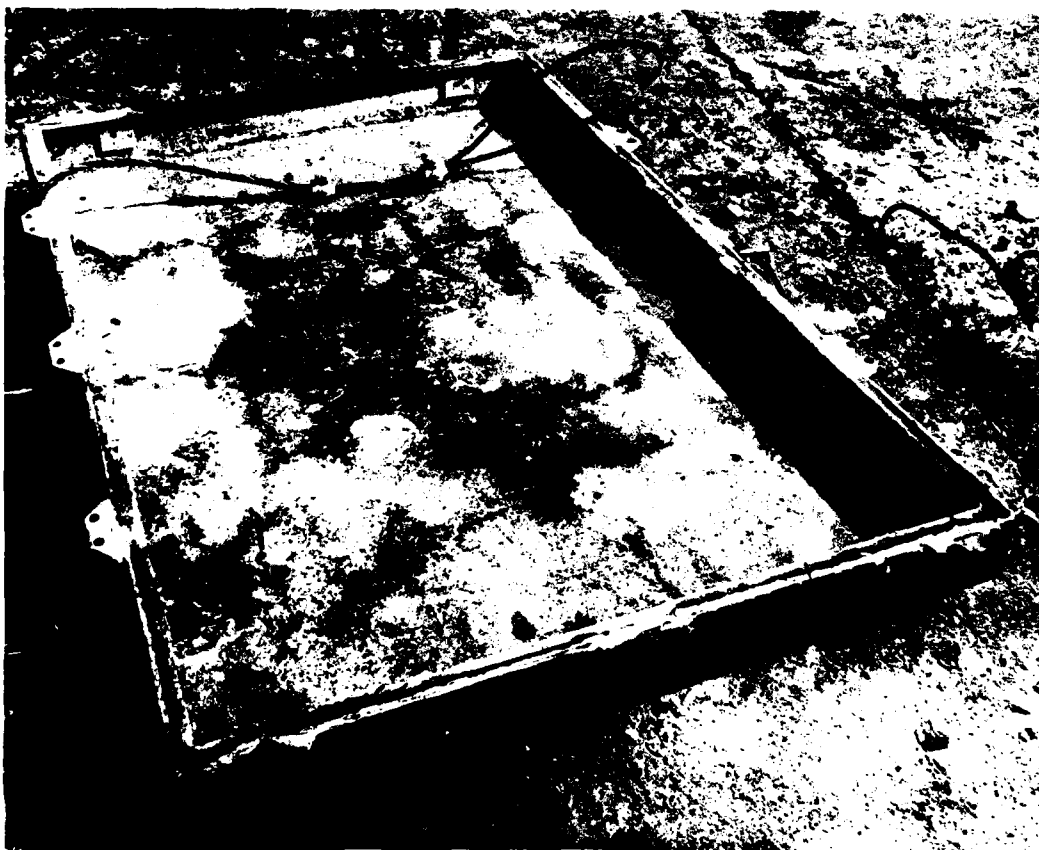
The refractory material of the sewage chamber, partition, and ash door overhead was removed as shown in Figures 10 and 11. The condition of the metal structures is shown in Figures 12, 13, and 14. Figure 12 shows the sewage roof metal structure. Figure 13 is a front view of the sewage chamber wall metal structure. The partition's metal structure, shown in Figure 14, was repaired by replacing the destroyed air manifold pipe. The location of that pipe was also changed, so that an increased thickness of refractory material protected the pipe. All metal structures were then sandblasted and

Figure 12. The Sewage Chamber Roof Metal Structure After the Refractory was Removed

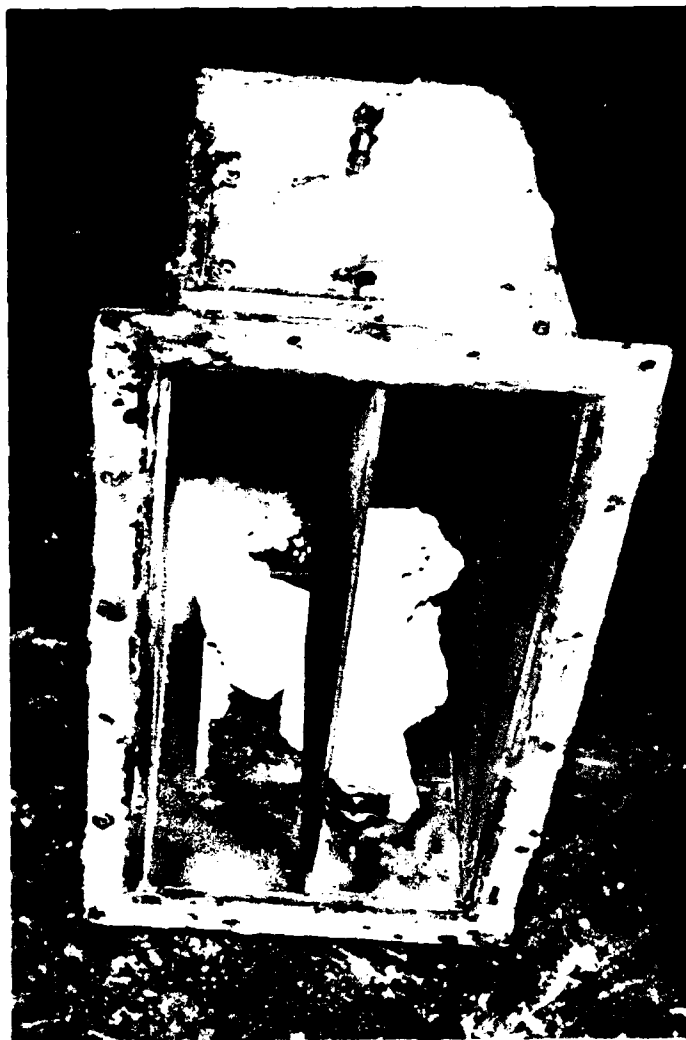
Figures 47 through 51 are a pictorial damage assessment of the MFI. Figure 47 is a view of the front of the MFI with the cooling chamber hatch removed; the damage is very apparent. Figure 48 gives a closer view of the damage in the cooling chamber. Figure 49 is a view of the cooling chamber exhaust port. The pieces of broken refractory blocked the air flow path through the chamber; this blocking would have caused a significant change in the main chamber draft had it occurred during the testing. This damage was assumed to have been a result of the fall rather than because of the vibration testing. Vibration may have cracked or weakened the structure to an extent where the damage from the fall was excessive, but no record could be obtained to prove this. Figure 50 shows the refractory that entered the fan plenum, and Figure 52 illustrates some of the damage to the outer jacket. The main and sewage chambers suffered very minor damage, as shown in Figures 52 through 58.

Figure 50. Refractory in the ID Fan Plenum
