# Special Report 83-21

## *Examination of a blistered built-up roof: O'Neill Building, Hanscom Air Force Base*

C. Korhonen and A. Greaiores

EXAMINATION OF A BLISTERED BUILT-UP ROOF: O'NEILL BUILDING,  
HANSCOM AIR FORCE BASE

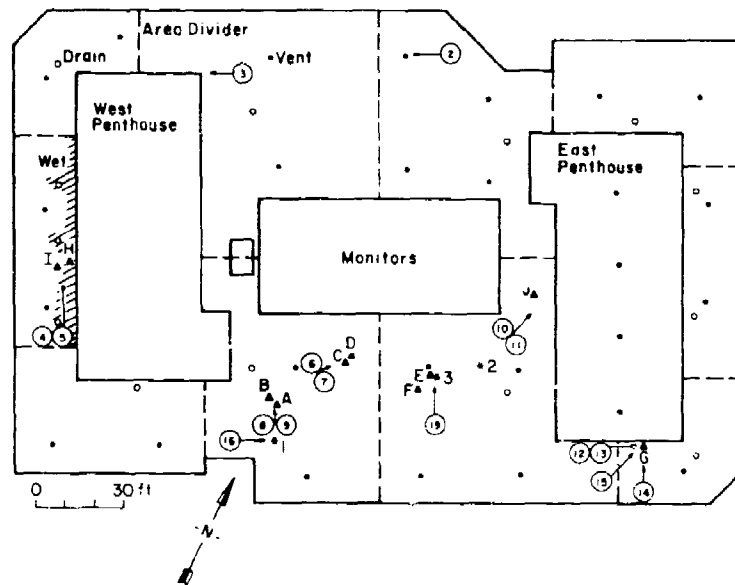
Figure 1. Plan view of O'Neill Building roof. Numbered arrows indicate the viewing direction of figures in this report. Numbers indicate blister cut locations. Letters indicate sample locations.

As shown in Figures 4 and 5 and as verified by sample H, a strip of damp insulation parallels the west side of the west penthouse. The fact that this wet insulation is near the penthouse flashings suggests that a leak has occurred there. However, since our visual examination did not uncover any obvious flaws in this area, it is possible either that the leak occurred during construction before the flashings were watertight, or that spring meltwater from snow drifts gets behind the flashings and into the roof. We are uncertain exactly how water has entered this area, but we do suggest that a qualified roofer examine this area in more detail than we could during our brief overview.

Next summer an additional 5 in. of gravel should be spudded from around each patch. They were not graveled in so they should be easy to locate by referring to Figure 1. The membrane should then be cleaned with a wire brush and a new layer of roofing cement added, followed by a felt 3 in. larger than the old patch. Then the area should be covered with more roofing cement and graveled. Spray paint should be used to mark each patch to assist future maintenance in those areas.
