RELIABILITY OF PORTABLE DRY CHEMICAL
FIRE EXTINGUISHERS IN USE
ON MOTORBOATS

W.C. HELGESON

U.S. Coast Guard Research and Development Center
Avery Point Groton, Connecticut 06340

FINAL REPORT

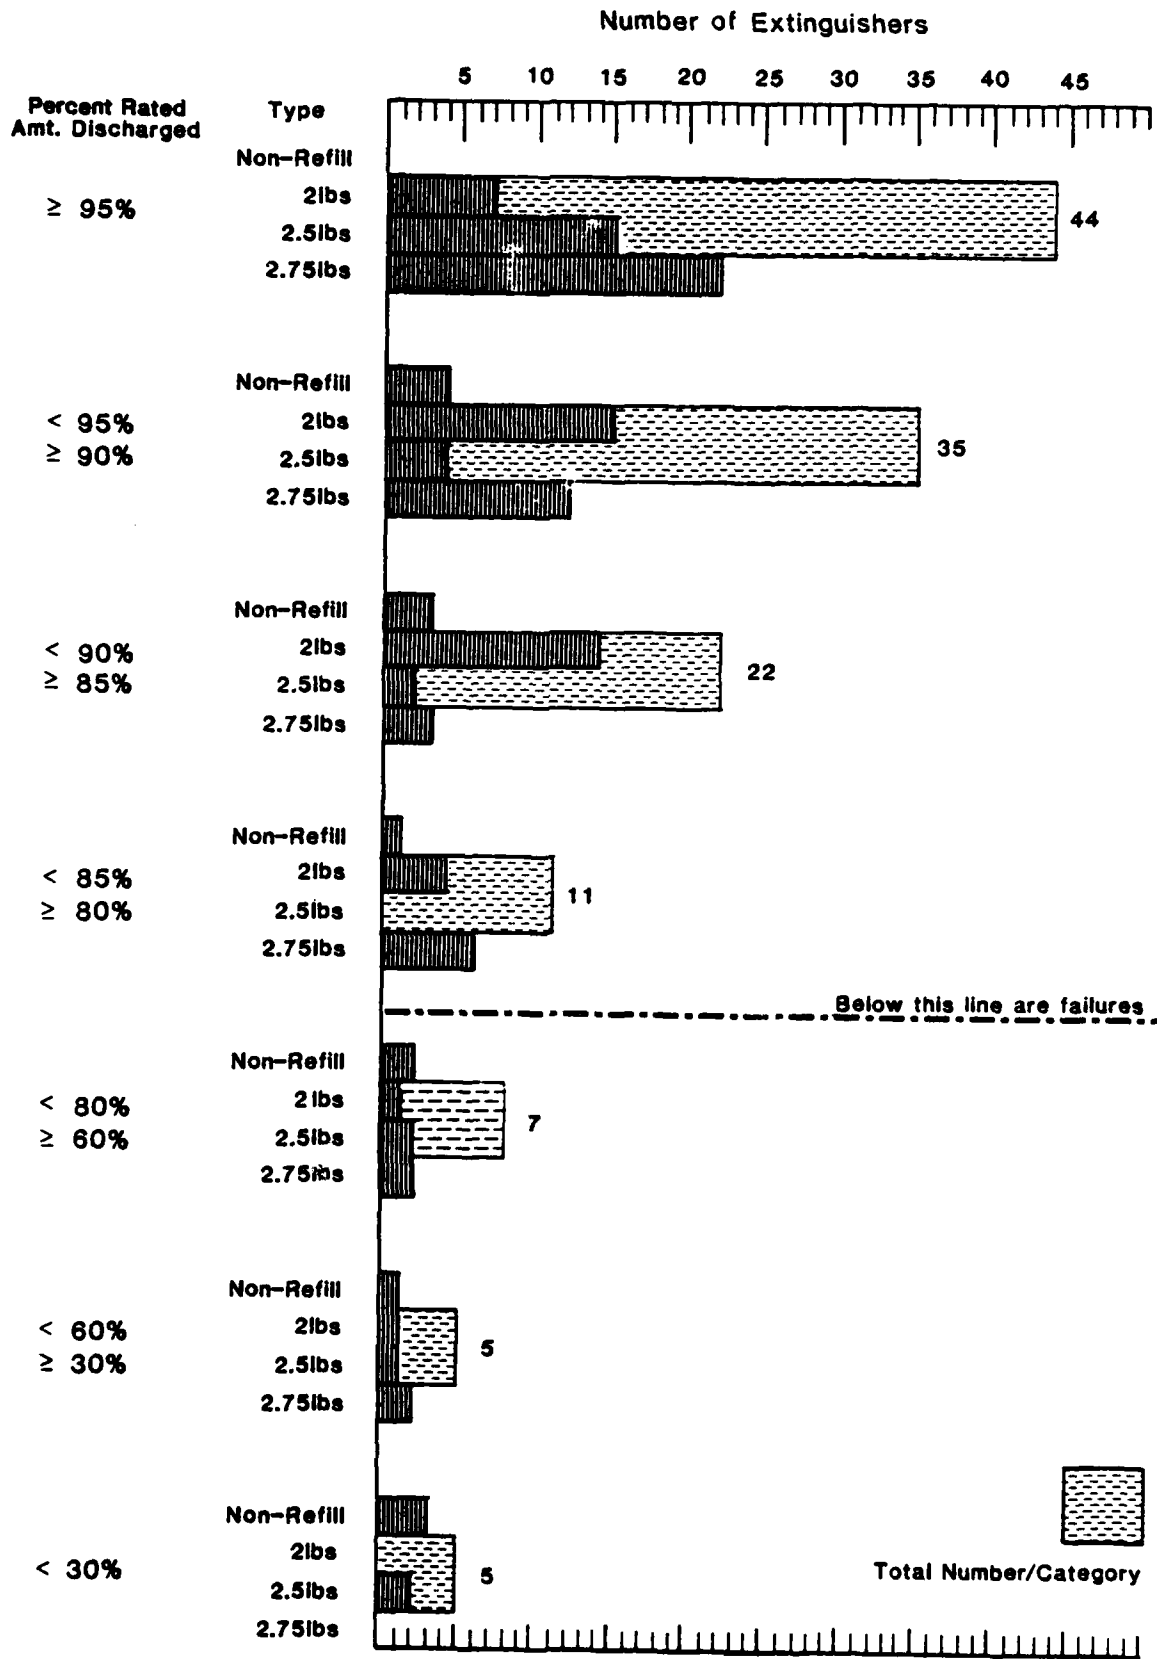
FIGURE 1
COMPARISON OF DISCHARGE AMOUNTS

The amount of powder expelled compared to the rated capacity is shown in Figure 1 for all the extinguishers. Over half of the extinguishers discharged 90% or more of their rated capacity. Seventeen (17) of the one hundred thirty (130) extinguishers failed one or more of the tests. Appendix A describes each failed extinguisher. Tables 1 through 5 categorize the extinguishers by manufacturer and dates. Figure 2 shows pictures of the cut-open, failed extinguishers.
