MISCELLANEOUS PAPER SL-83-17

EVALUATION OF CONCRETE CORES CARUTHERSVILLE FLOODWALL

G. Sam Wong

September 1983
Final Report

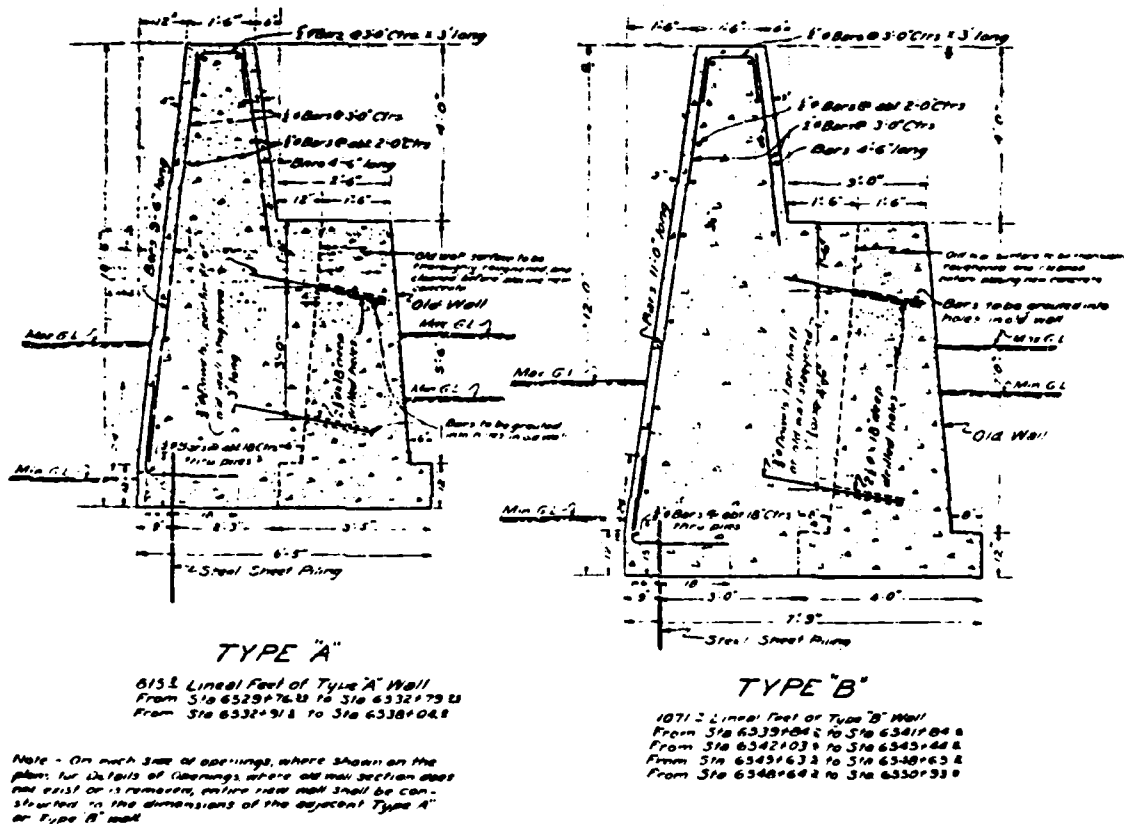
Figure 1. Typical wall sections incorporating an existing wall

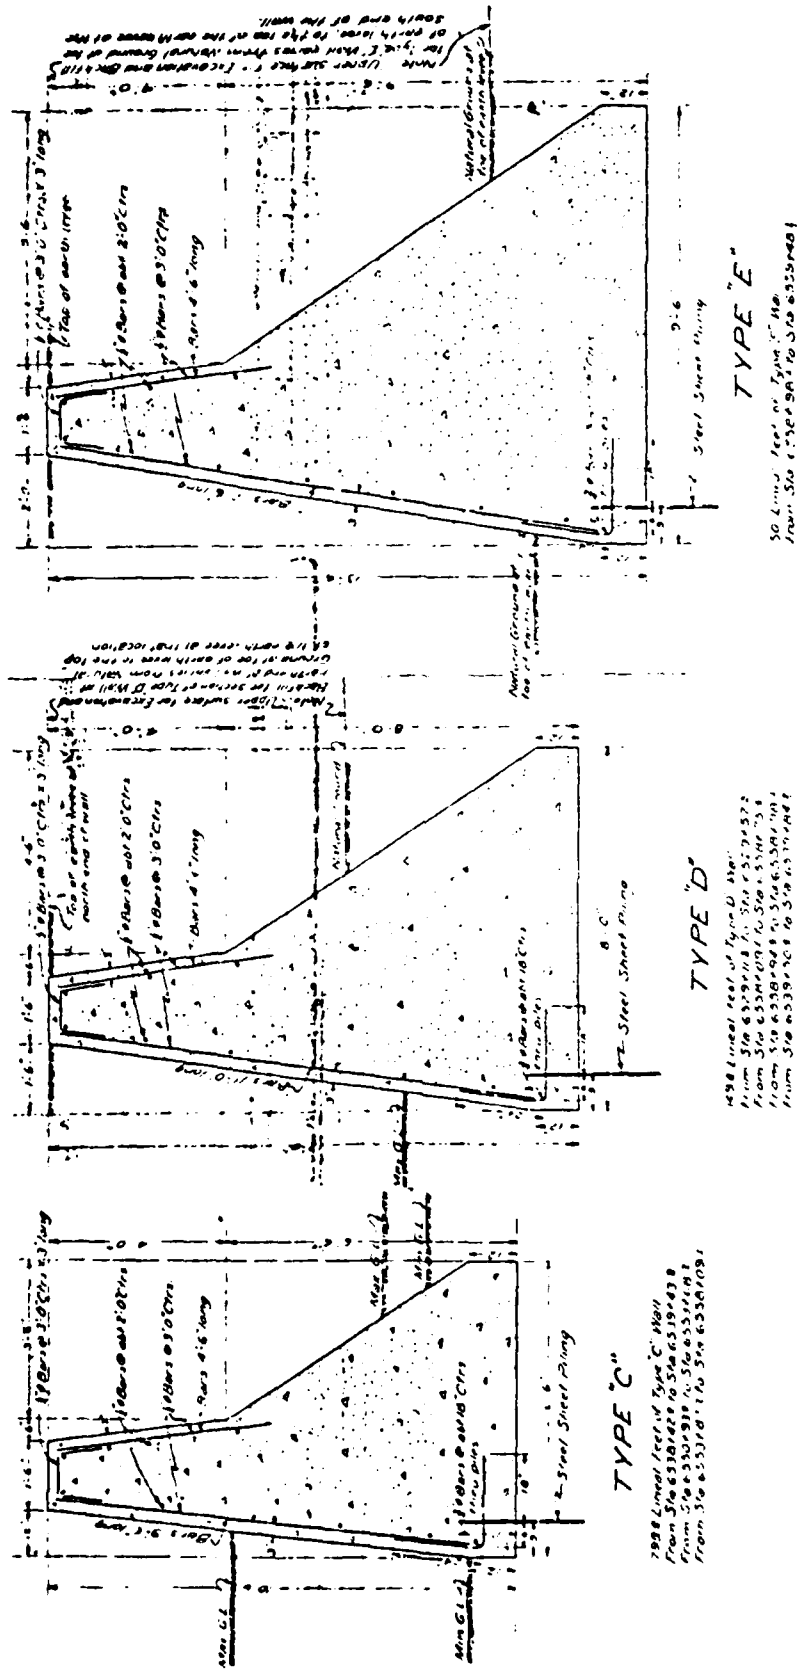
Figure 2. Typical wall sections, Types C-E

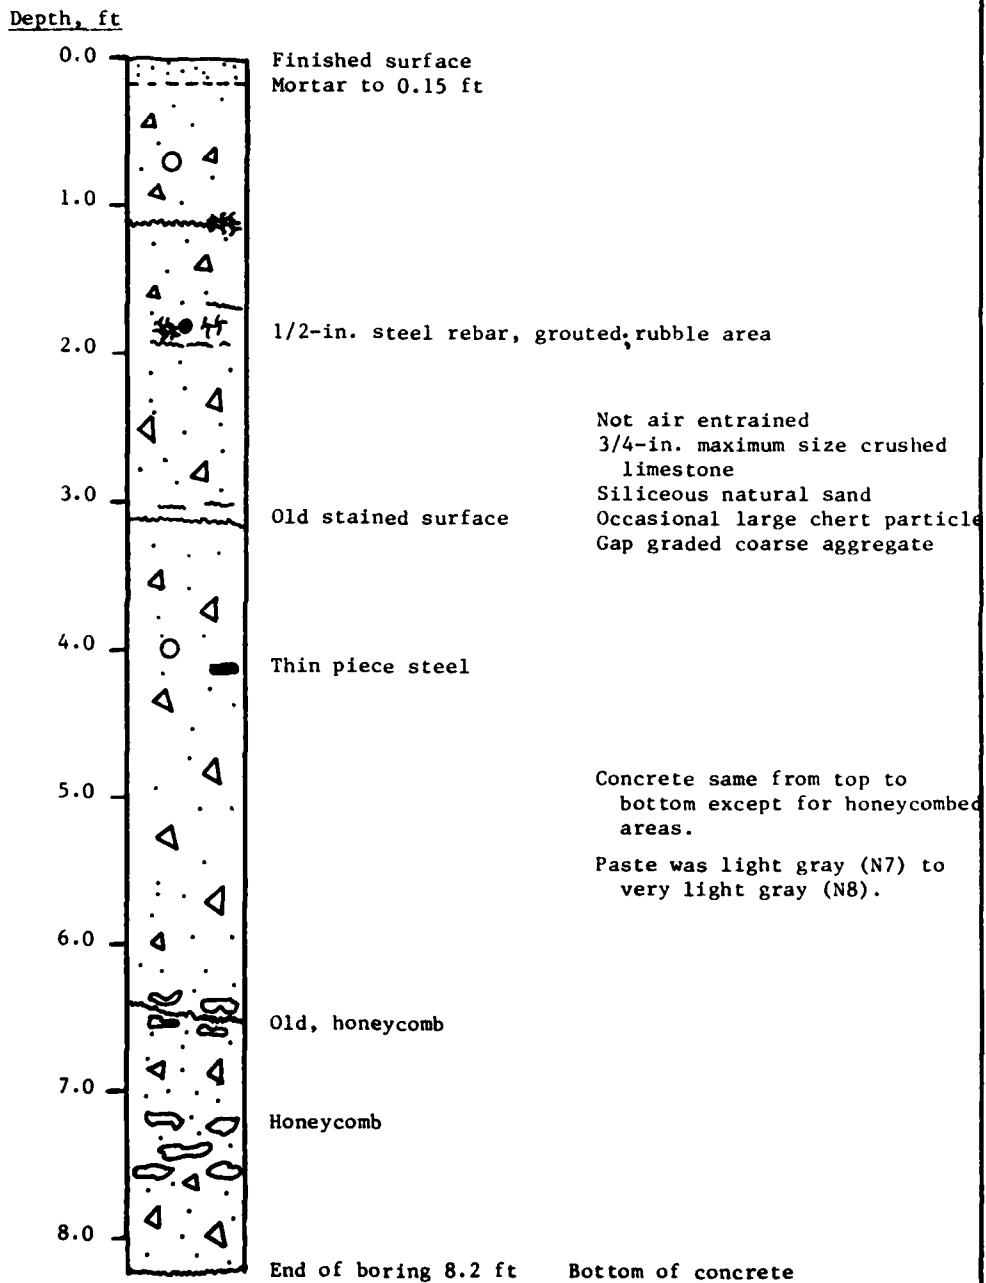
PLATE 9

MEM-5 CON-9 (New and old concrete, slant boring)
Caruthersville Floodwall, Caruthersville, Missouri
6-in.-diameter core

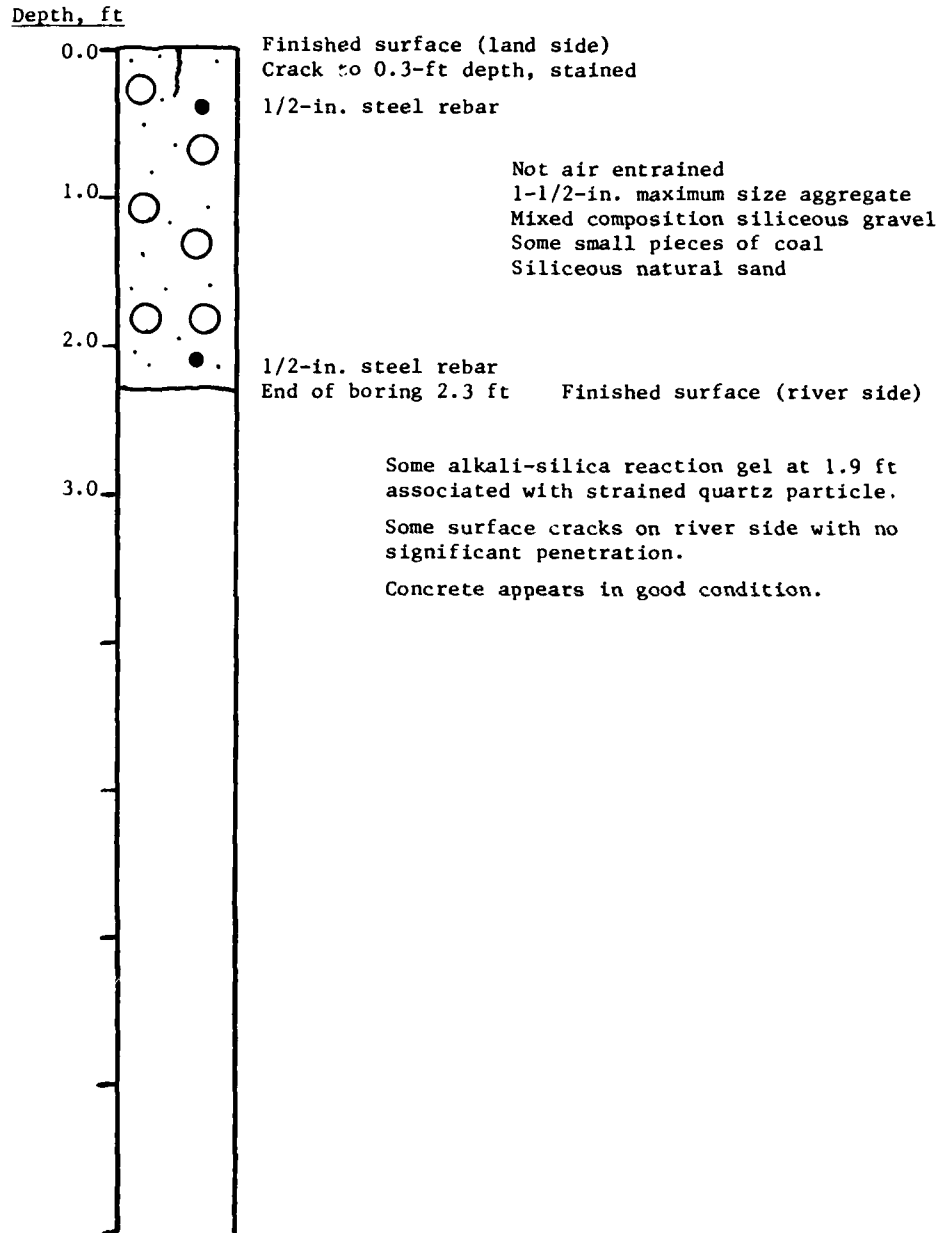
PLATE 11

MEM-5 CON-11 (New concrete, horizontal boring)
Caruthersville Floodwall, Caruthersville, Missouri
6-in.-diameter core
