MISSISSIPPI RIVER
STUDY OF ALTERNATIVES FOR REHABILITATION
OF LOCK AND DAM NO. 1
MINNEAPOLIS, MINNESOTA

VOLUME III
APPENDICES B-F

DEPARTMENT OF THE ARMY
ST. PAUL DISTRICT, CORPS OF ENGINEERS
ST. PAUL, MINNESOTA

APRIL 1976

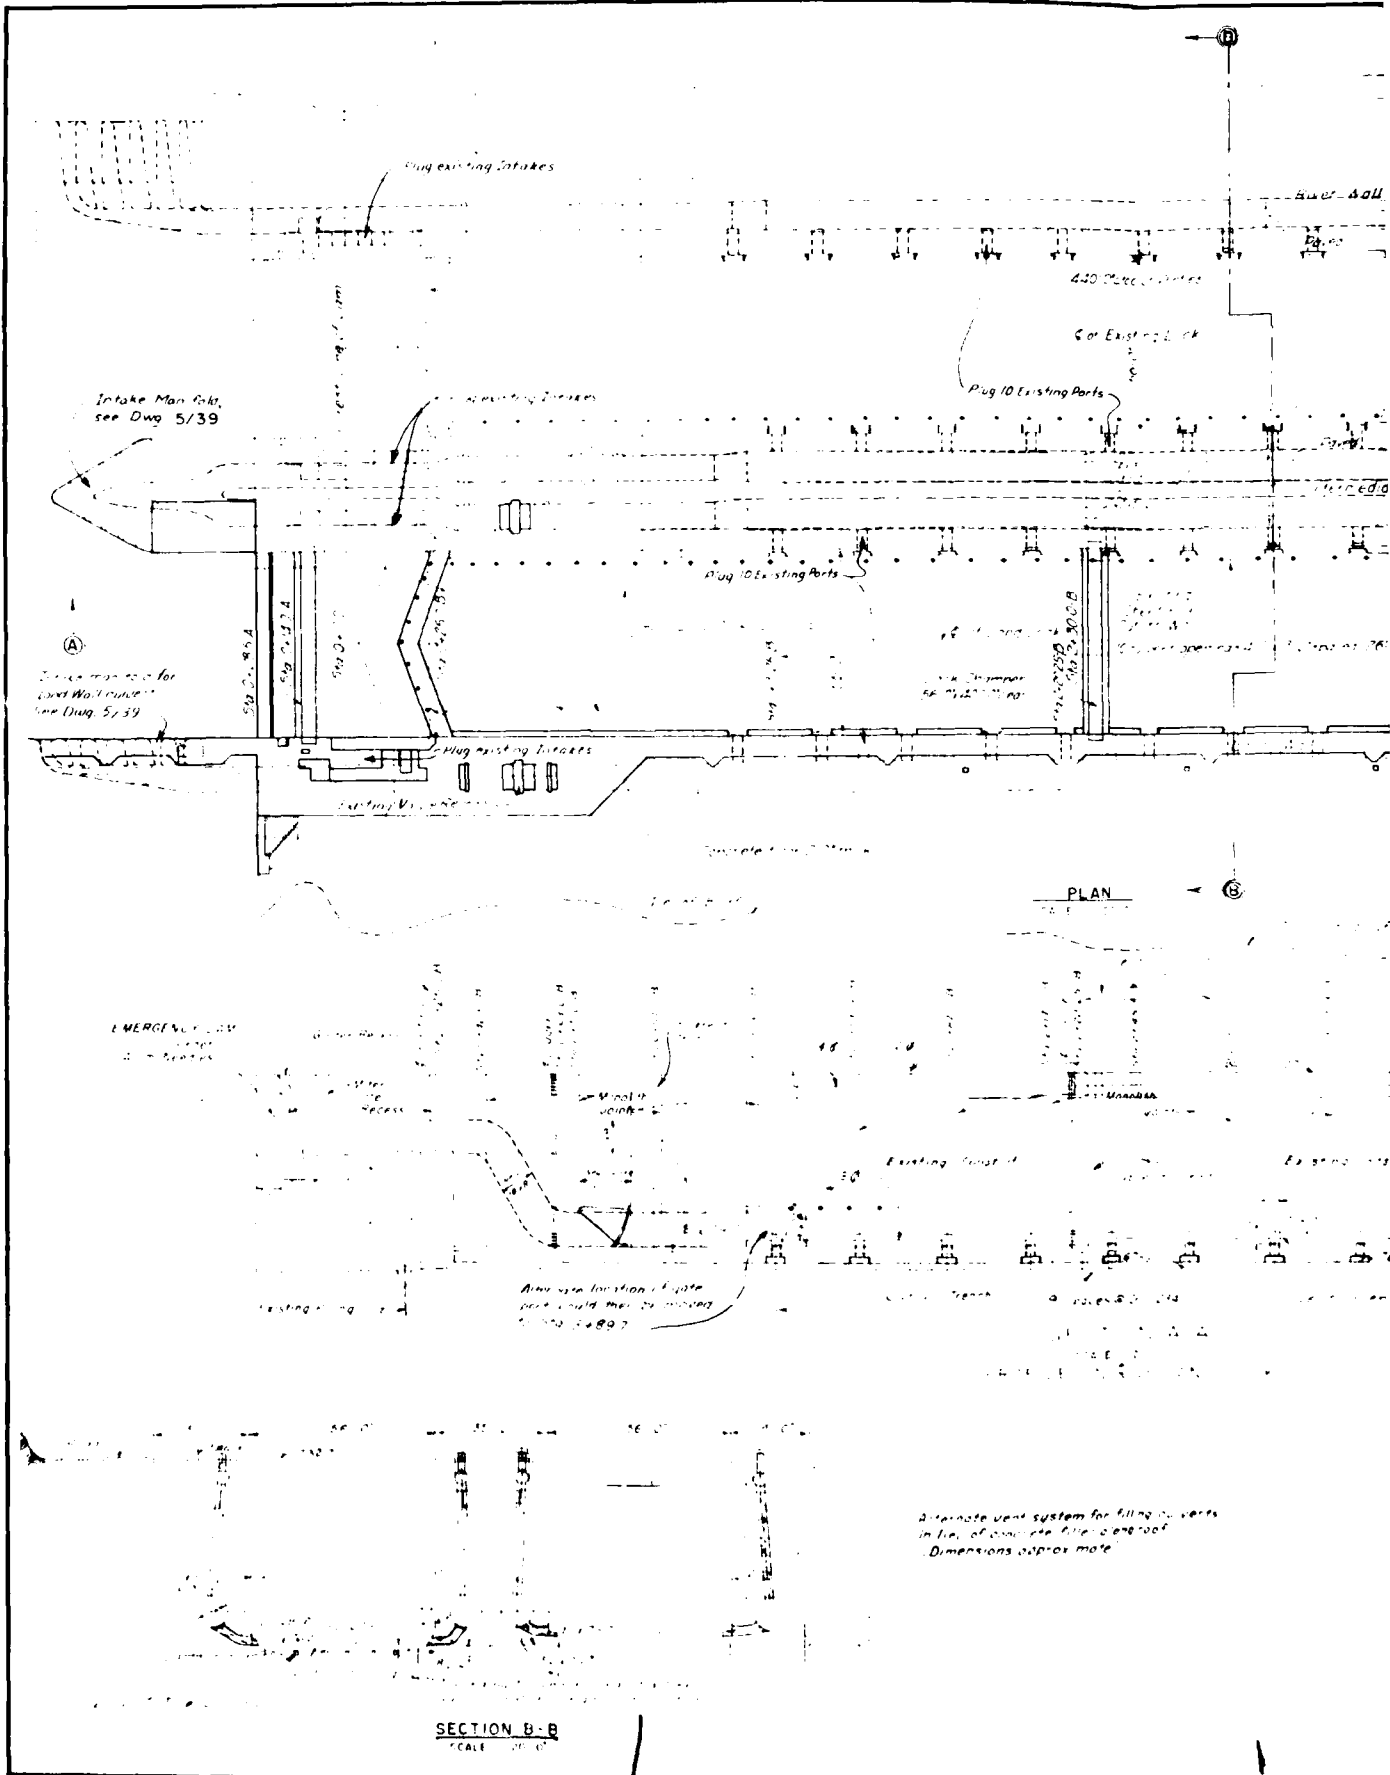
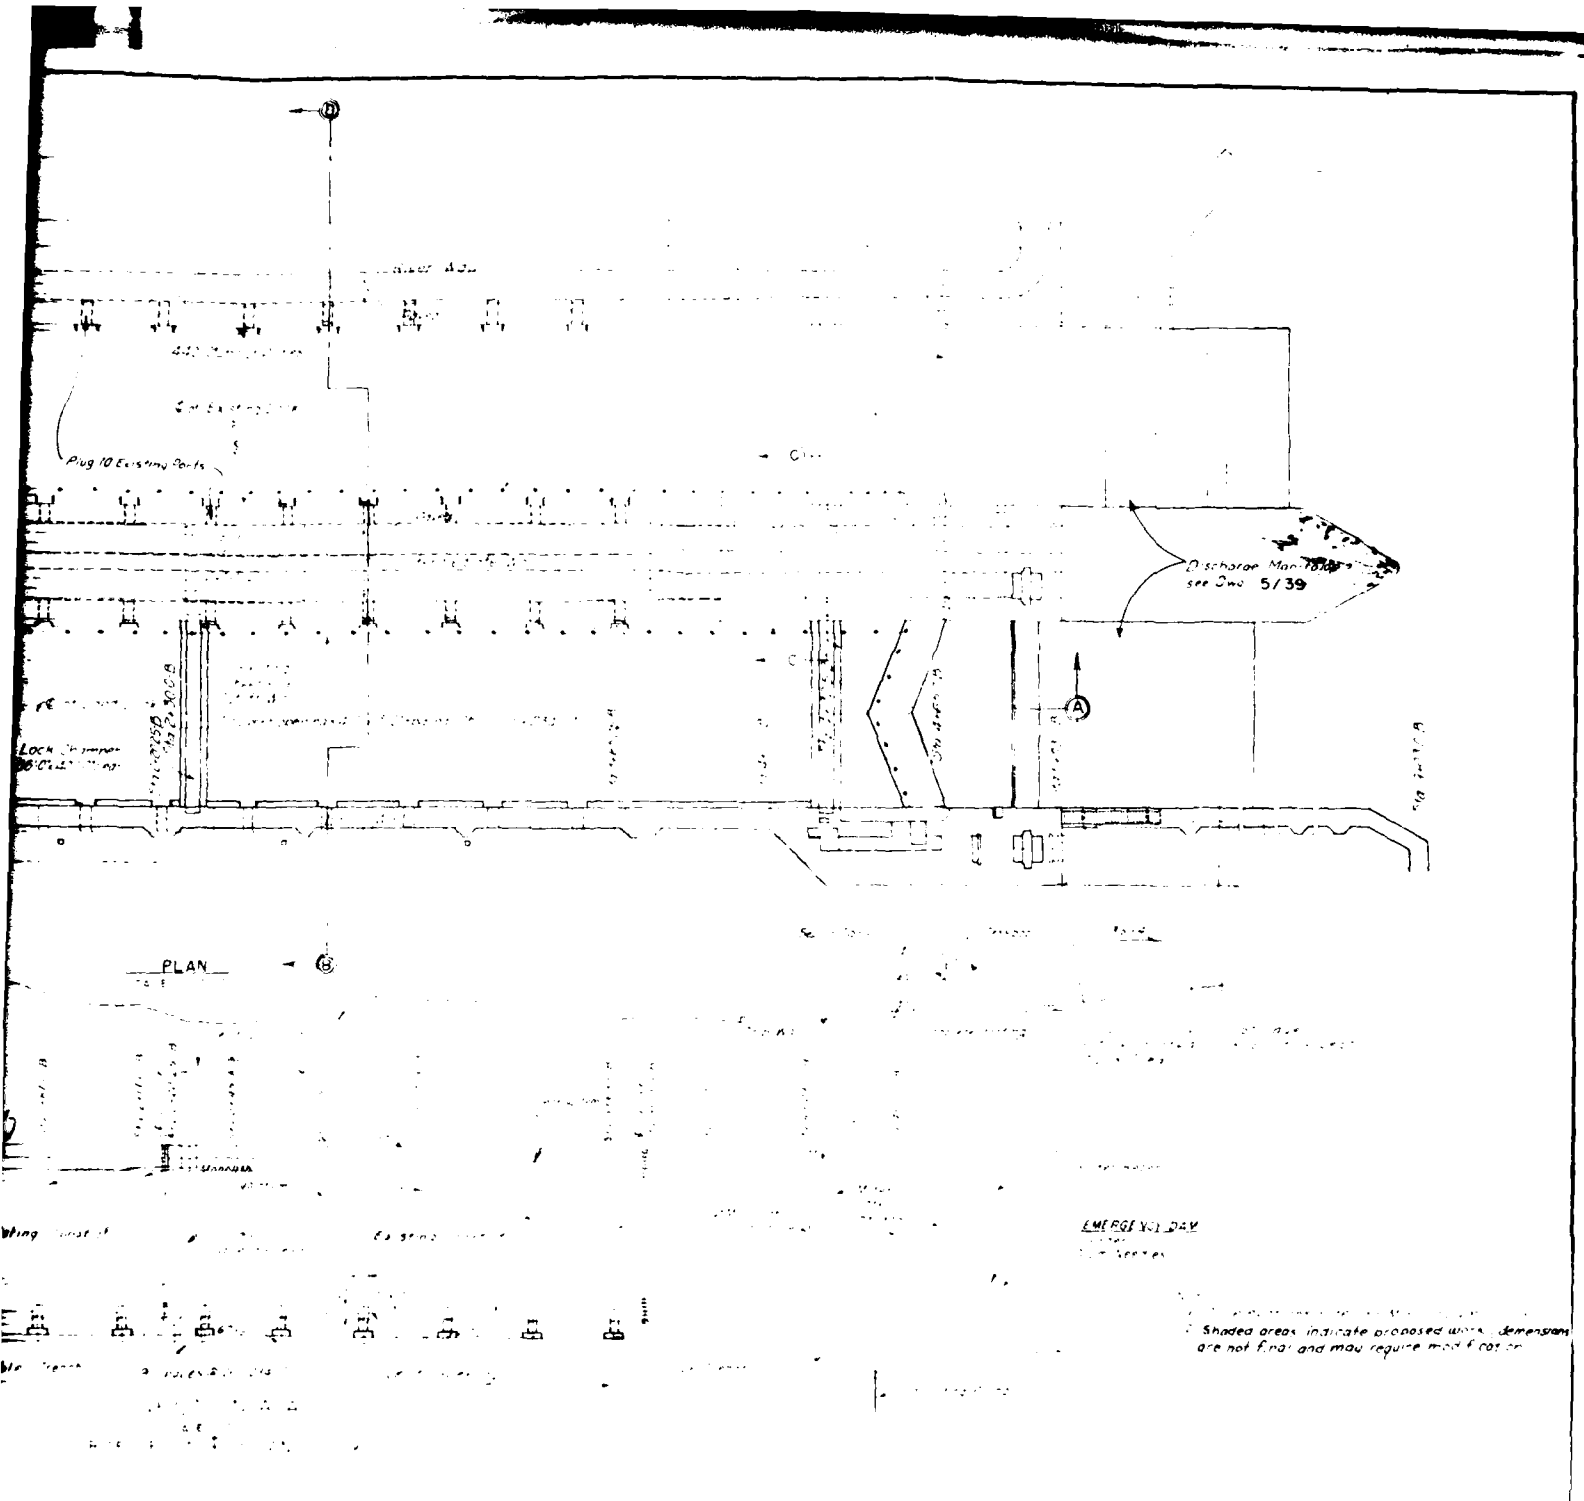
An extension of the intermediate wall upstream, permitting construction of dual intake manifolds, as shown in Figure 3 of Drawing 5/39, will provide flow to respective culverts in either lock, whichever is to be filled. By drawing water from both sides of the I-wall the current into the lock entrance will be substantially reduced. A typical intake manifold for the landward guide wall is shown in Figure 6. The port areas are graduated to provide uniform flow, as nearly as possible, into all the ports. A similar intake can be constructed in the riverward guide wall. By facing the ports toward the river, drift will not be carried into the lock entrance by flow approaching this intake.

Shaded areas indicate proposed work. Dimensions are not final and may require modification.

Alternate vent system for filling piers
 in lieu of concrete filling and roof
 (Dimensions approximate)

6. Construct lateral diffusers below the downstream miter gates as shown in Figure 5 of Drawing 5/39 to dissipate the energy of discharge during emptying operations in order to minimize hazardous currents and disturbances in the lower lock approach.

8. Constant new intake manifolds upstream of the miter gate recesses to reduce tendency for floating debris to interfere with opening of miter gates. Suggested intake revisions are shown on Drawing 5/39.

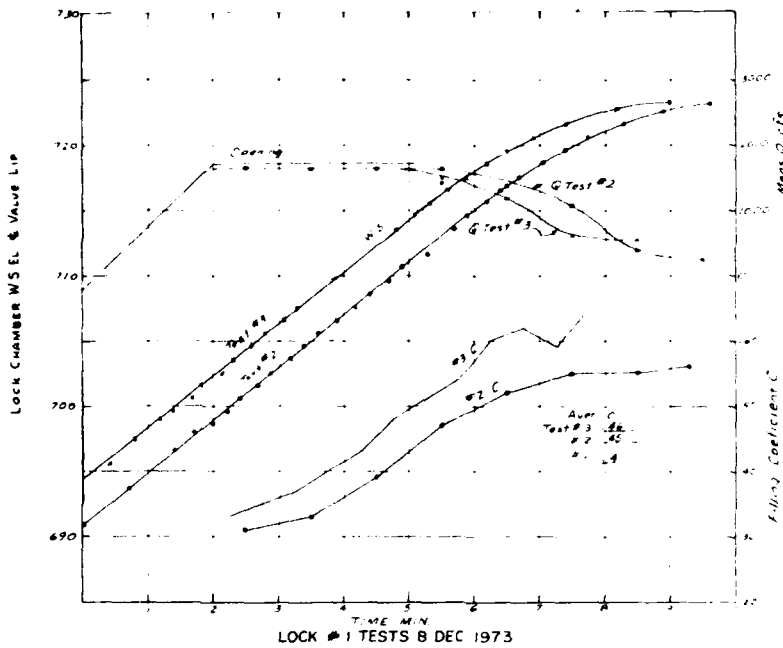
The results of these computations are shown in Figure 1 (see Drawing 5/39). The slope of the filling curve is precisely the same in both tests and the rate of filling is identical until the water level in the lock chamber reaches approximately elevation 713.6. This indicates that the flow in this part of the filling operation is controlled solely by the culvert system upstream from the drop section. As the increasing back pressure suppresses the jump, the curve assumes the characteristic shape of usual filling curves.

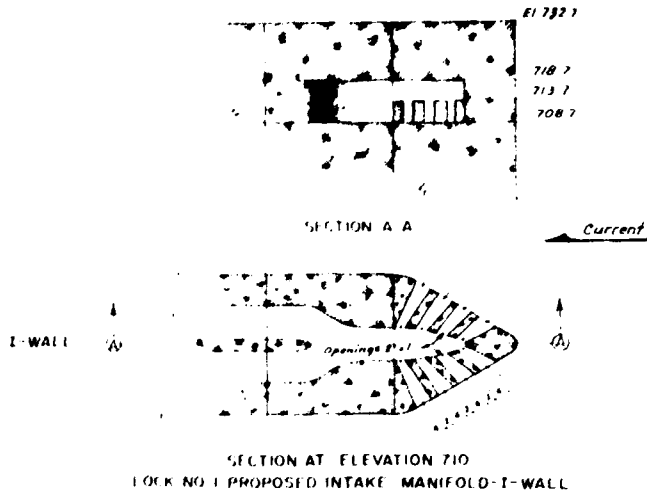
For comparison of the filling characteristics of Lock No. 1 with those of a typical modern lock, data similar to those shown in Figure 1 obtained in a model test of the Eisenhower Lock are shown in Figure 2 (see Drawing 5/39). It will be noted that the hydraulic coefficient for the filling system after the valves are fully open in the Eisenhower Lock remains practically constant at 0.75 throughout the rest of the operation. Also the rate of filling decreases uniformly after the valves are fully open, indicating that the hydraulic system is operating under a gradually falling head. In tests 2 and 3 at Lock No. 1, the filling rate remained constant several minutes due to the discontinuity in flow caused by the hydraulic jump in the drop section.

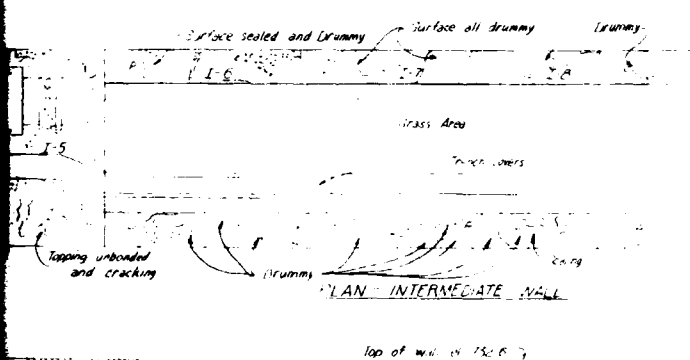
<p>There is no cracking on top surface. Moderate to severe longitudinal cracking at water and lower portion of the river side and local areas of lock side wall.</p> <p>Slight spalling along vertical joints and slight to moderate spalling on lower portion of landlock wall. Slight spalling on all surface. Top surfaceummy over most areas. 50% top surface repaired.</p> <p>See above</p> <p>Vertical joints tight.</p> <p>Moderate to severe chalking from longitudinal cracks.</p>	<p>Minor cracks on lower portion of wall at both sides.</p> <p>Slight spalling at bottom of wall on riverlock side & along vertical joints. Severe spalling on most areas of landlock wall. Slight to moderate spalling on walls. Top surface drummy and moderate spalling. 60% top surface repaired.</p> <p>See above</p> <p>Vertical joints tight.</p> <p>Slight leaching from cracks. Local areas of unbound repair on top surface.</p>	<p>Minor cracks at upper edge of riverlock side of wall and in local areas of landlock side wall.</p> <p>Slight spalling along vertical joints. Slight spalling on lower portion of wall on landlock side. Slight spalling on walls. Top surface drummy. 50% repaired.</p> <p>See above</p> <p>Vertical joints tight.</p> <p>Slight leaching from cracks. Local areas of unbound repair on top surface.</p>	<p>Cracking in upper portion of wall. Minor cracks in lower portion of wall on landlock side.</p> <p>Slight spalling at bottom of landlock side wall. Moderate to severe spalling in portions of walls above waterline. Slight spalling in wall 50%. Top surface drummy. Repair surface drummy and spalling.</p> <p>See above</p> <p>Vertical joints tight.</p>

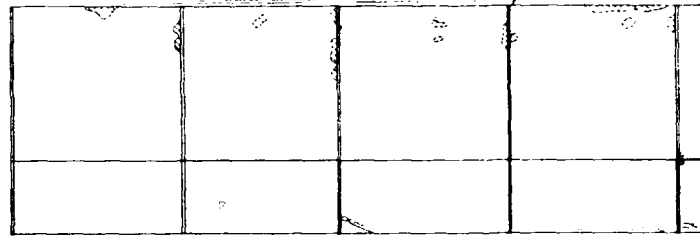
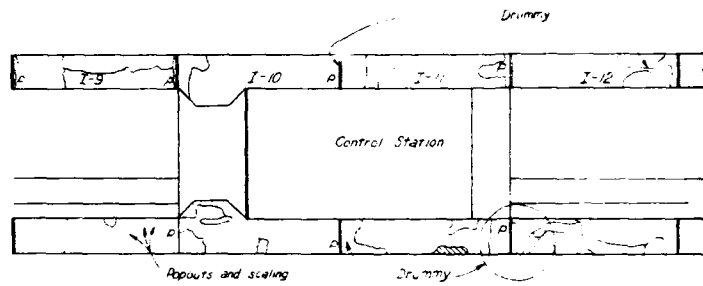
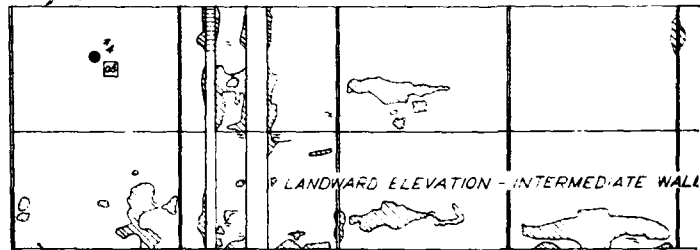
PLAN - INTERMEDIATE WALL

(CONTINUED)		MONOLITH NO.			
CONCRETE CONDITION		9	10	11	12
CRACKING	Maximize cracks on top surface. Minor cracks at lower portion of wall on landlock side.	Cracks, scaling and cracking along rebar on top surface. Minor scaling in local areas on sea at landlock side.	Diagonal cracking at upper portion of wall. Cracks in upper portion of wall. Minor scaling on sea at landlock side. Local areas.	Moderate scaling on top surface. Slight scaling along vertical joints and on sea at landlock side. Moderate scaling on sea at landlock side. Slight scaling on sea at landlock side.	Moderate scaling on top surface. Slight scaling along vertical joints and on sea at landlock side. Moderate scaling on sea at landlock side. Slight scaling on sea at landlock side.
SCALING AND SPALLING	Slight spalling along vertical joints. Slight to moderate spalling on lower portion of walls. Slight to moderate scaling on walls. Top surface weathered. 20% repaired.	0% concrete pavement on the surface weathered. Moderate spalling along vertical joints. Slight spalling on walls in local areas. Slight to moderate scaling on both walls. 10% top surface repaired.	Moderate scaling on top surface. Slight scaling along vertical joints and on sea at landlock side. Moderate scaling on sea at landlock side. Slight scaling on sea at landlock side.	Moderate scaling on top surface. Slight scaling along vertical joints and on sea at landlock side. Moderate scaling on sea at landlock side. Slight scaling on sea at landlock side.	Moderate scaling on top surface. Slight scaling along vertical joints and on sea at landlock side. Moderate scaling on sea at landlock side. Slight scaling on sea at landlock side.

JOINTS	See above. Vertical joints tight.	See above. Vertical joints tight.	See above. Vertical joints tight.	See above. Vertical joints tight.	See above. Vertical joints tight.
OTHER	Slight leaching from cracks. Local areas of spalled repair on top surface.	Slight leaching from cracks in upper portion of wall. Local areas of spalled repair on top surface.	Slight leaching from cracks in upper portion of wall. Local areas of spalled repair on top surface.	Slight leaching from cracks in upper portion of wall. Local areas of spalled repair on top surface.	Slight leaching from cracks in upper portion of wall. Local areas of spalled repair on top surface.

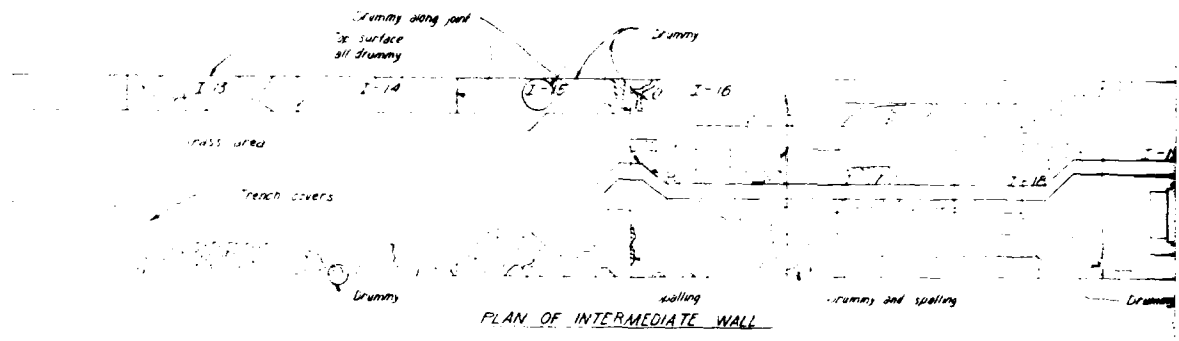
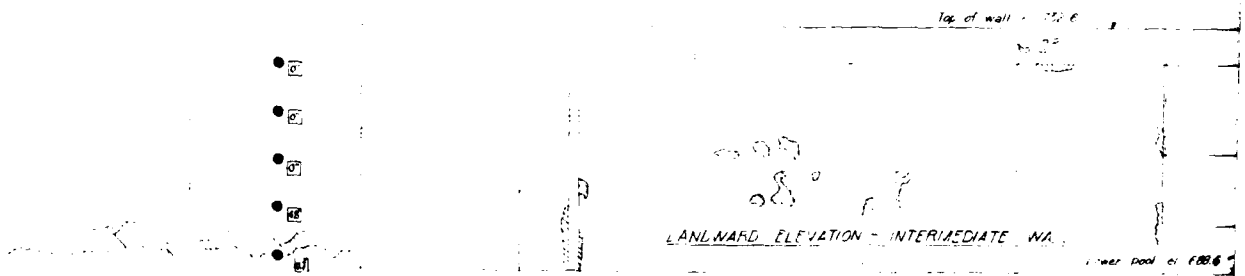
UPPER ELEVATION - INTERMEDIATE WALL (CONT'D)

CONCRETE CONDITION	MONOLITH NO.							
	13	14	15	16	17	18		
CRACKING	Major cracking & transverse barrel cracks on top surface. Minor cracks at upper portion of wall near top edge. Minor longitudinal cracks on inner joint of wall on both sides.	Minor hair cracks and stains around repair on top surface. Minor cracks at lower portion of wall on exterior side.	Major cracking in repair concrete on top surface.	Minor cracking in top surface. Slight spalling along vertical joints and on both walls. Slight moderate spalling in both walls. Top surface 30% repaired.	Minor cracking in top surface. Slight spalling along vertical joints. Slight moderate spalling on both walls. Severe along on wall on outside side. 25% top surface repaired.	Minor cracking in upper portion of wall on inside side. Moderate spalling.	Slight moderate spalling along vertical joints. Slight moderate spalling on both walls. Slight cracking in wall on inside side. 10% top surface repaired.	Some large vertical cracks on side.

SCALING AND SPALLING	Slight spalling along vertical joints. Moderate spalling and slight scaling on both walls. 95% of top surface repaired.	Minor spalling along joints and edges on top surface. Slight spalling along vertical joints. Slight moderate spalling on both walls. 10% of top surface repaired.	Minor spalling in top surface. Slight spalling along vertical joints and on both walls. Slight moderate spalling in both walls. Top surface 30% repaired.	Slight scaling along vertical joints. Slight moderate scaling on both walls. Severe along on wall on outside side. 25% top surface repaired.	Slight moderate spalling along vertical joints. Slight moderate scaling on both walls. 15% top surface repaired.	Slight moderate spalling along vertical joints and on both walls. Slight cracking in wall on inside side. 10% top surface repaired.	Slight moderate spalling along vertical joints and on both walls. Slight cracking in wall on inside side. 10% top surface repaired.	Slight moderate spalling along vertical joints and on both walls. Slight cracking in wall on inside side. 10% top surface repaired.

JOINTS	See above. Vertical joints tight.	See above. Vertical joints tight.	See above. Vertical joints tight.	See above. Vertical joints tight.	See above. Vertical joints tight.	See above. Vertical joints tight.	Vertical joints of wall on inside side. Some spalling at joint.	
OTHER	Top surface at upper portion drummy. Slight moderate scaling from top edge of upper portion of exterior side wall and lower portion of inside side wall. Water seepage in cracks at lower portion of exterior side wall.	Local areas drummy on top surface. Water seepage in cracks at lower portion of wall at upper side.	Local areas drummy on top surface.	Top surface weathered and some scaling areas. Minor scaling in top surface. Slight moderate scaling in upper portion of wall on inside side. 25% top surface repaired.	Top surface weathered and some scaling areas. Minor scaling in top surface. Slight moderate scaling in upper portion of wall on inside side. 25% top surface repaired.	Top surface weathered and some scaling areas. Minor scaling in top surface. Slight moderate scaling in upper portion of wall on inside side. 25% top surface repaired.	Top surface weathered and some scaling areas. Minor scaling in top surface. Slight moderate scaling in upper portion of wall on inside side. 25% top surface repaired.	Top surface weathered and some scaling areas. Minor scaling in top surface. Slight moderate scaling in upper portion of wall on inside side. 25% top surface repaired.

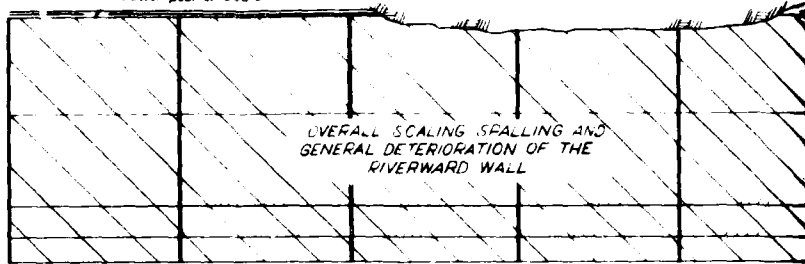
OVERALL SCALING, SPALLING AND GENERAL DETERIORATION OF THE RIVERWARD WALL

Severe scaling

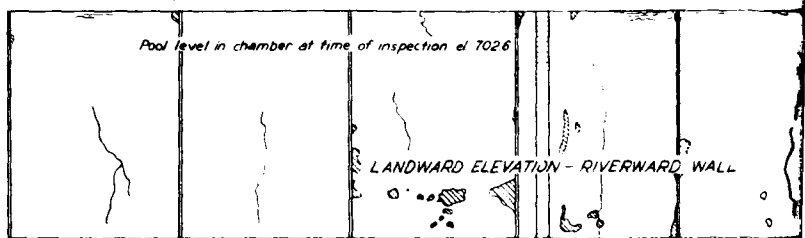
LANDWARD ELEVATION - RIVERWARD WALL

CONCRETE CONDITION	9	10	11	12	13
CRACKING	Mild longitudinal cracking at top of riverward wall. Vertical cracks in face of riverward wall.	Vertical cracks in face of riverward wall.	Mild longitudinal cracking in surface. In vertical cracks in face of riverward wall.	Vertical cracks in face of riverward wall.	Vertical cracks in face of riverward wall.
SCALING AND SPALLING	Moderate scaling of the surface to severe on face of riverward wall. Very slight spalling along vertical joints riverward wall.	Moderate to severe scaling of the surface and severe spalling along vertical joints riverward wall.	Moderate scaling of the surface and severe spalling along vertical joints riverward wall.	Severe scaling of the surface and severe spalling along vertical joints riverward wall.	Moderate to severe scaling of the surface and severe spalling along vertical joints riverward wall.
JOINTS	Vertical joints tight.	Vertical joints tight.	Vertical joints tight.	Vertical joints tight.	Vertical joints tight.

OTHER	Mild staining along face of wall. 20% of surface area.	20% of surface area.	25% of surface area.	25% of surface area.	25% of surface area.

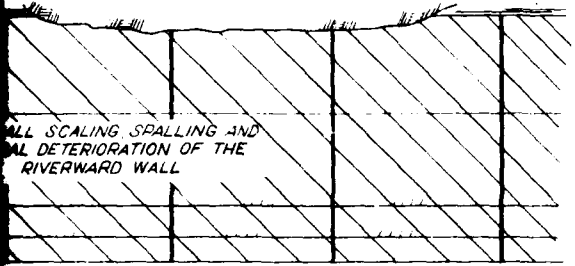
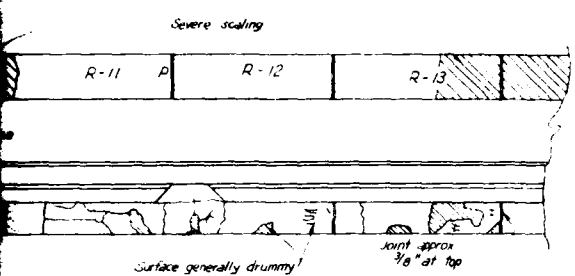
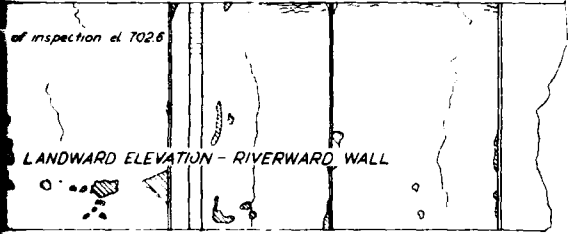
PLAN OF RIVERWARD WALL

11	12	13
Minimum scaling on top surface of concrete cracks in riverward wall.	Minimum scaling on top surface of concrete in the riverward wall. Vertical crack in riverward wall.	Minimum longitudinal cracking at top of riverward wall. Severe vertical cracks on the riverward wall.
Minimum scaling on face of concrete in riverward wall. Face of concrete.	Minimum scaling on face of concrete in riverward wall. Face of concrete.	Minimum scaling on face of concrete in riverward wall. Face of concrete.
Vertical joint height.	Vertical joint height.	Vertical joint height between R-11 and R-12. Joint approx 3/8" at top. Also see scaling above.
30% of concrete face of concrete in riverward wall.	Minimum scaling on face of concrete in riverward wall.	Minimum scaling on face of concrete in riverward wall.

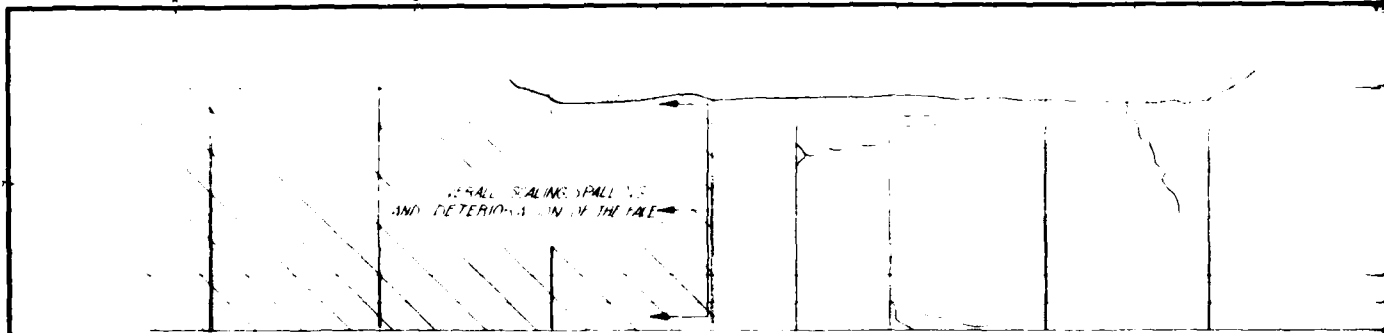
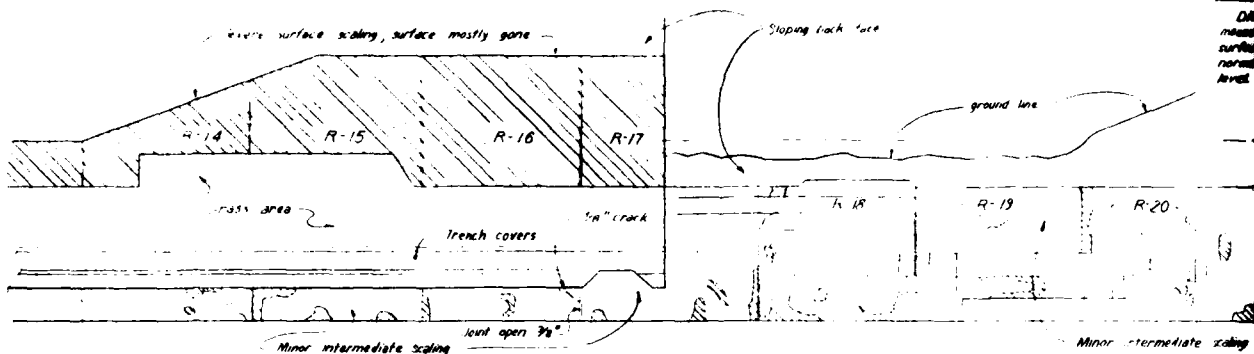
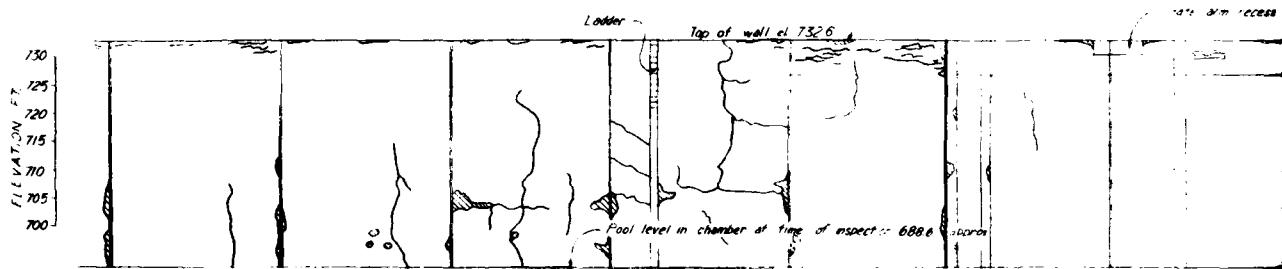
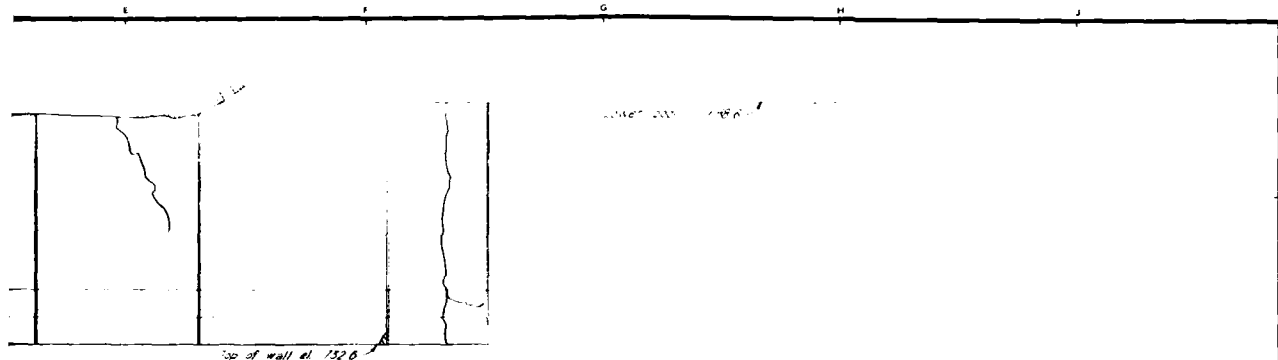
RIVERSIDE ELEVATION (INVERTED)

MONOLITH NO							
CONCRETE CONDITION		14	15	16	17	18	19	20	
CRACKING	Vertical	Minor to moderate longitudinal cracking at top of riverlock wall. Vertical crack in riverlock wall.	Minor longitudinal cracking at top of riverlock wall. Vertical crack in riverlock wall.	Minor longitudinal cracking at top of riverlock wall. Several vertical cracks in riverlock wall.	Vertical and horizontal cracking in riverlock wall. Minor longitudinal cracks.	Severe longitudinal cracking at top of riverlock wall. Vertical crack in riverlock wall.	Some vertical cracks.	Minor longitudinal cracking at top of riverlock wall.	
	Horizontal	Minor random cracking in local areas of top surface.	Severe scaling on river wall face and top of river wall. Moderate weathering and scaling on top of riverlock wall.	Several scaling on river wall face and top of river wall. Minor surface scaling on top and face of riverlock wall.	Severe scaling on top of river wall. River wall face weathered. Minor scaling and weathering on top, and moderate scaling & spalling on face of riverlock wall.	Moderate scaling of top surface. Minor spalling and scaling on riverlock wall.	Minor weathering on top surface. Some spalling along edges of riverlock wall.	Minor spalling along vertical edges. Moderate scaling on top surface.

SCALING AND SPALLING	Vertical	Vertical joints between mono #13 and mono #14. Open 3/8" at top.	Minor spalling along vertical joints in riverlock wall. Vertical joints tight.	Vertical joint between mono #16 and mono #17. Open 3/8" at top.	Vertical joint between mono #18 and mono #17. Open 3/8" at top.	Vertical joints tight.	Vertical joints tight. Leaching from horizontal construction joints on riverwall.	Vertical joints tight. Leaching from horizontal construction joints on riverwall.	
	Horizontal	Moderate leaching from longitudinal cracks at top of riverlock wall.	Slight leaching from top of riverlock wall.	Minor leaching from longitudinal cracks at top of riverlock wall.	Minor to moderate leaching for longitudinal cracks and from vertical cracks in riverlock wall.	Severe leaching from longitudinal cracking in moderate along vertical crack.	Minor leaching from vertical cracks.	Minor leaching from longitudinal cracks.

JOINTS		Vertical joints between mono #13 and mono #14. Open 3/8" at top.	Minor spalling along vertical joints in riverlock wall. Vertical joints tight.	Vertical joint between mono #16 and mono #17. Open 3/8" at top.	Vertical joint between mono #18 and mono #17. Open 3/8" at top.	Vertical joints tight.	Vertical joints tight. Leaching from horizontal construction joints on riverwall.	Vertical joints tight. Leaching from horizontal construction joints on riverwall.	
OTHER		Moderate leaching from longitudinal cracks at top of riverlock wall.	Slight leaching from top of riverlock wall.	Minor leaching from longitudinal cracks at top of riverlock wall.	Minor to moderate leaching for longitudinal cracks and from vertical cracks in riverlock wall.	Severe leaching from longitudinal cracking in moderate along vertical crack.	Minor leaching from vertical cracks.	Minor leaching from longitudinal cracks.

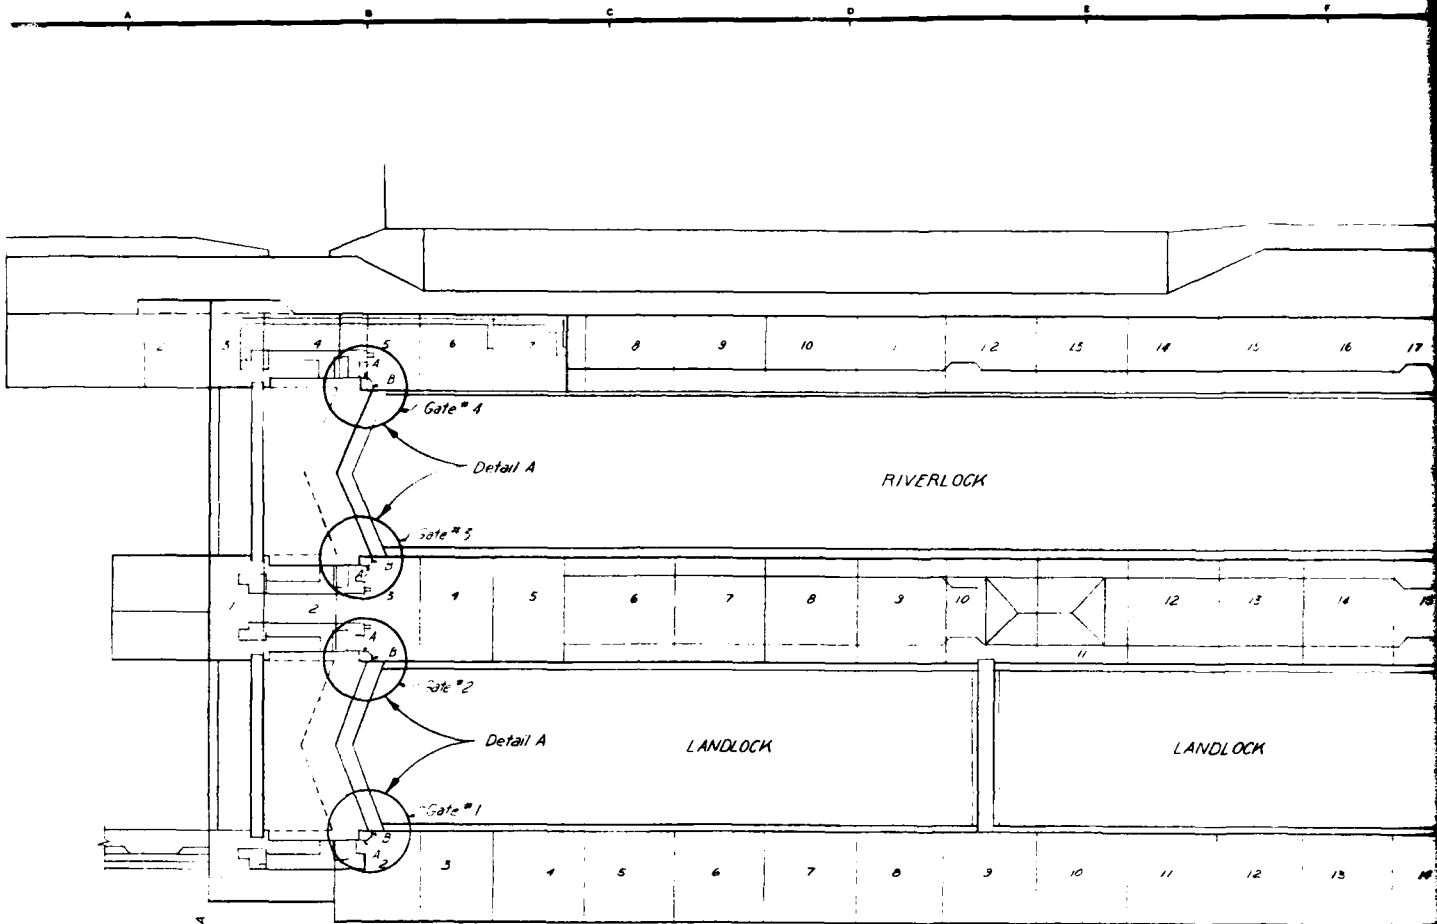
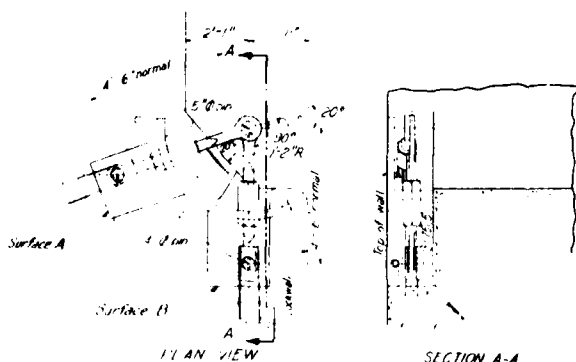
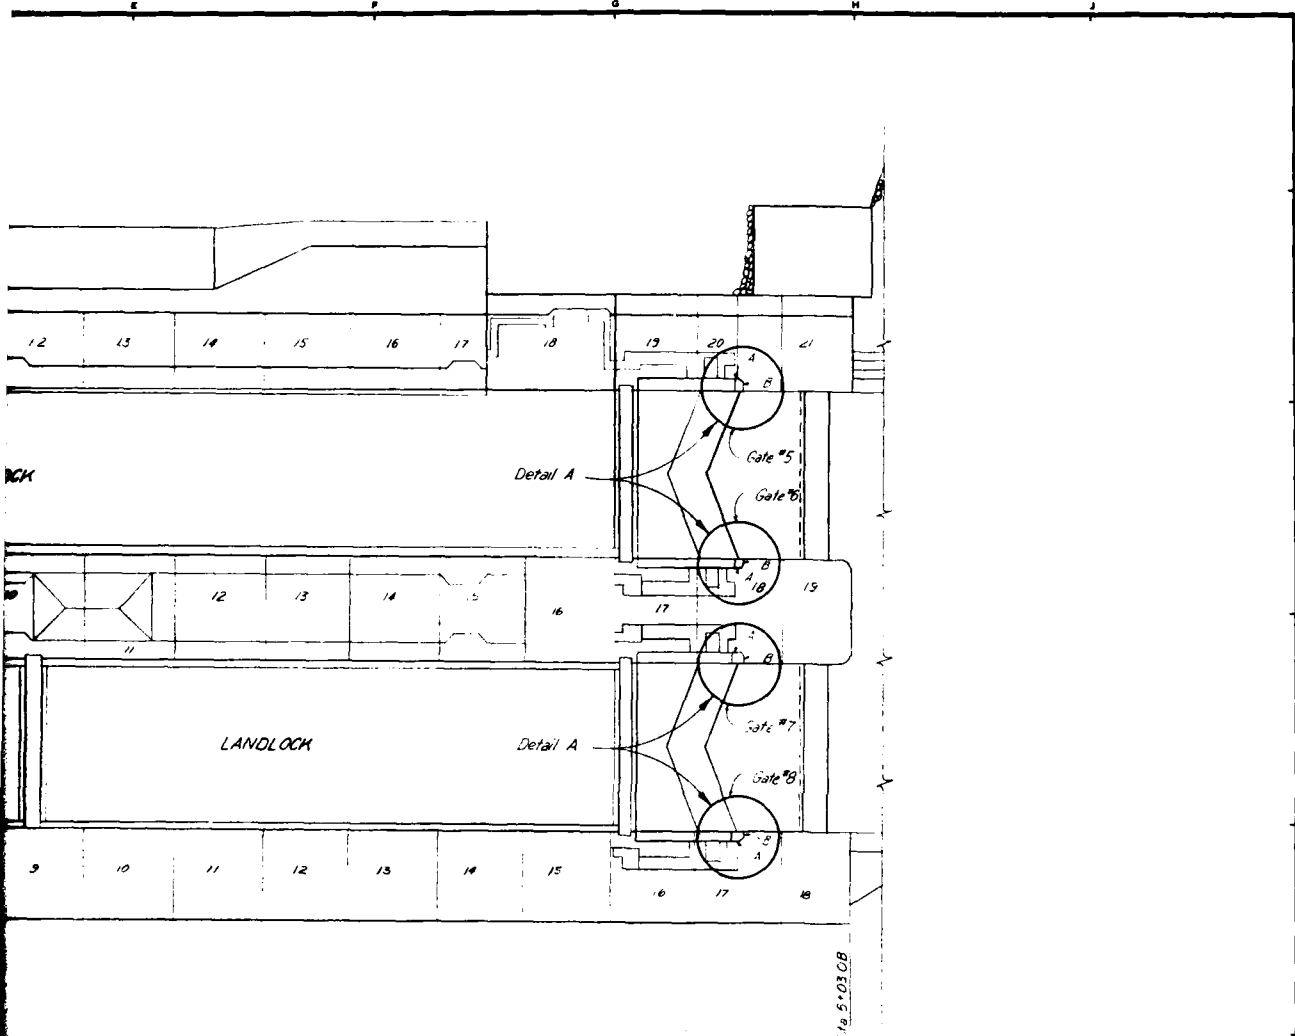
CHART SHOWING COMPRESSIVE STRENGTHS FOR GATE ANCHORS

- 1) The values of compressive strengths were obtained by Swiss Impact Hammer with an average value from 10 readings
- 2) Surface scaling around anchor
- 3) D-cracking and leaching

SURFACE A'	SURFACE B'
4200 psi	3350 psi
3500 psi	6250 psi
4000 psi	4000 psi
3400 psi	4950 psi
3500 psi	2950 psi
4000 psi	3300 psi
5800 psi	6500 psi
6000 psi	5500 psi

Values of compressive strengths
found by Swiss Impact Hammer
average value from 11 readings.
Including mixed anchor
dry and leaching

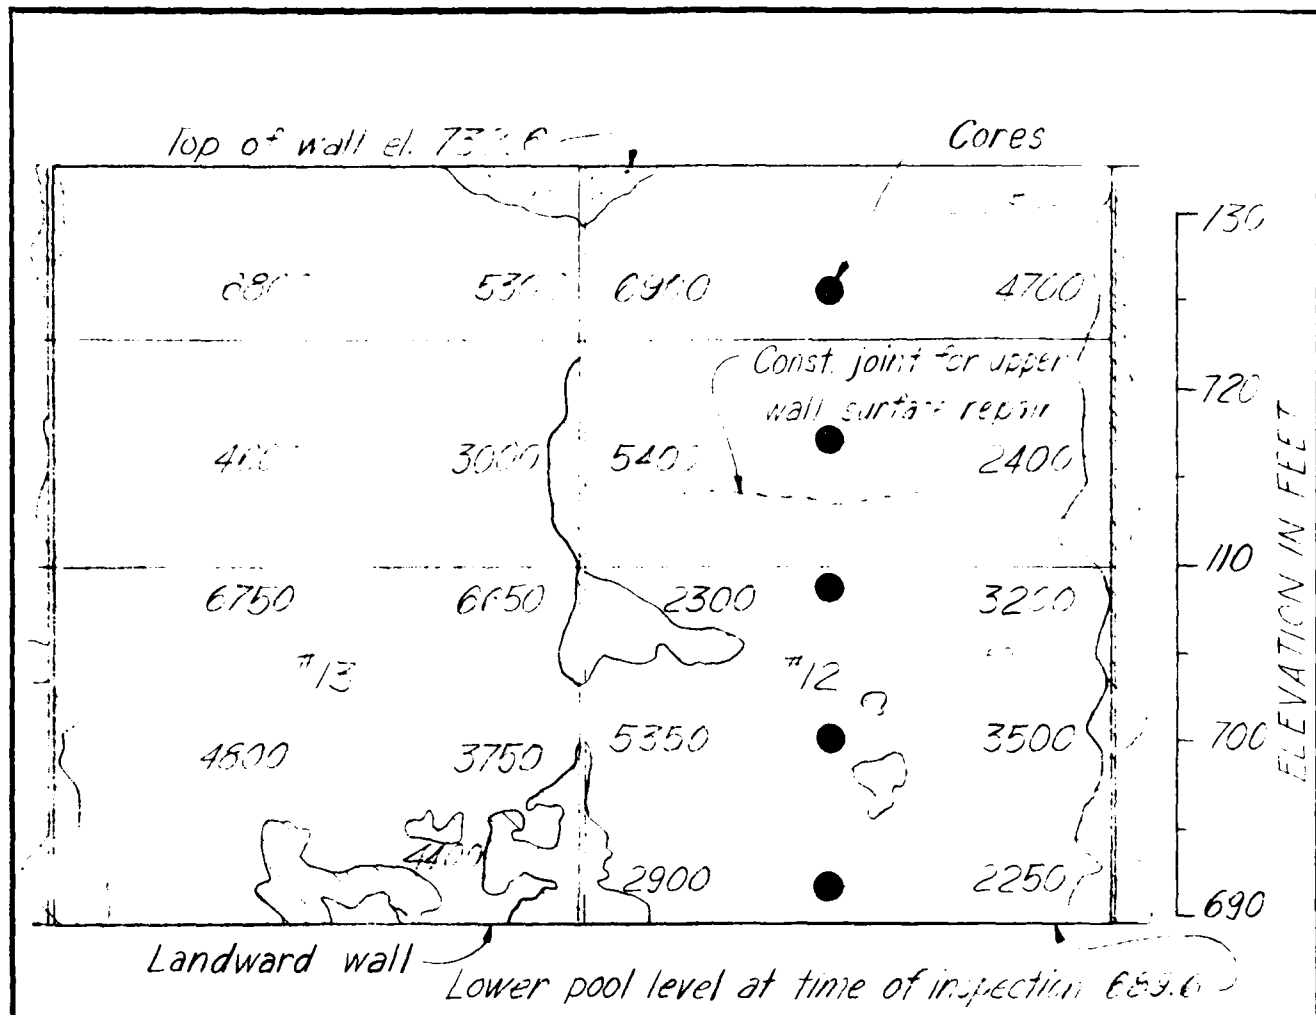
CONCRETE CONDITION SURVEY
SURFACE COMPRESSIVE STRENGTH

- 1.) Compressive strengths are in-place strengths at the location shown.
- 2.) All readings are in psi, taken from an average of 10 Swiss hammer readings.
- 3.) Horizontal cores are 11" deep

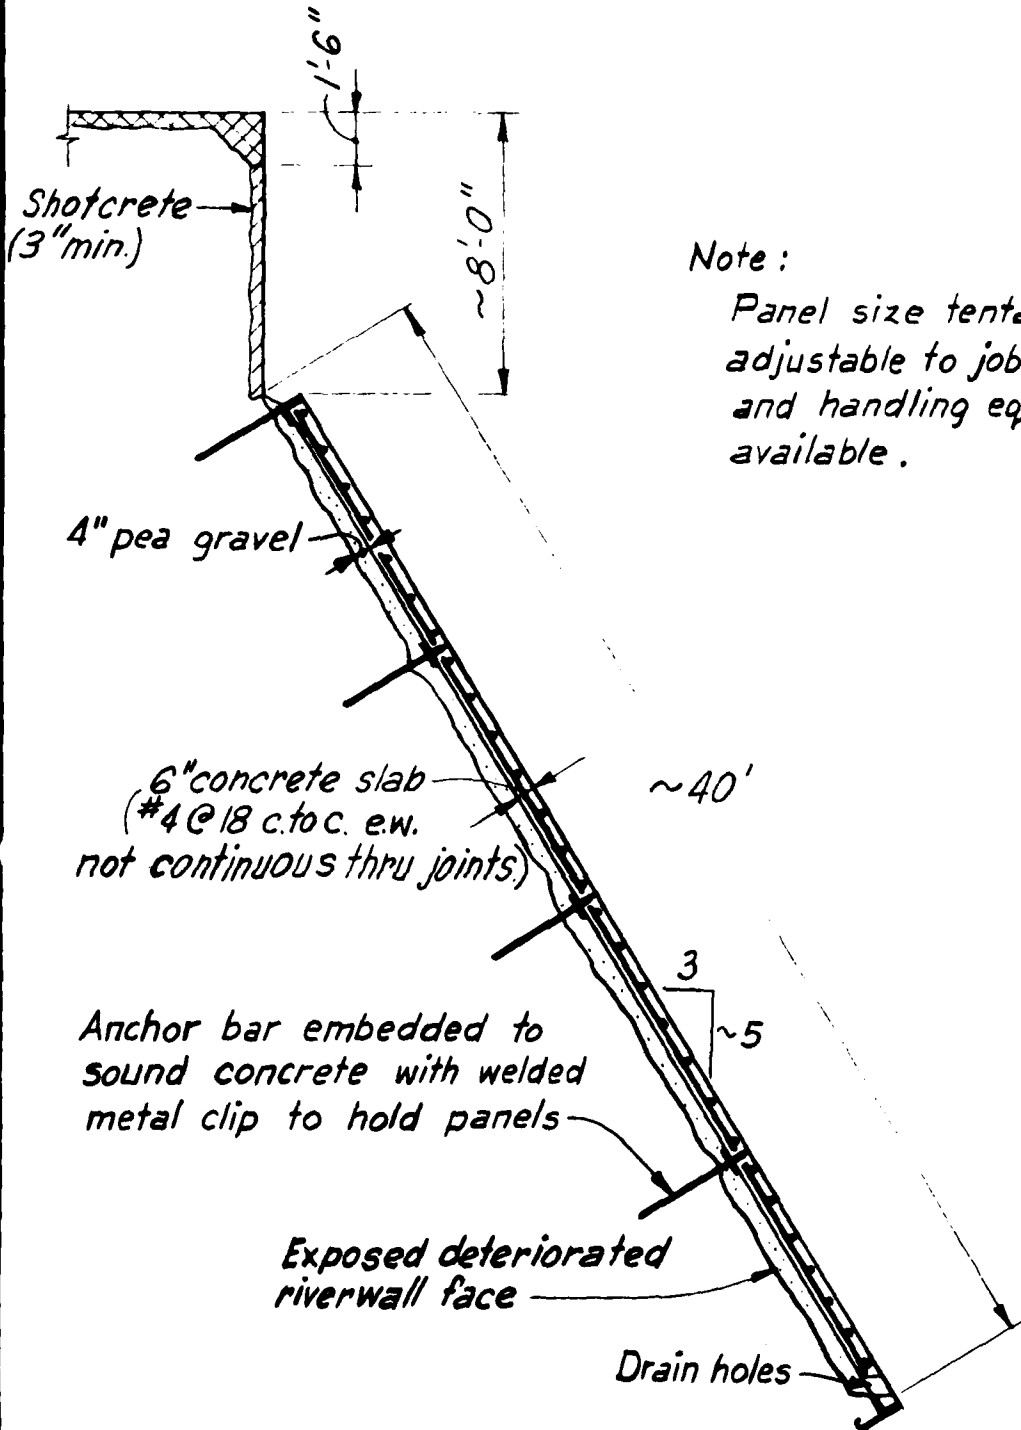
CONCRETE REPAIR
 EXPOSED RIVER WALL

Exposed deteriorated
 riverwall face

Note:
 Panel size tentative 10'x10'
 adjustable to job conditions
 and handling equipment
 available.

6" concrete slab
 (#4 @ 18 c.to.c. e.w.
 not continuous thru joints)
