Special Report 84-3

March 1984

U.S. Air Force roof condition index survey Ft. Greely, Alaska

Barry A. Coutermarsh

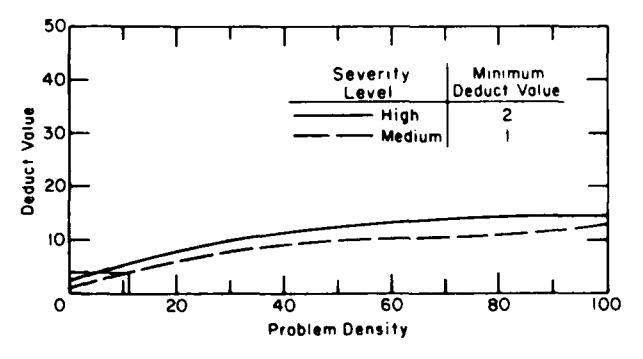
The next step is to determine a deduct value for each problem by u \therefore the appropriate graph in AFM 91-36 and the problem density number. The educt value for problem 3 in the above example is found by using the graph own in Figure 4 and the density value of 11.11 found previously. The deduct value equals 5. The problem 8 deduct value is 50.5, found by using the graph shown in Figure 5 and the previously determined density of 4.00. The severity level of the problems determines which curve on the graphs is to be used.

Figure 4. Deduct value curves for metal flashing defects, problem 3. The example in the text, with a density of 11.1, has a deduct value of 4.0 (after U.S. Air Force 1980).

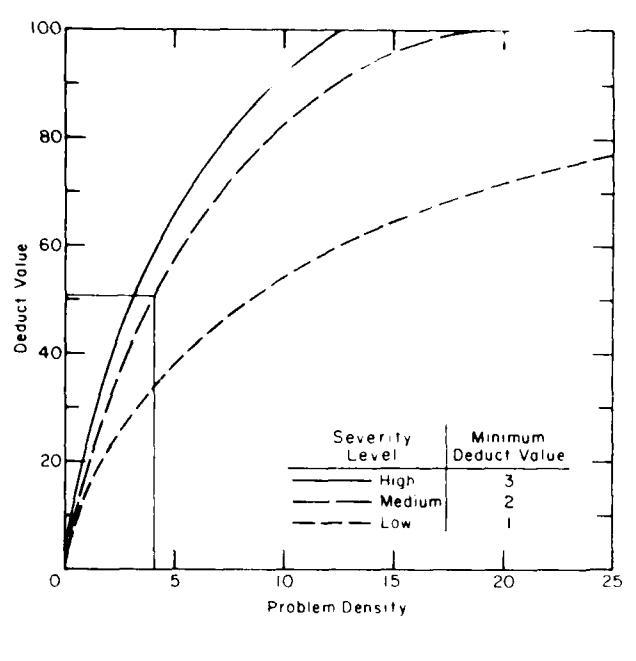
Figure 5. Deduct value curves for membrane blisters, problem 8. The example in the text, with a density of 4.0, has a deduct value of 50.5 (after U.S. Air Force 1980).

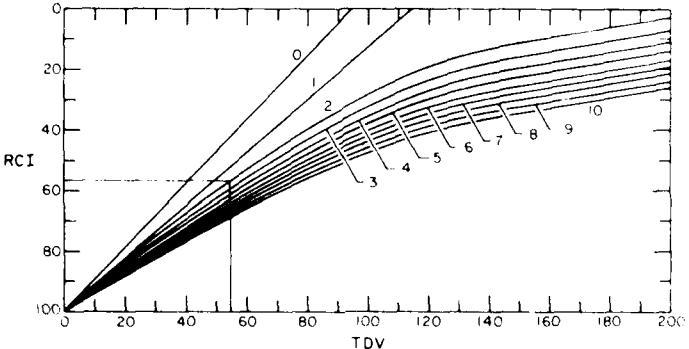
Figure 6. Roof Condition Index (RCI) curve (curve number is the q number). From the example in the text, where the Total Deduct Value (TDV) is 54.5 and q = 2, the RCI is 56.5 (after U.S. Air Force 1980).

example) are used to determine the RCI Index (Fig. 6). The RCI for the example roof is 56.5. The SF is determined from the RCI number, roof age and the bitumen type (Fig. 7). The example roof has an SF of 7 years (7.8 years x 0.85 since the bitumen is asphalt). The SF is "the anticipated useful life of the roof beyond the time of the rating, assuming no work is done except to fix leaks (U.S. Air Force 1980)."

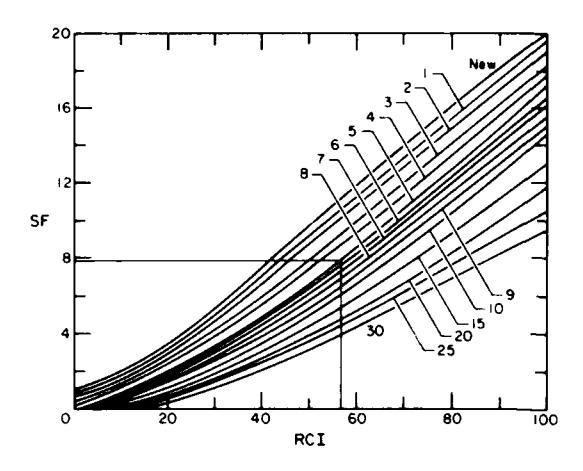
Figure 7. Serviceability Forecast (SF) curve (curve numbers are roof age in years; for asphalt roofs, multiply the serviceability forecast from the graph by 0.85). For the example roof with an RCI of 56.5 (see Fig. 6) and a roof age of 5 years, the SF value is 7.8 years. This value must be multiplied by 0.85 since the bitumen is asphalt, giving a final SF of about 7 years (after U.S. Air Force 1980).

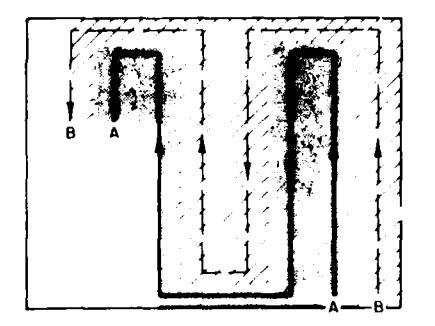
The membrane must be inspected carefully to avoid overlooking small defects and to avoid counting the same defect twice. We established a walking pattern to accomplish this. We walked side-by-side about 4 ft apart, each of us inspecting a path about 4 ft wide. By using the method shown in Figure 16, we inspected an 8-ft wide area on each traverse. And when a new traverse is begun, the person that scrutinized the last swath is adjacent to it on the new traverse. This helps to prevent counting the same defect twice.

Figure 16. Inspection pattern. After the first traverse, inspector B swings around inspector A to maintain his position to the right of A. On the second traverse, A is therefore inspecting an area of membrane adjacent to the area that he last inspected. Inspector A can remember defects counted on the first traverse and avoids counting them again.

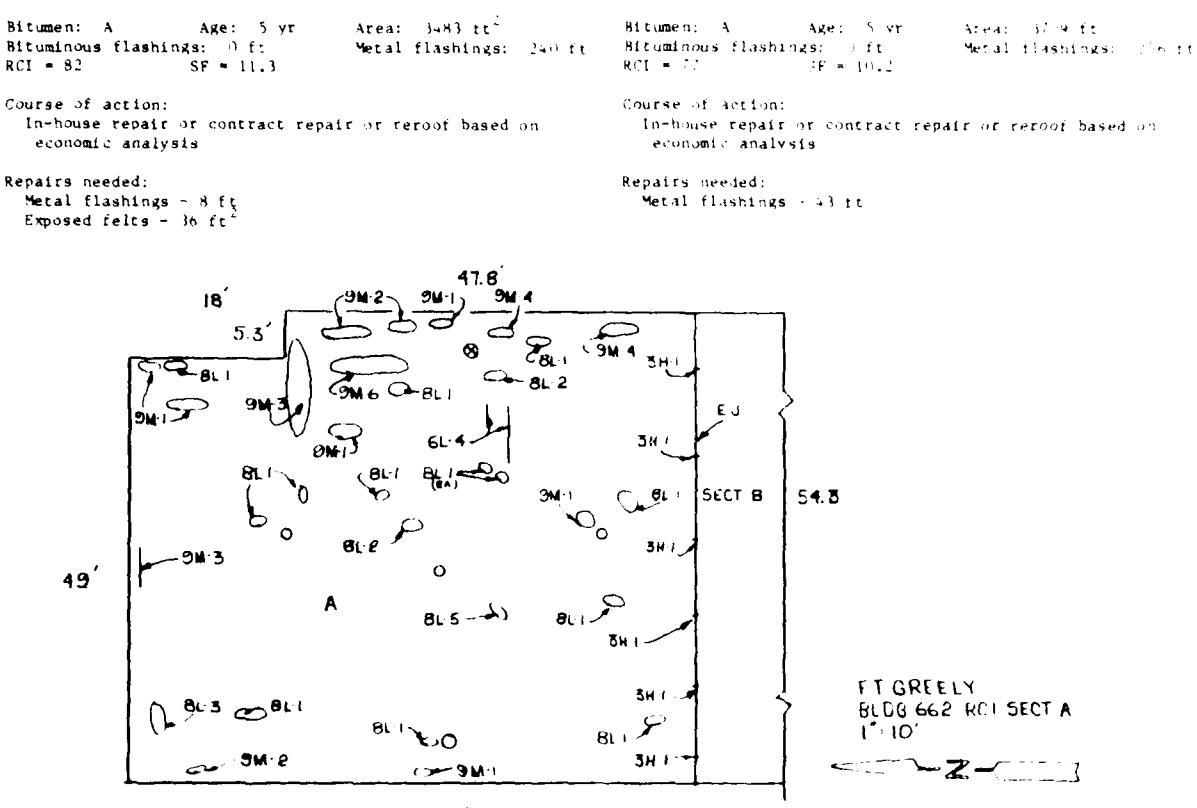
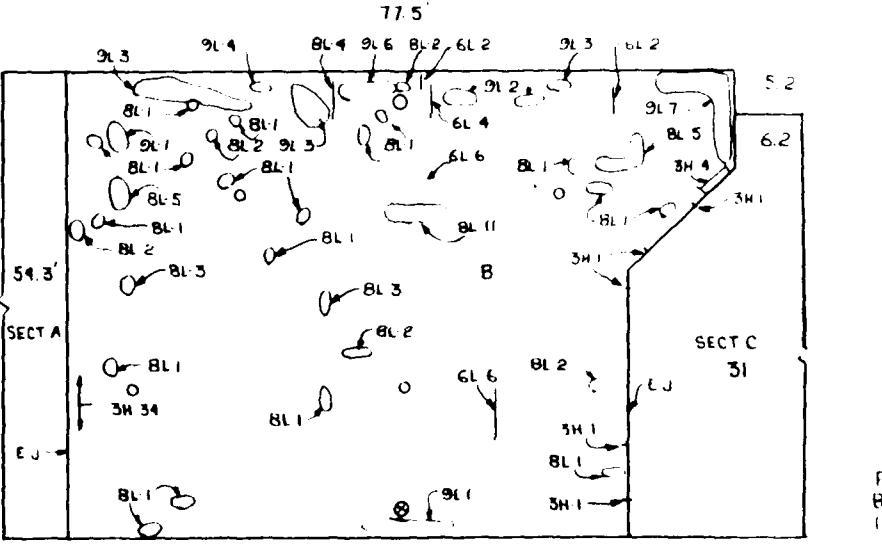
FTGREELY BLDB 662 RCI 'FCT B I'+10'
