HOWARD RESERVOIR DAM

CT 00015

PHASE I INSPECTION REPORT
NATIONAL DAM INSPECTION PROGRAM

DEPARTMENT OF THE ARMY
NEW ENGLAND DIVISION, CORPS OF ENGINEERS
WALTHAM, MASS. 02154

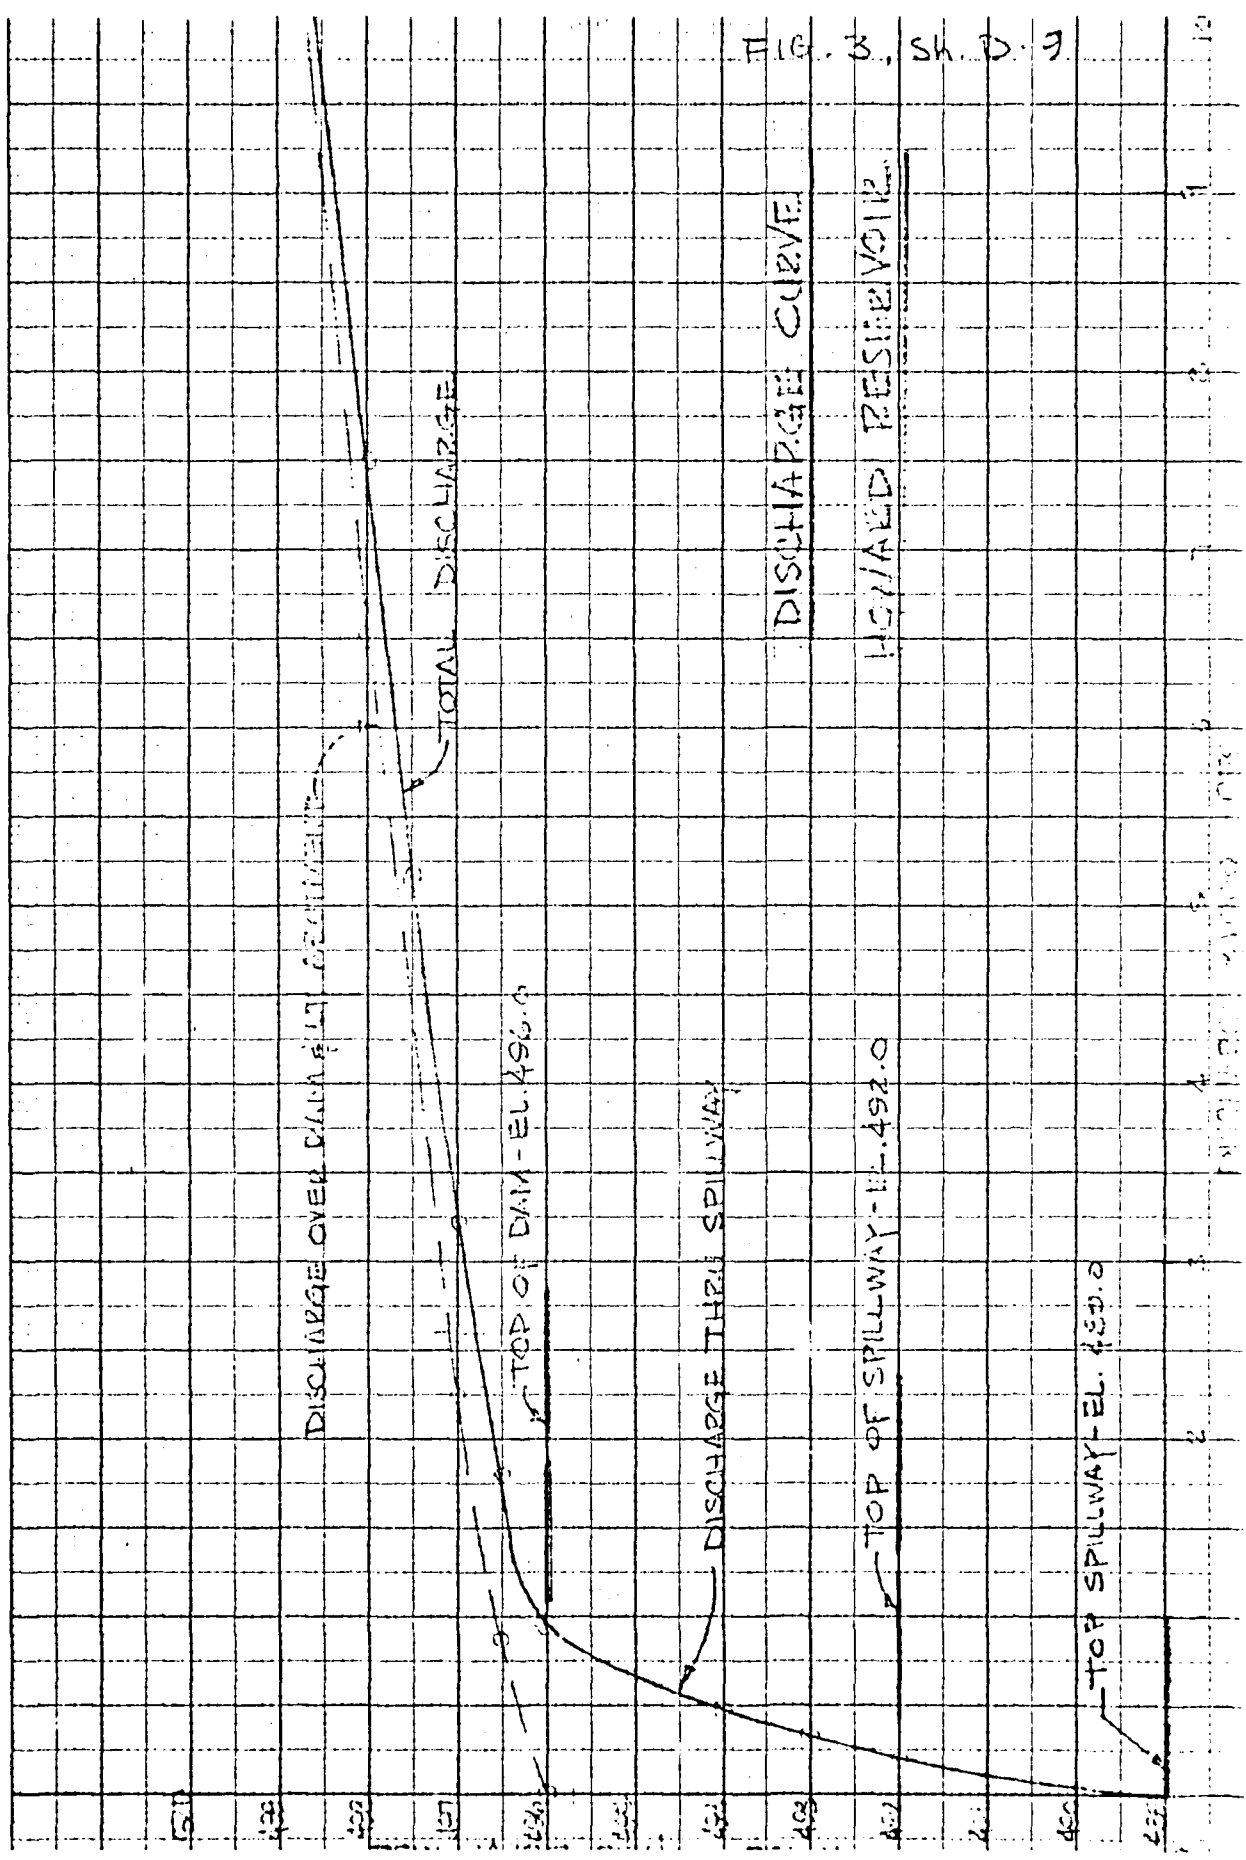
FIG. 3, SH. D. 9

Discharge tables and curves for the spillway and for over the top of the dam are shown on Sheets D-7 and D-8 and Fig. 3 Sheet D-9, Appendix D. The spillway capacity at top of dam, elevation 496.0 MSL, is 967 cfs.

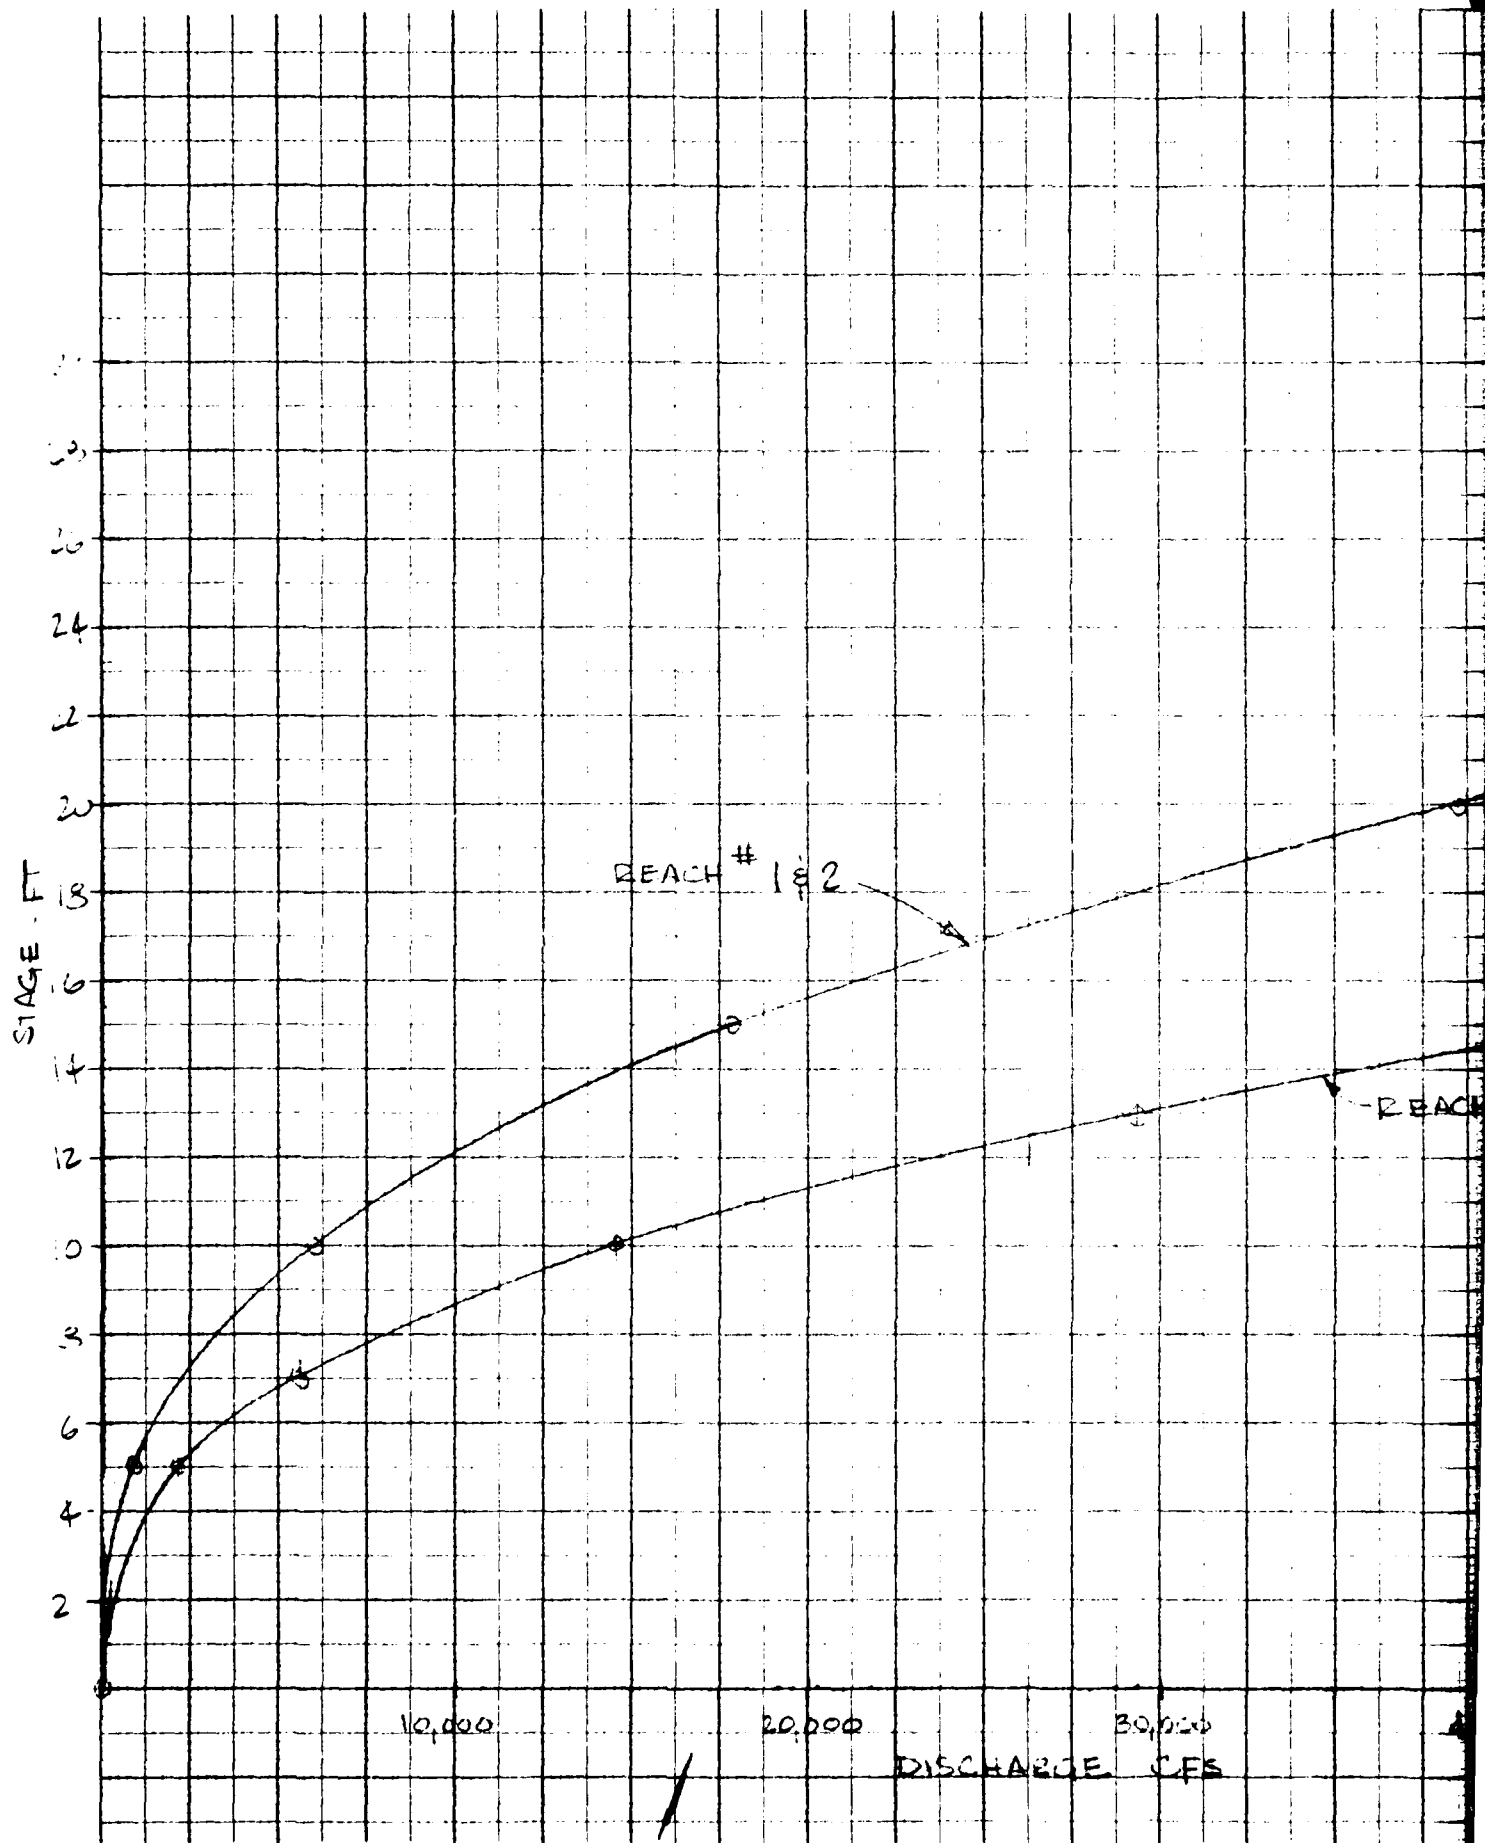
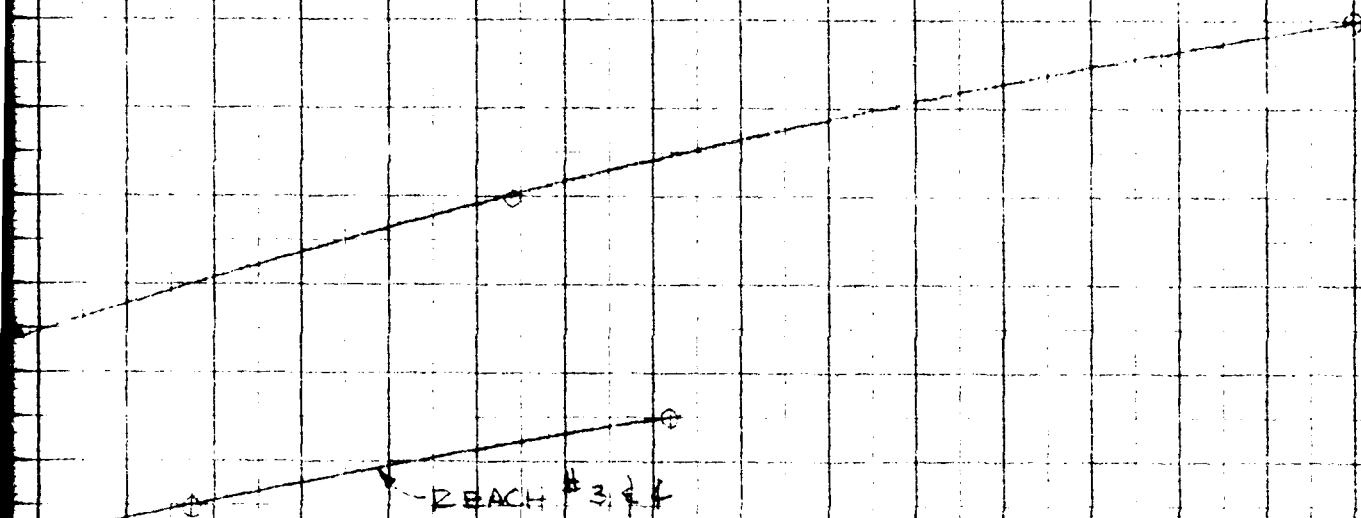
FIG. 4, Sh. D-21

HOWARD RESERVOIR
STAGE-DISCHARGE RATING
CURVE
DOWNSTREAM

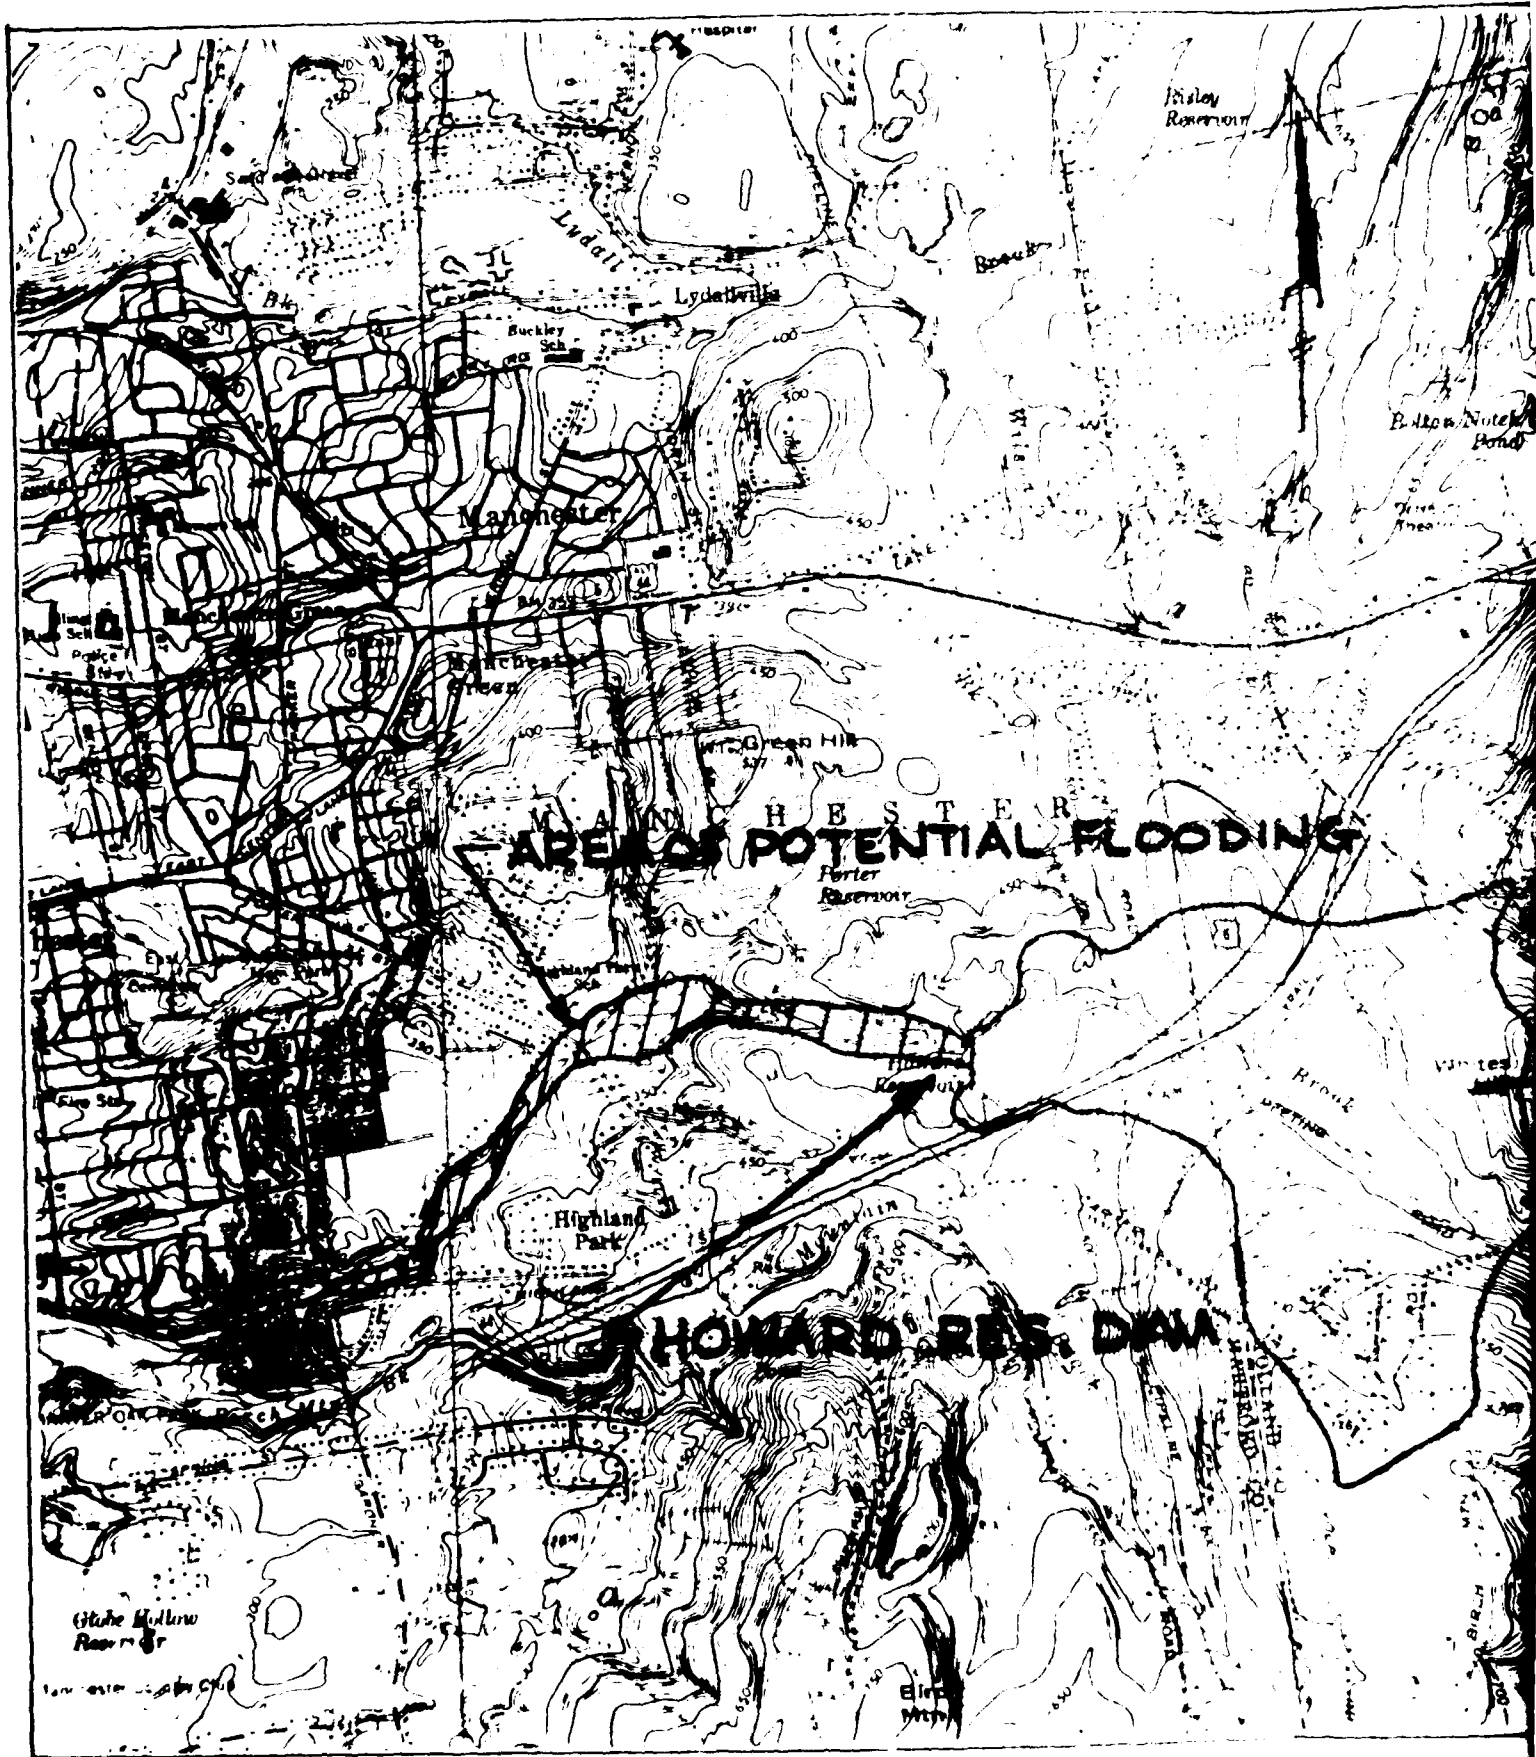
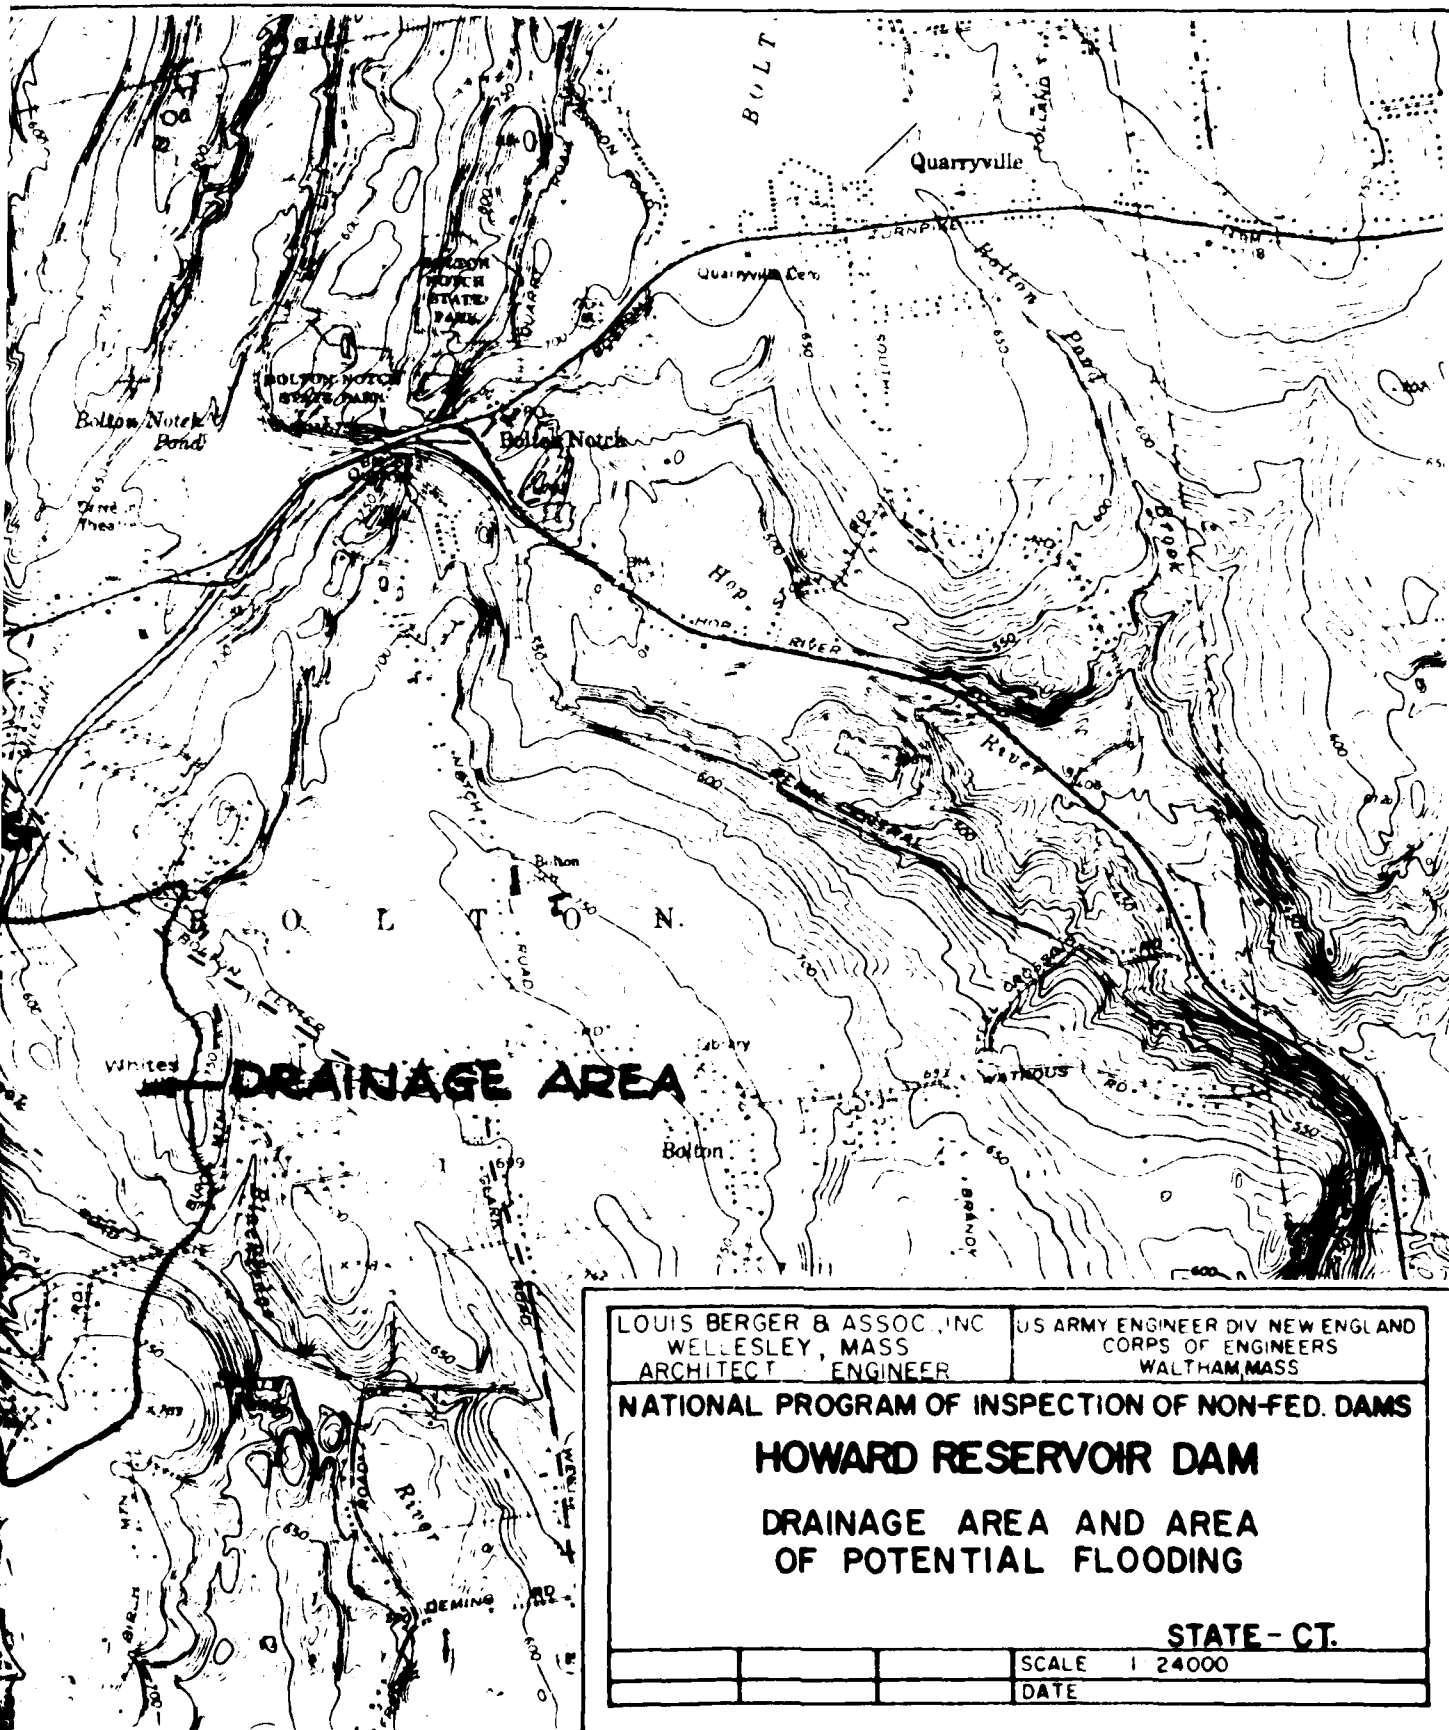
FIG 5, Sht D-22

or about 13 ft. higher than the stage caused by the full spillway discharge. There are no structures in the first two reaches below the dam. However, in the third reach are located the Highland Park School, 6 homes, and the Porter Street crossing of Porter Brook, all of which would sustain damage by flood waters resulting from a breach of the dam. The stage in the third reach is estimated to be about 12 ft. for the breach flow or about 8 ft. higher than would be realized from the full spillway discharge. In the next 2,000 ft. long reach beyond Porter Street the breach stage would be about 10 ft. or about 7 ft. above the anticipated full spillway discharge stage. In the next 3,000 ft. long reach the stage would rise from a depth of about 4 ft. to a depth of 9 ft. In the later two reaches are located 9 houses that would sustain major damage due to the rising waters. Approximately 2 miles downstream from the dam the flood depth is estimated to be below 9 ft. and appears that no further significant damage would result from high waters. Hence, a total of about 15 homes, the Highland Park School, and Porter Street crossing of Porter Brook would be damaged. Delineated on Figure 5, sheet D-22, Appendix D, are the areas which would be flooded as a result of a breach of the dam.
