PEQUONNOCK RIVER BASIN
BRIDGEPORT, CONNECTICUT

FOREST LAKE DAM
CT 00078

PHASE I INSPECTION REPORT
NATIONAL DAM INSPECTION PROGRAM

AUGUST 1978

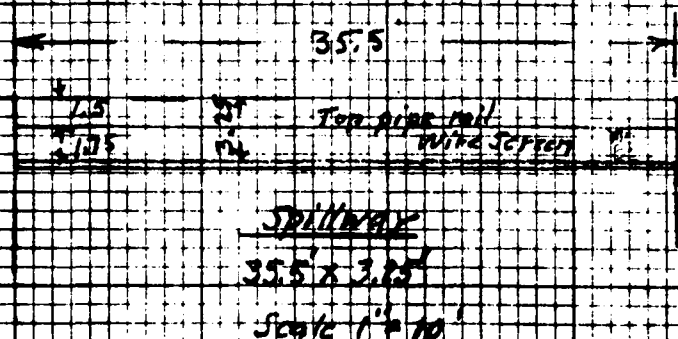
DAM #45
LAKE FOREST
Bridgeport
Watershed 925 Ac
Wind mark 1900'

NOTE: Evident spillway is inadequate; that screen should be removed, and that other measures should be taken to provide required safety.

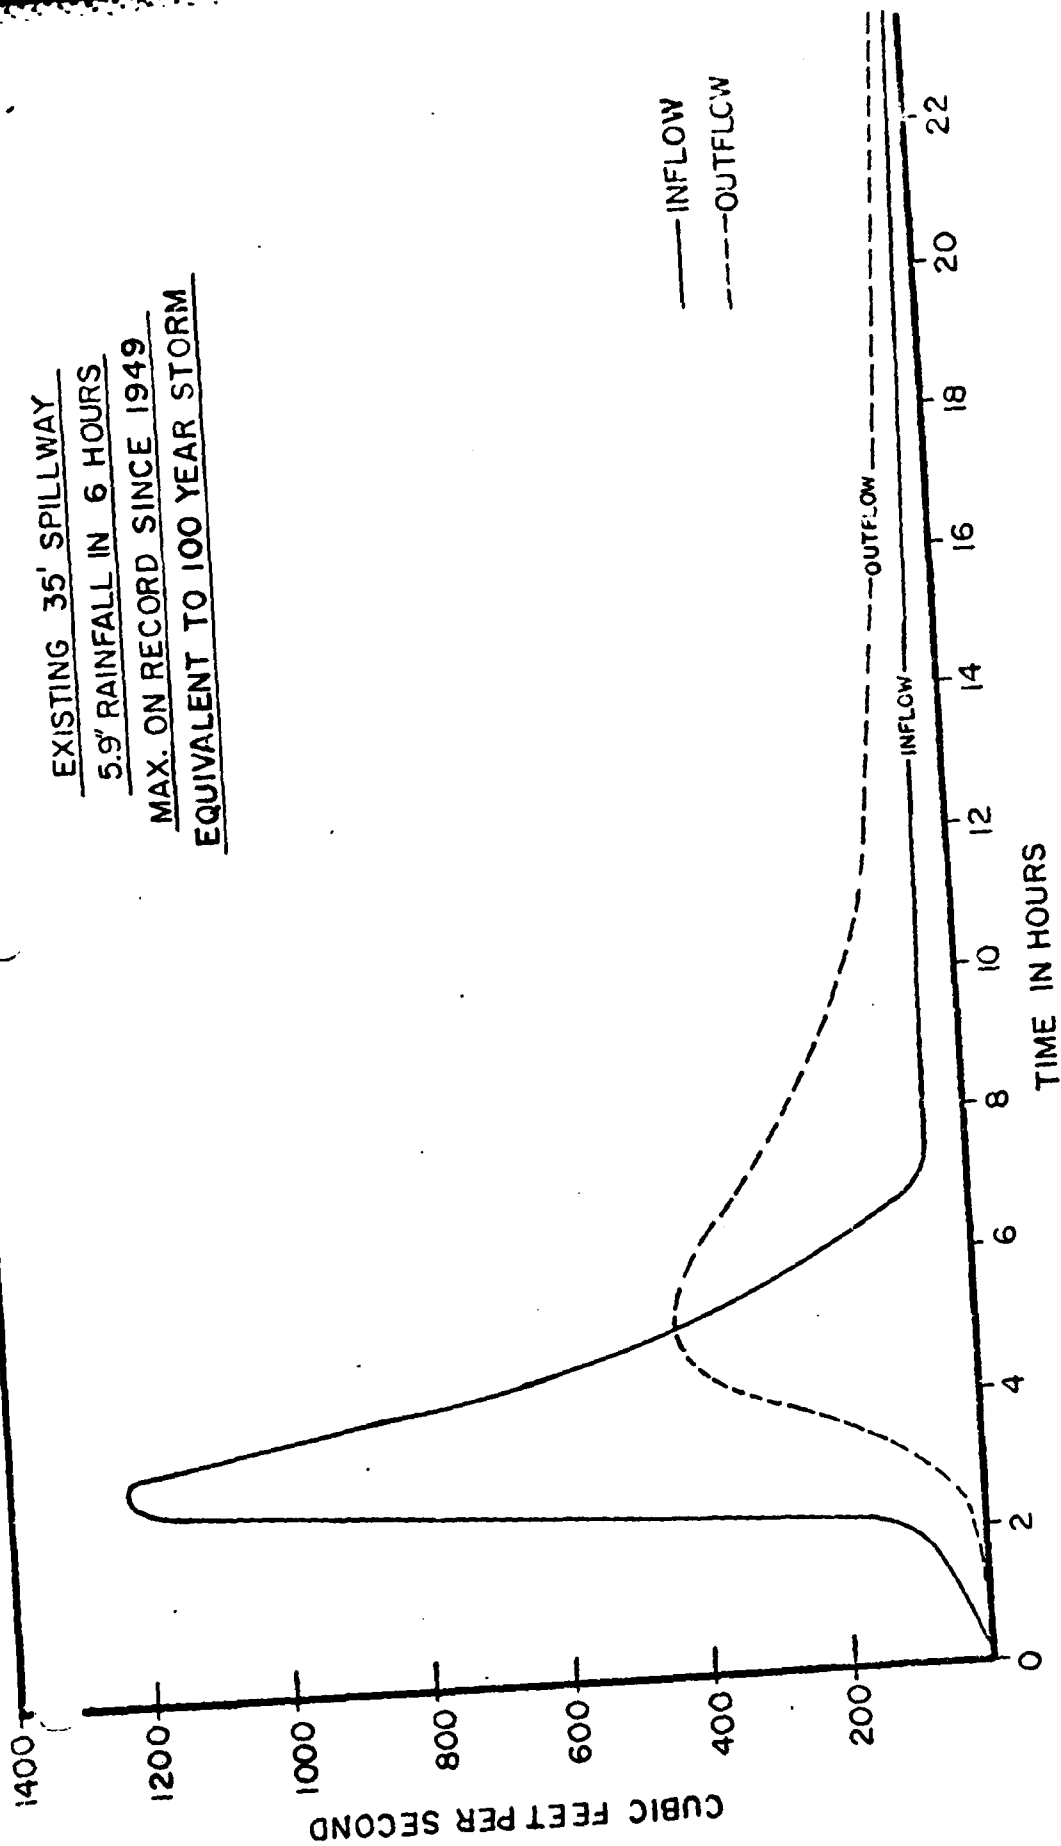
FLOOD ROUTING
LAKE FOREST

EXISTING 35' SPILLWAY
5.9' RAINFALL IN 6 HOURS
MAX. ON RECORD SINCE 1949
EQUIVALENT TO 100 YEAR STORM
