BRISTOL RESERVOIR DAM
CT. 00008

PHASE I INSPECTION REPORT
NATIONAL DAM INSPECTION PROGRAM

Identification Number:	CT 00008
Name:	Bristol Reservoir Dam
Town:	Bristol
County and State:	Hartford County, Connecticut
Stream:	Pequabuck River
Date of Inspection:	September 21, 1978

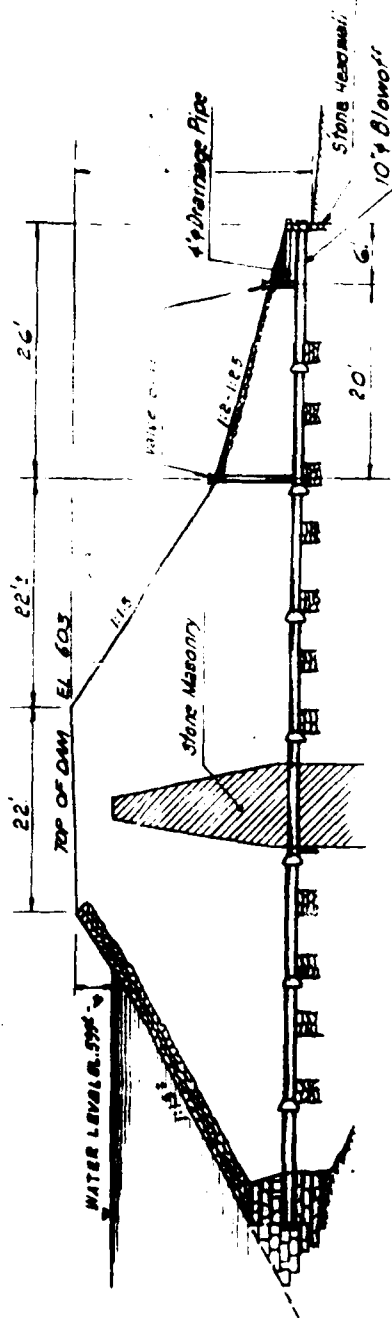
SECTION A-A

- (1) Type: Earth embankment
- (2) Length: 250 feet ±
- (3) Height: 25 feet ±
- (4) Top Width: 22 feet ±
- (5) Side Slopes: 1:1.5
- (6) Zoning: see section (Plate 2)
- (7) Impervious Core: Stone masonry
- (8) Cutoff: unknown
- (9) Grout curtain: unknown
- (10) Other: N/A

b. Dam - According to the data sheet supplied from the Bristol Water Department, the body of the dam is composed of earth fill with a stone masonry core. The crest of the dam has no visible bulges or cracks (Appendix B, Plates 1 and 2). Several rodent holes were found on the dam face and soft ground was noted on the downstream slope of the dam (Appendix C, Photo 2). Inspection of the toe showed some seepage, which included several marshy areas that are noted in Appendix B on Plate 1. The seepage water was clear and did not appear to be carrying any sediment. There is an extensive seepage source at the downstream zone of the
