NATIONAL DAM INSPECTION PROGRAM UNION POND DAM (CT
00013) UPPER CONNECTIC... (U) CORPS OF ENGINEERS WALTHAM
MA NEW ENGLAND DIV FEB 79

4. TITLE (and Subtitle) Union Pond Dam, Upper Connecticut River Basin Phase I Inspection Report NATIONAL PROGRAM FOR INSPECTION OF NON-FEDERAL DAMS		5. TYPE OF REPORT & PERIOD COVERED INSPECTION REPORT

UNION POND DAM

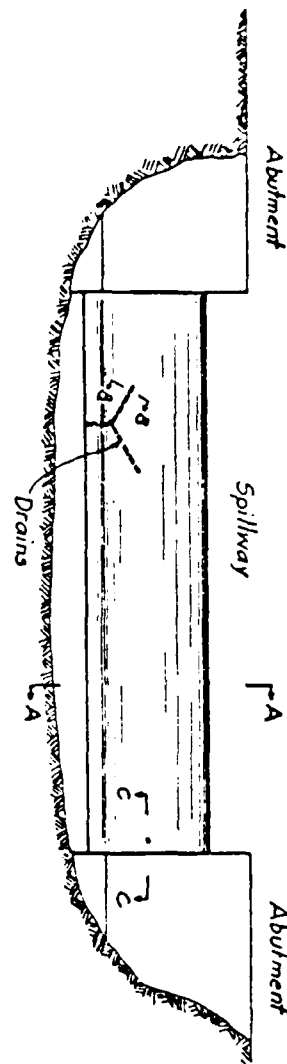
SECTION B-B

Leaking crack
1/2 Gunite-Minimum
One half clay tile

Leaks on face of Dam which cannot be grouted are drained to bottom of spillway.

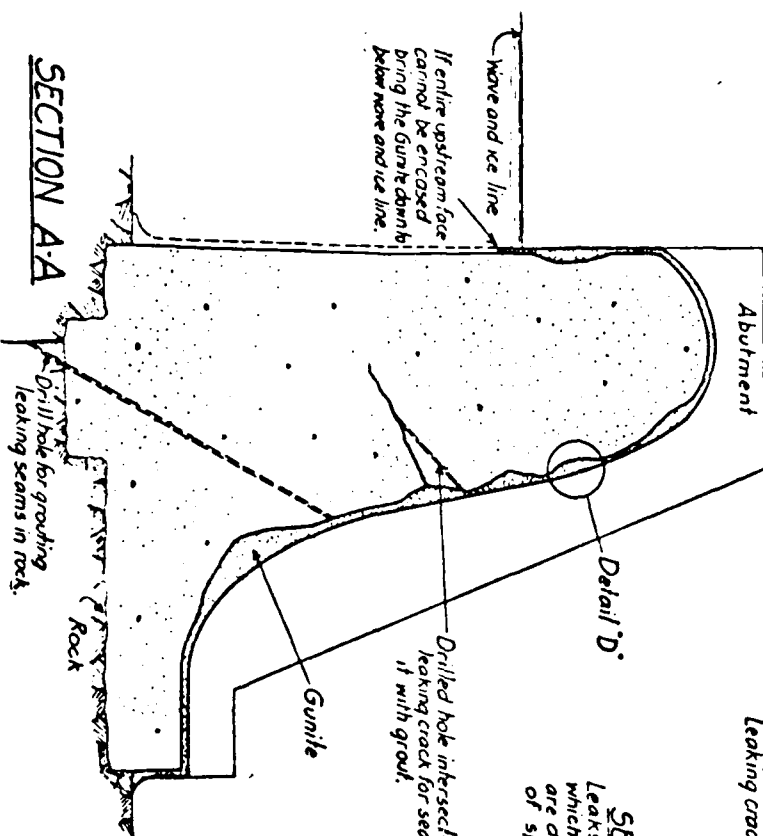
DETAIL D

Drilled hole intersects leaking crack for sealing it with grout.

Drill hole for grouting
Leaking seams in rock.
