HOUSATONIC RIVER BASIN

CHESTNUT RIDGE RESERVOIR DAM
CT 00075

PHASE I INSPECTION REPORT
NATIONAL DAM INSPECTION PROGRAM

AUGUST, 1979

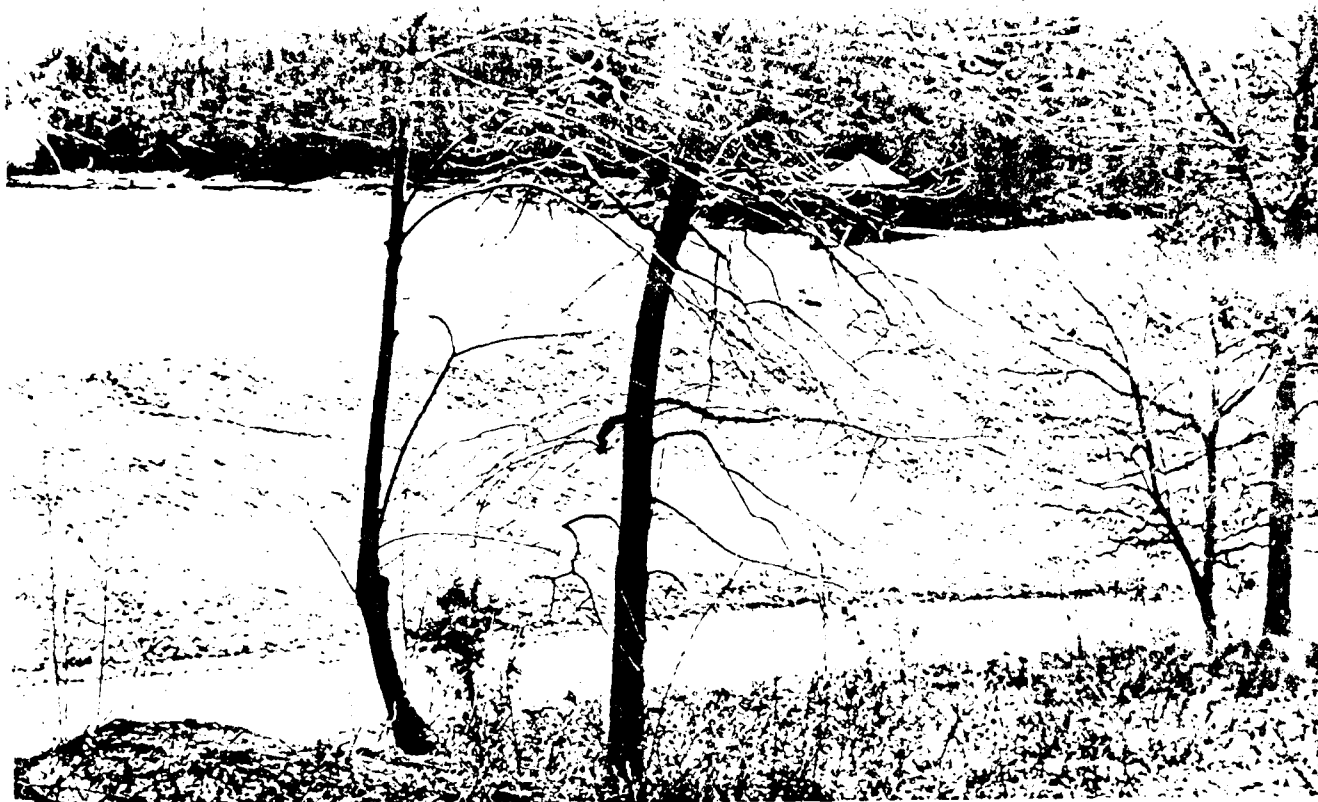
Look E west of construction slope.
 Entire slope is not covered with rock.
 Note large stone retaining wall at stream.
