HOUSATONIC RIVER BASIN
DANBURY, CONNECTICUT

MARGERIE LAKE RESERVOIR DAM
CT 00063

PHASE I INSPECTION REPORT
NATIONAL DAM INSPECTION PROGRAM

DECEMBER 1978

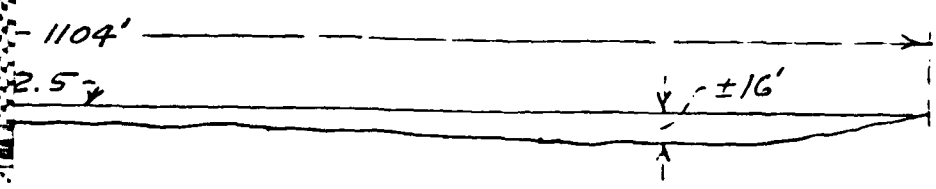
FIGURE 2

The north dike has an embankment about 1,100 ft. long with a maximum height of about 16 ft. and a crest width of about 10 ft. There are no evidences of bulges, or horizontal or vertical movement, although the horizontal alignment is irregular (Appendix B, Figure 2). The upstream slope protection consists of dumped and hand-placed riprap (Appendix C, Photo No. 3). Some riprap is missing in an area adjacent to an earth ramp near the center of the dike. The upper part of the upstream slope, crest and downstream slope are all covered with light brush growth (Appendix C, Photo No. 4). There is a drainage ditch along the downstream toe of the dike which takes runoff from the shopping center development immediately downstream from the dike, which was dry at the time of the inspection. There is a manhole on the downstream slope located about 150 ft. to 200 ft. right of the left abutment. The water level was measured at 13 ft. below the rim, or about 13 ft. below the reservoir level, indicating that the water is probably seepage and the manhole is probably connected to a toe drain. There is an outlet pipe on the north side of Highway 39 located immediately north of the dike and

CREST OF DIKE

point \pm El. 624' - Highway
 vent and drainage unknown.

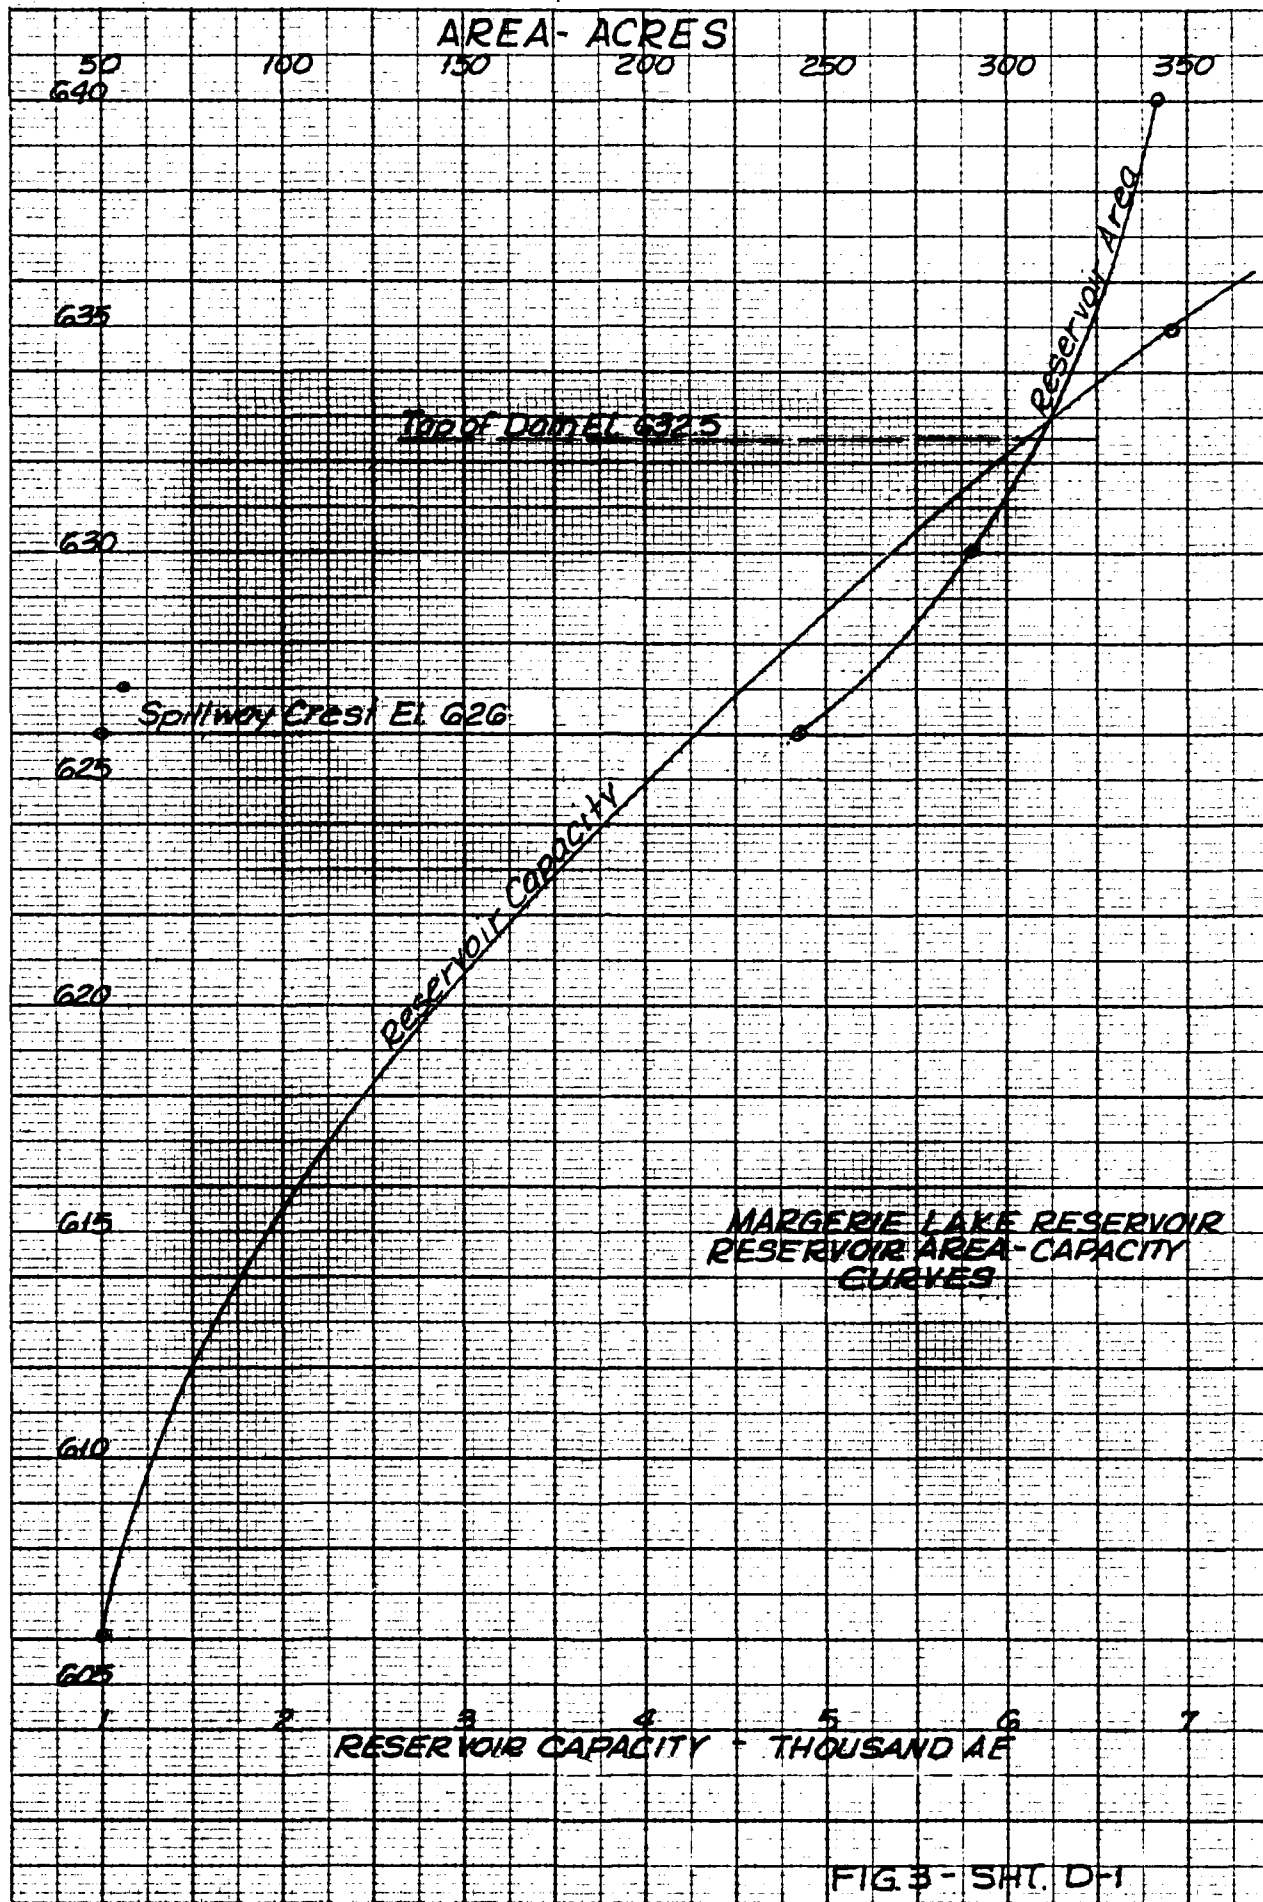
FIG. 3 - SHT. D-1

It is believed that the Margerie Lake Reservoir is an enlargement of a small lake which formerly occupied the area, such that some inactive storage below the level of the foundation of the dam is contained in the lake. The reported active capacity of the reservoir is 4,297 acre-ft. to the level of the spillway crest. Surcharge capacity above the normal storage has been computed from planimetered areas of the contours delineated on the USGS 7.5 minute series quadrangle sheets. A reservoir area-capacity curve is shown on Figure 3 in Appendix D, page D-1.

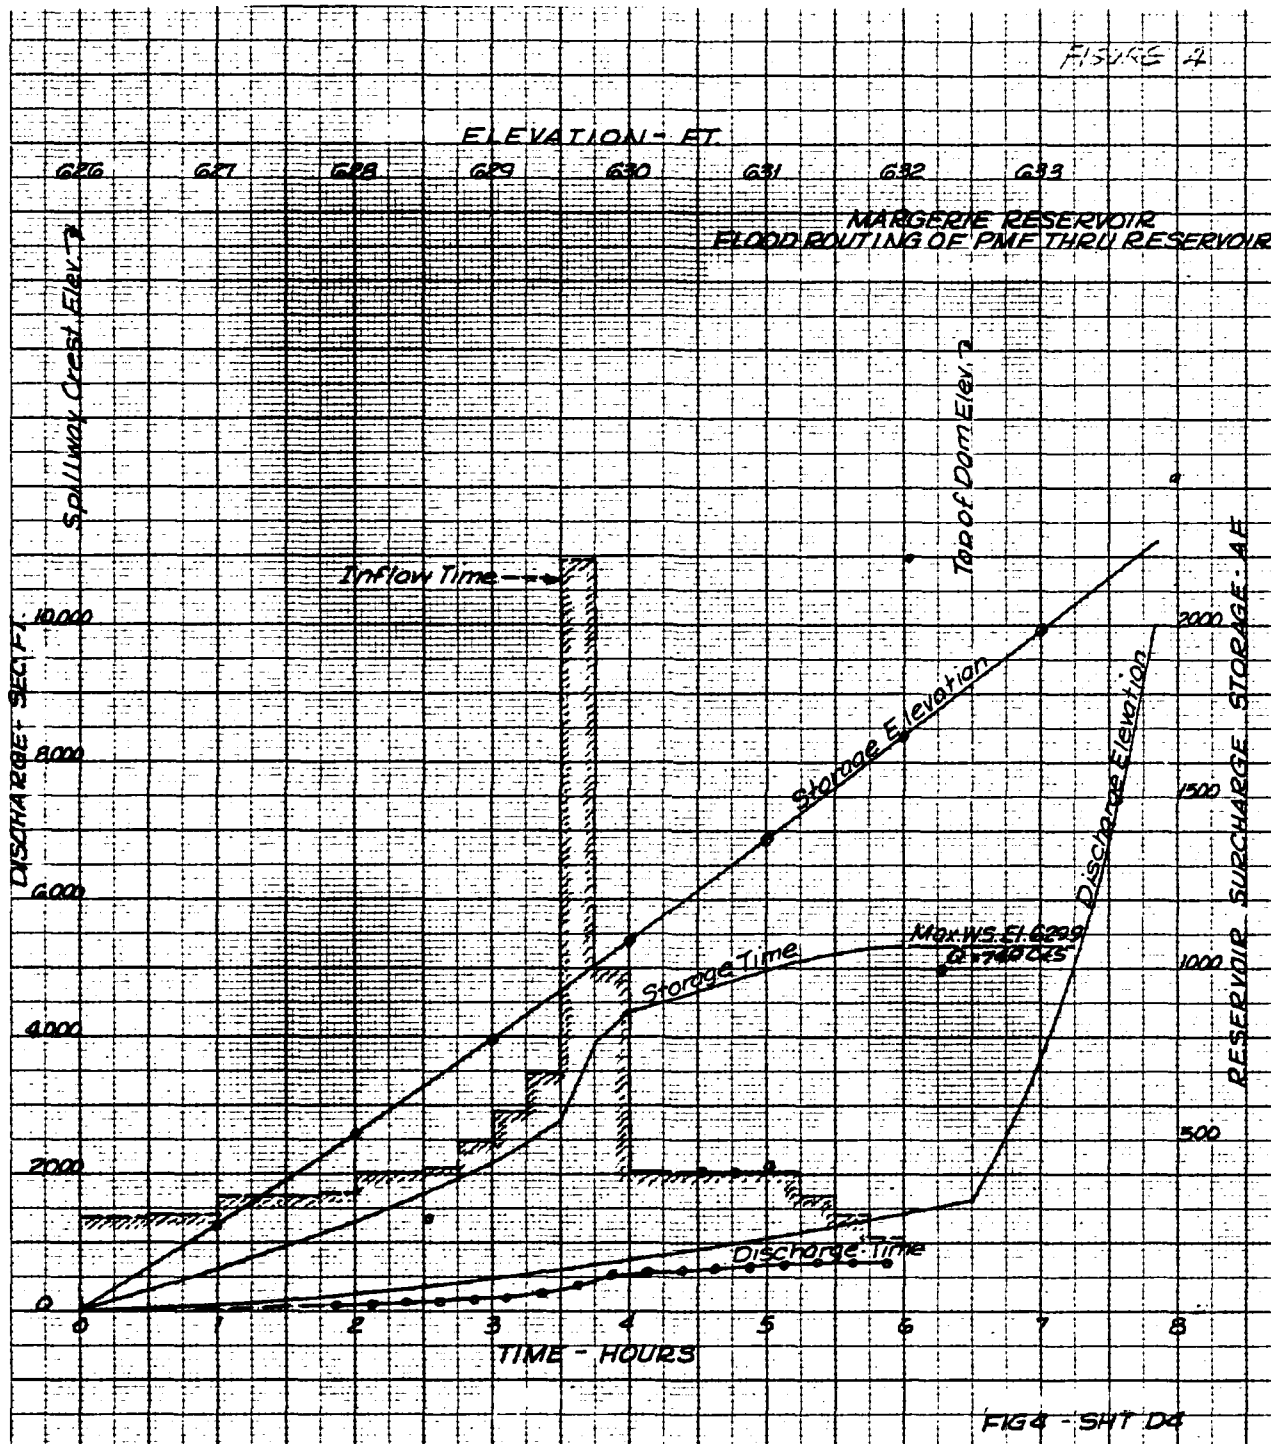
FIG 4 - SHT D4

confined basin. The inflow hydrograph shows an inflow peak of about 11,000 cfs. occurring about 3½ hours after the start of the flood event. The hydrograph is shown on Figure 4 in Appendix D, page D-4.

Routing the above PMP hydrograph inflow flood through the reservoir and spillway results in a maximum spillway outflow of about 740 cfs. at reservoir elevation 629.9 or with a remaining freeboard of 2.6 ft. to top of dam. It is thus apparent that overtopping the dam from a PMP flood event would not be possible (Appendix D, Figure 4, page D-4).
