WAUBEEKA LAKE DAM

CT 00065

DANBURY, CONNECTICUT

PHASE I INSPECTION REPORT

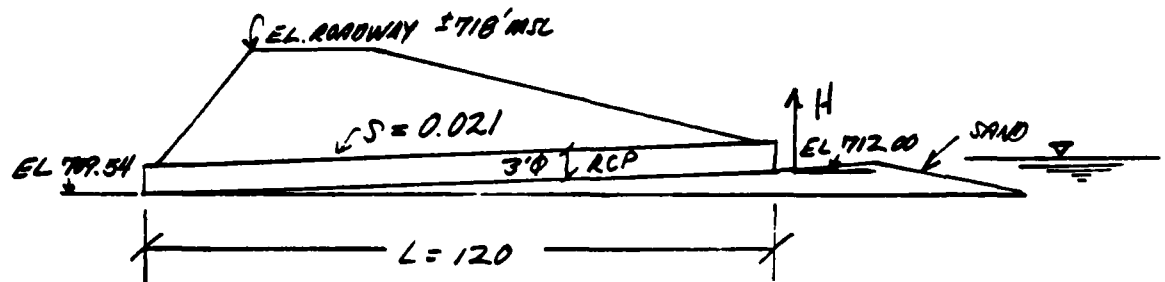
THE DAM CONSISTS OF A ROAD EMBANKMENT BUILT ALONG A  
 NATURAL SADDLE WHICH LIES BETWEEN HILLS FORMING A RIDGE  
 ALONG THE WESTERN AND SOUTH WESTERN FRINGES OF THE LAKE.  
 A SECTION THROUGH THE ROAD EMBANKMENT AND  $\frac{1}{2}$  OF  
 CULVERT IS SHOWN BELOW.

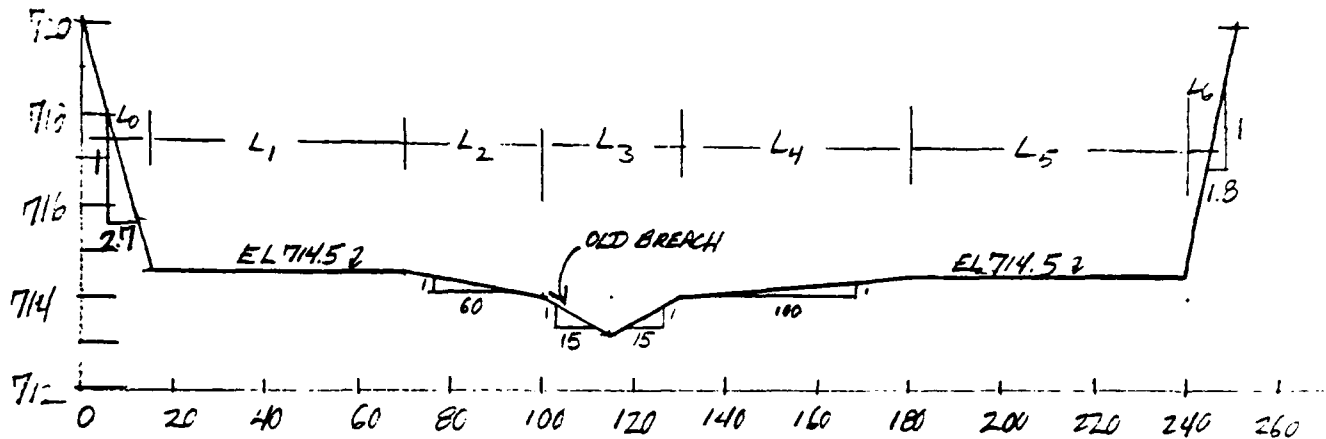
PROFILE ALONG  $\frac{1}{2}$  OF EAST DIKE ESTABLISHED FROM DANBURY TOWN  
TOPOGRAPHY,  $1"=100'$ , AND FIELD SURVEY MEASUREMENTS.

DISCHARGE CURVE FOR EAST DIKE: (ZERO FLOW AT EL 712, INVERT OF  
3" RCP UNDER WEST DIKE).
