**SOUTHWESTERN COASTAL BASIN  
GREENWICH, CONNECTICUT**

**AMERICAN FELT DAM  
CT 00043**

**PHASE 1 INSPECTION REPORT  
NATIONAL DAM INSPECTION PROGRAM**

**FEBRUARY, 1980**

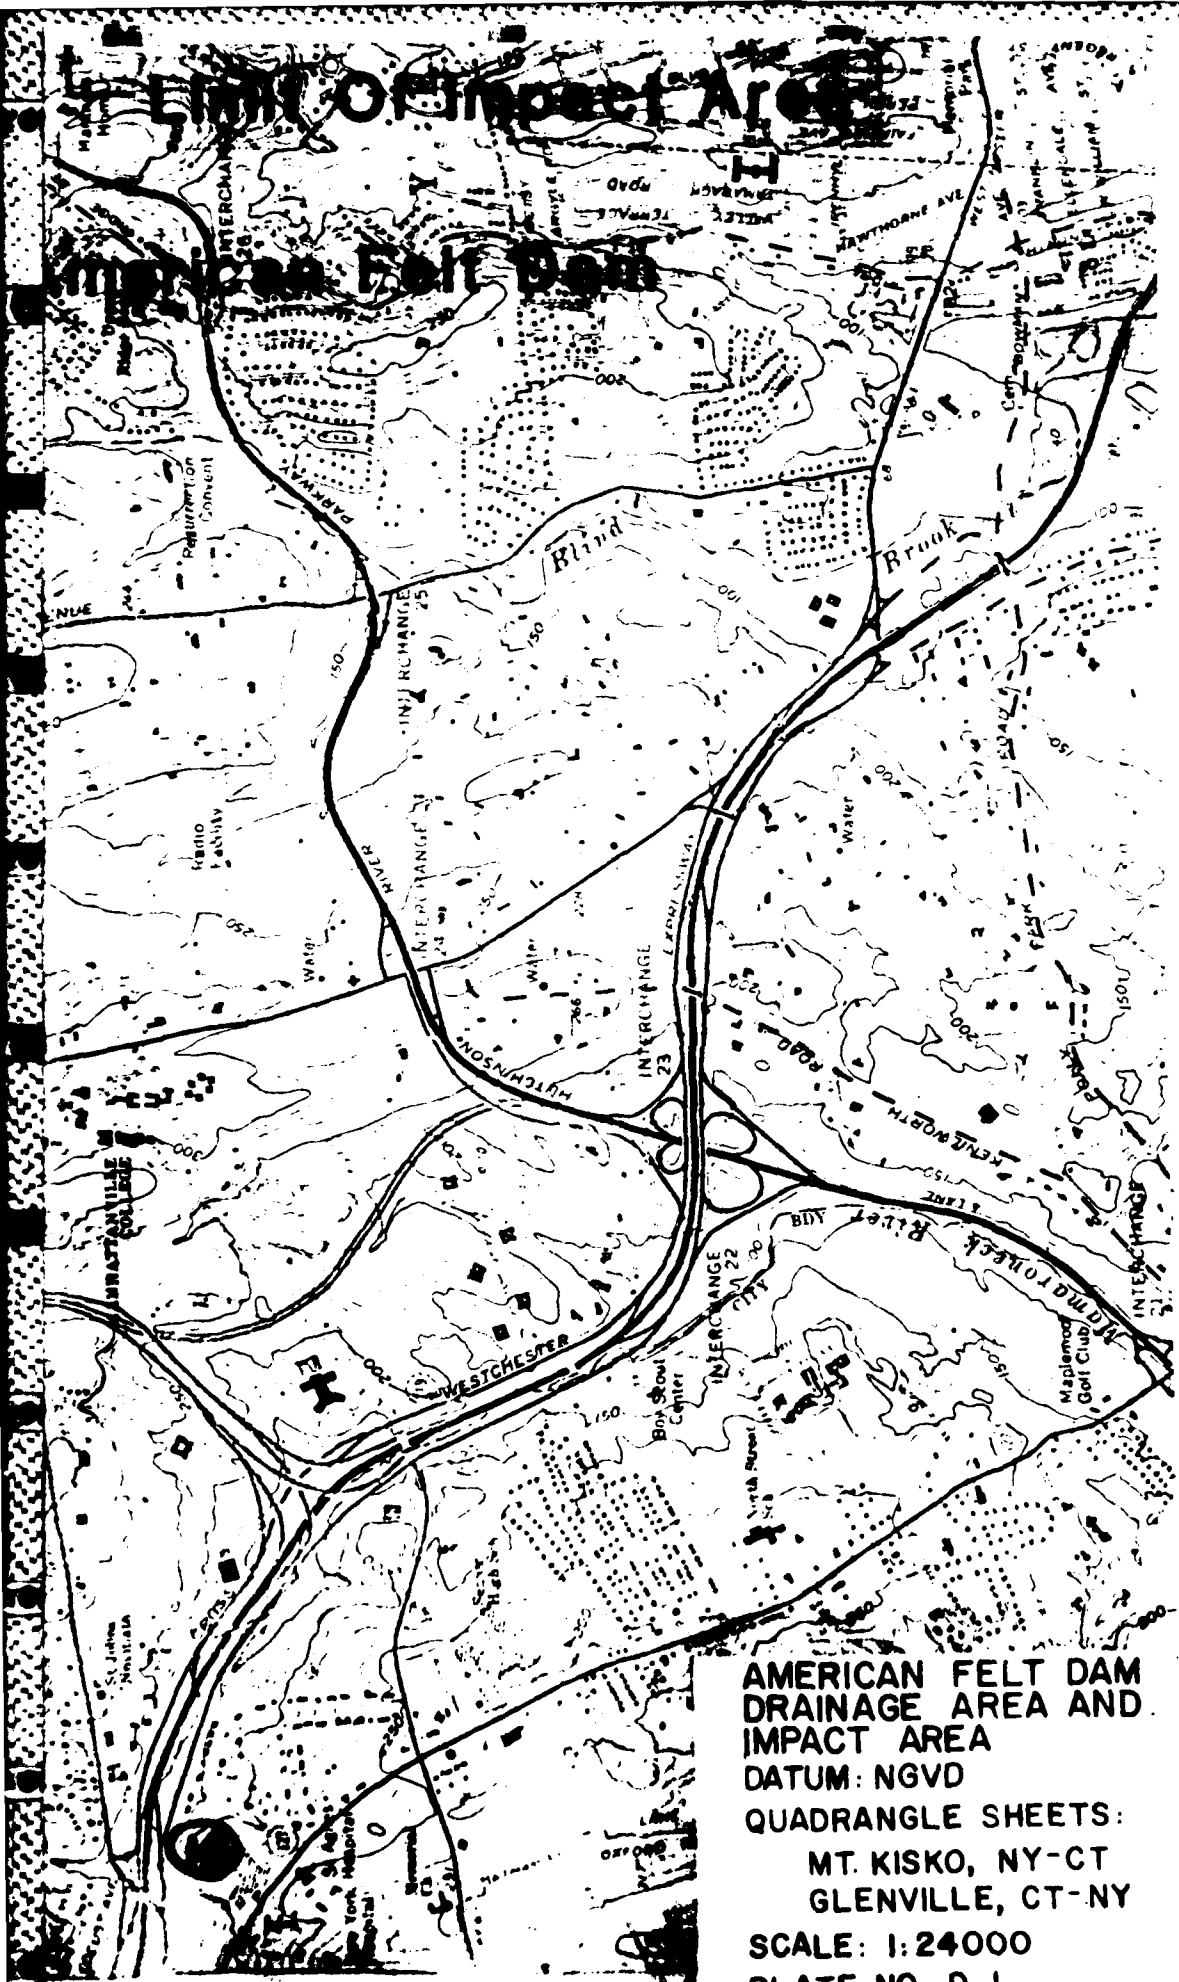
**AMERICAN FELT DAM**  
**DRAINAGE AREA AND**  
**IMPACT AREA**  
 DATUM: NGVD  
 QUADRANGLE SHEETS:  
 MT. KISKO, NY-CT  
 GLENSVILLE, CT-NY  
 SCALE: 1:24000  
 PLATE NO. D-1

Pemberwick Dam is located 3000 feet downstream of American Felt dam. There is a 20 foot drop to Pemberwick Dam which will cause the dissipation of wave and kinetic energy of the failure discharge. Approximately, the water surface elevations between American Felt dam and Pemberwick Dam will be as given on Dam Failure Analysis. The increase of depth at Pemberwick Dam due to failure of American Felt dam is estimated to be 6.2 feet.
