PRITCHARDS POND DAM
CT 00033

NAUGATUCK RIVER BASIN
WATERBURY, CONNECTICUT

PHASE I INSPECTION REPORT
NATIONAL DAM INSPECTION REPORT

Name of Dam : Pritchards Pond Dam
Identification Number : CT 00033
Town : Waterbury
County and State : New Haven County, Connecticut
Stream : Hopeville Pond Brook
Owner : Risdon Manufacturing Company, 2100 South Main Street,
Waterbury, Connecticut
Date of Inspection : December 3, 1980

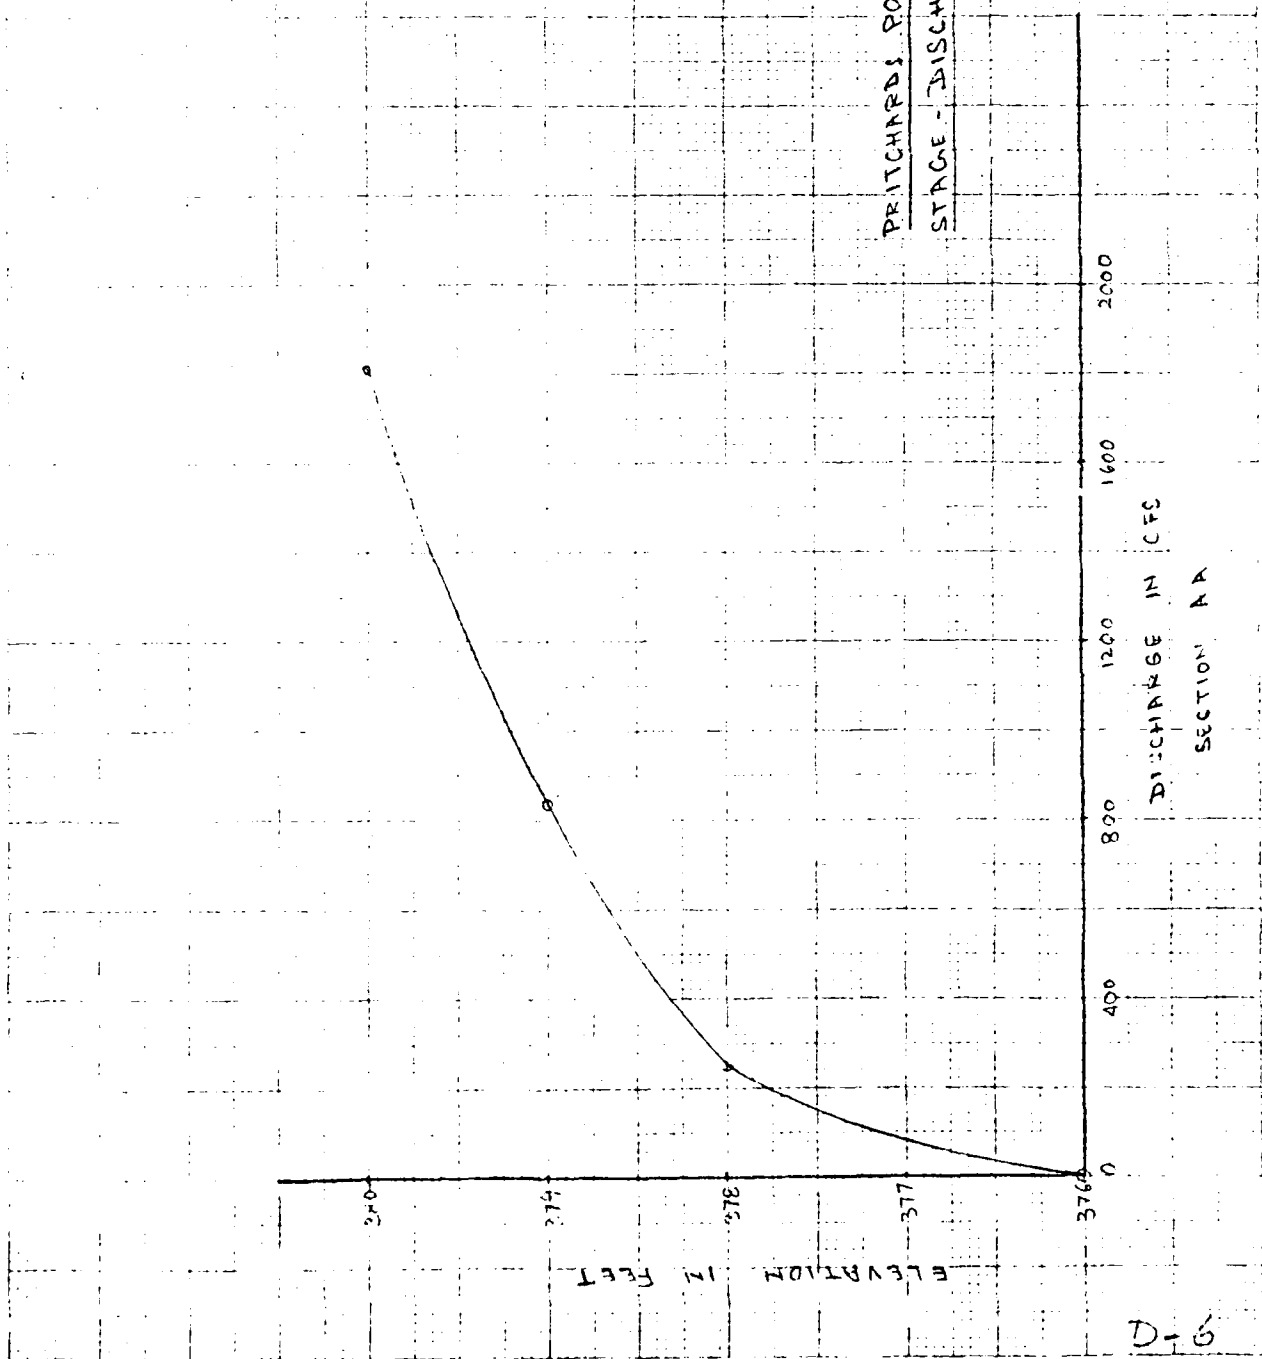
THUS, AT SECTION AA, NO SERIOUS FLOOD HAZARD IS LIKELY TO OCCUR.

IT IS HOWEVER, NOTED THAT THE CULVERT ON SPRING LAKE RD. IS INADEQUATE TO ACCOMMODATE THE ENTIRE PEAK OUTFLOW AT DAM FAILURE.

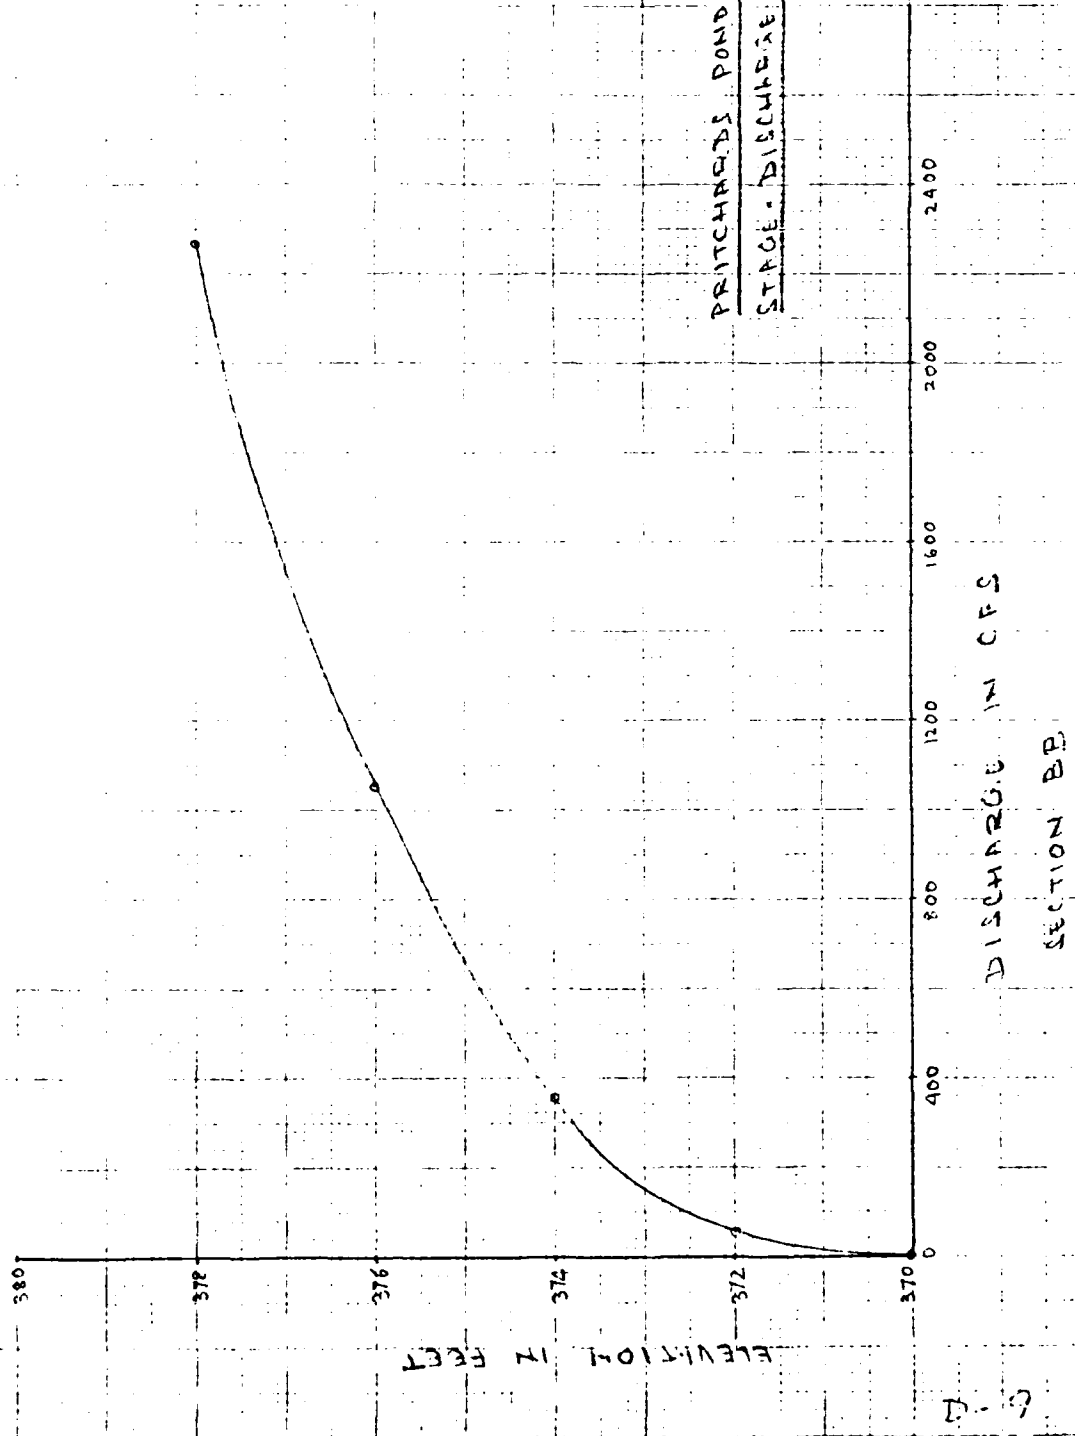
THE TWO HOUSES ADJACENT TO THE SMALL POND LOCATED AT SECTION BB ARE HIGHER THAN THE ESTIMATED FLOOD STAGE; THEREFORE ARE NOT LIKELY TO BE IMPACTED BY DAM FAILURE.

FOR PEAK FAILURE OUTFLOW $Q_1 = 1148 \text{ CFS}$
 ELVN FROM STAGE-DISCHARGE CURVE = 338.2
 AND STAGE AREA CURVE GIVES AREA = 262 SQ. FT.
 FOR A REACH LENGTH OF 2000 FT,

NO DAMAGE IS EXPECTED TO OCCUR
IN THIS REACH.

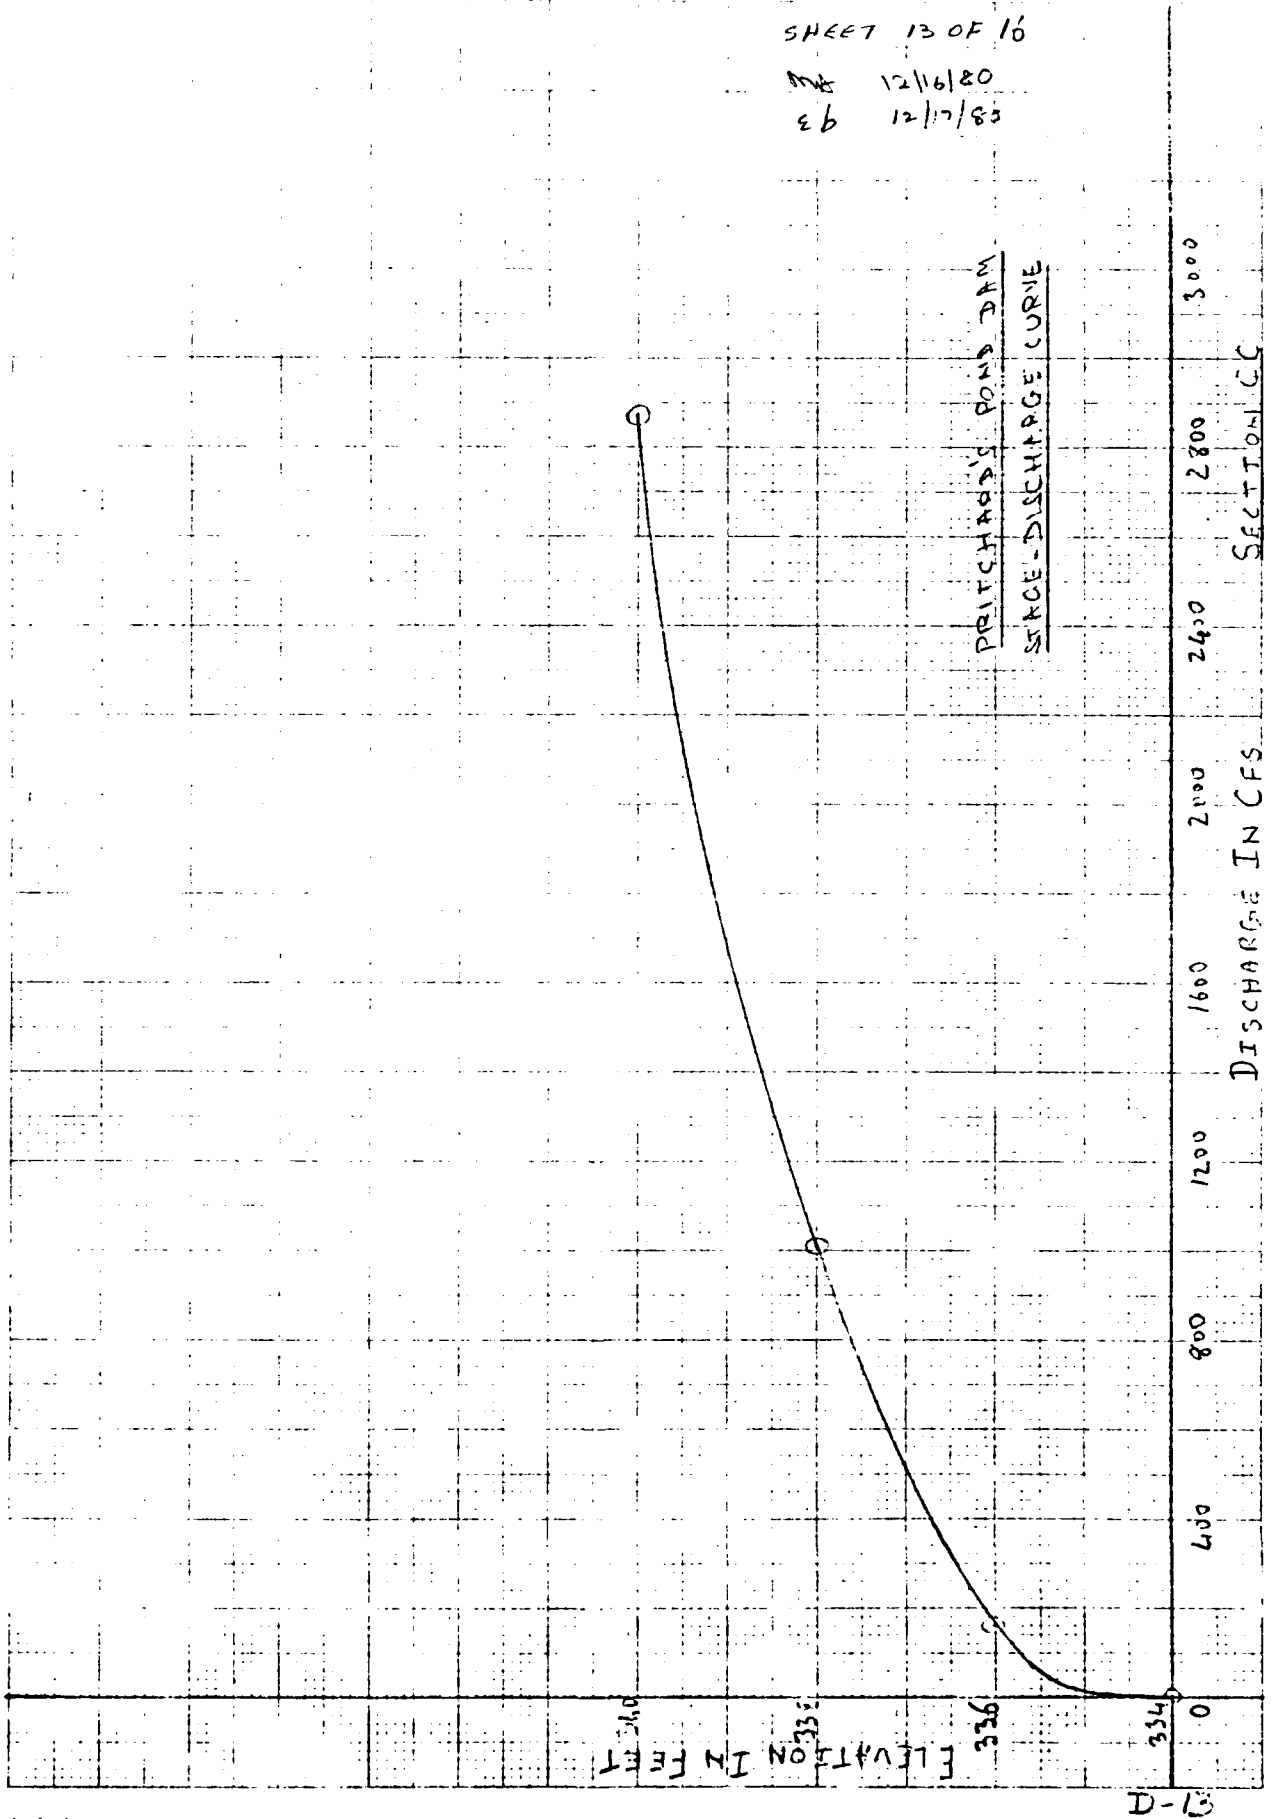
FOR PEAK FAILURE OUTFLOW $Q_1 = 1032$ CFS, THE STAGE DISCHARGE CURVE GIVES ELVN = 326.18 AND AREA = 270 SQ. FT.

THE HOUSES IN THIS VICINITY ARE 5⁺ FT ABOVE THE BED OF THE BROCK.
