N. STAMFORD RESERVOIR DAM

CT. 00048

PHASE I INSPECTION REPORT
NATIONAL DAM INSPECTION PROGRAM

FEBRUARY 1979

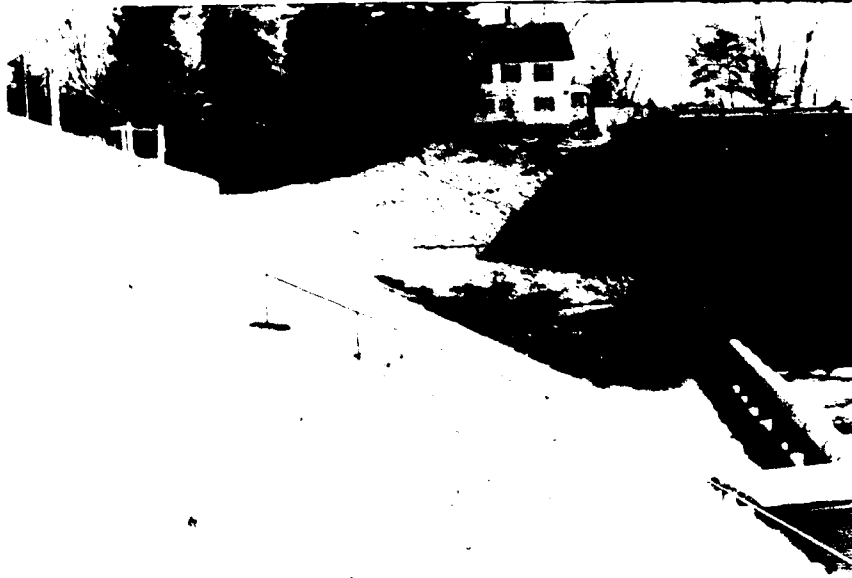
1. Earth slope at downstream toe of concrete gravity dam section.
