<sup>2</sup> SAMUEL P. SENIOR RESERVOIR DAM  
(CT 00108)  
and  
POPPS MOUNTAIN DIKE  
(CT 00022)

<sup>5</sup> PHASE I INSPECTION REPORT  
<sup>1</sup> NATIONAL DAM INSPECTION PROGRAM

PHASE I INSPECTION REPORT  
SAMUEL P. SENIOR DAM CT 00108

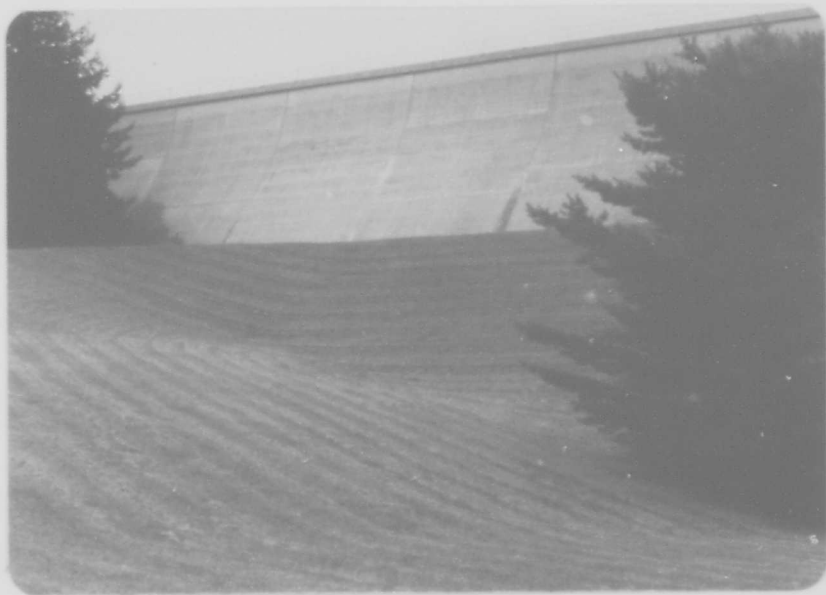
2) Downstream Face - There was evidence of wet spots, staining, efflorescence and joint spalling at nearly every construction joint. From Station 1+90 to Station 2+30 about 30 feet above the berm there was a horizontal line of efflorescence at a horizontal pour joint. In the panel between Station 3+45 to 3+85, about 10 feet up from the top of the berm, there are four drilled holes about 2 inches in diameter, depth undetermined, spaced 3 to 4 feet apart horizontally, which were dry but showed evidence of efflorescence (the purpose of these holes is unknown). There was quite a bit of spalling below the holes and some slight spalling above them. The joint at Station 3+85 was wet and stained from about the berm to a height of 35 feet. For about 20 feet from the top of berm, the joint was badly spalled and quite deteriorated.

PHOTO #1: View of the western, downstream  
face of the dam.

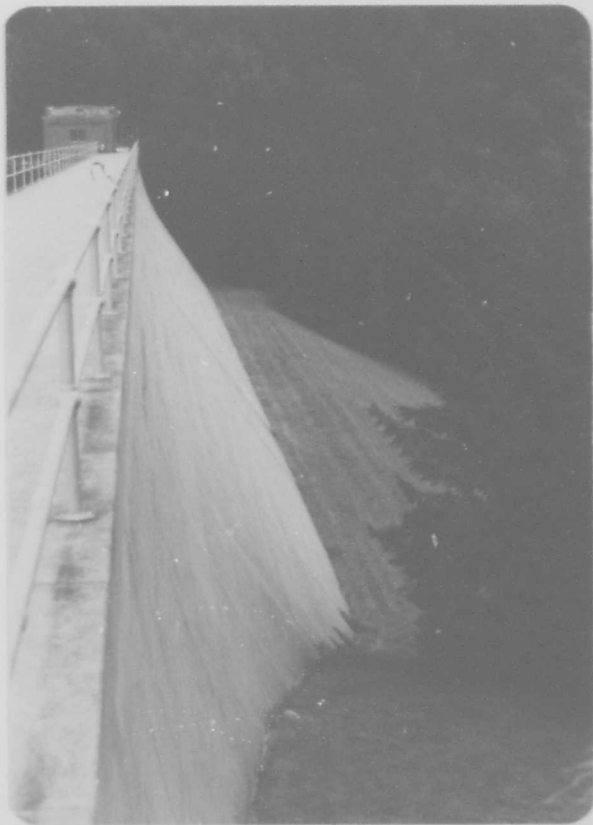
PHOTO #2: View along the face of the dam, looking  
east.

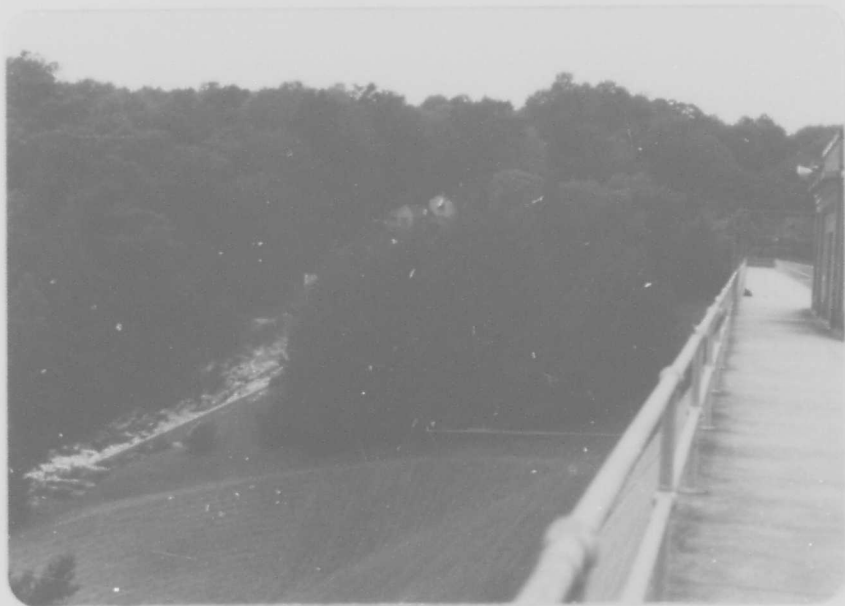
PHOTO #3: Looking west along the crest of the dam.

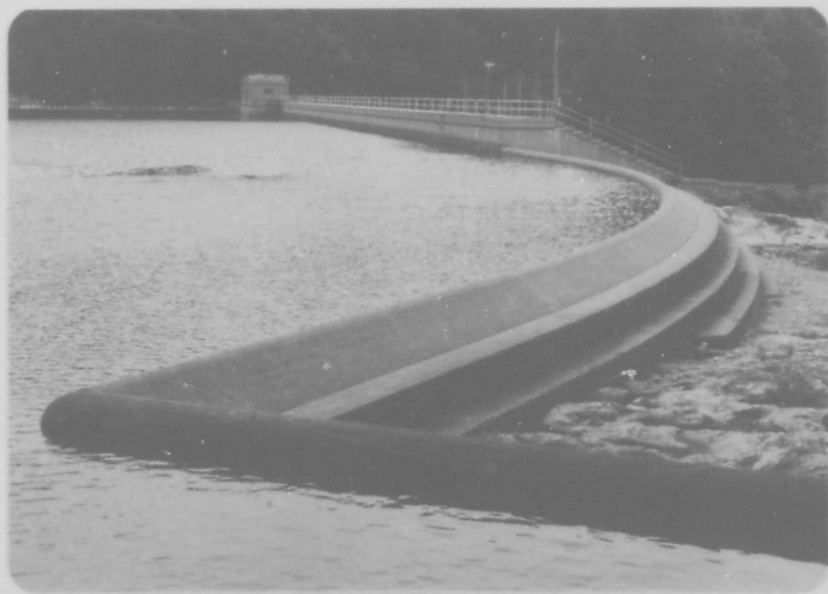
3) Spillway - The concrete in the spillway and steps was found to be in generally good condition. A crack was noted at the crest of the spillway, where it meets the training wall. Some surface spalling of the concrete steps was observed.

PHOTO #6: View of the spillway and dam, looking east from west abutment.

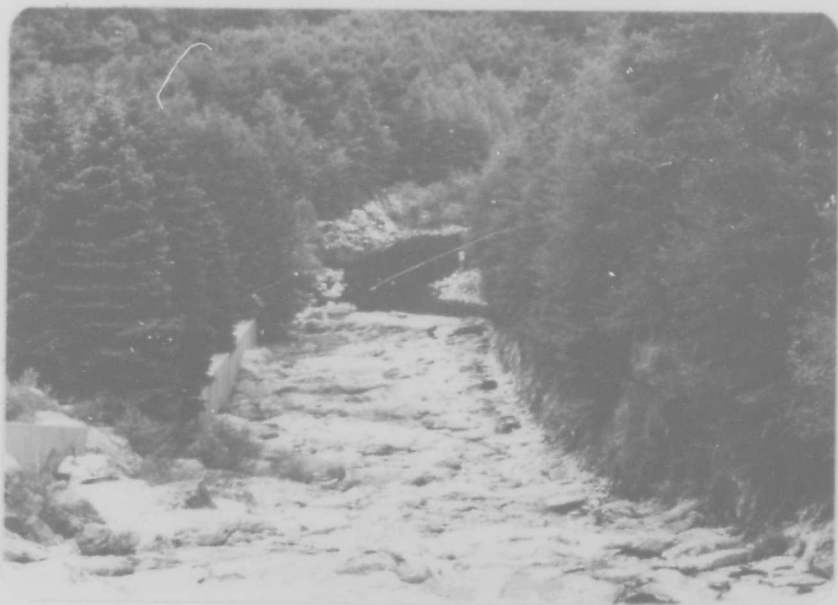
1) Spillway Channel - The spillway channel is in good condition. Low concrete walls on the right and left side of the channel are also in good condition. Layered mica gneiss bedrock is exposed in the bottom of the spillway channel from the spillway weir to the large pool at the end of the left concrete training wall. A small amount of seepage was noted in the channel floor. A rock fall has occurred in the upper part of the channel from its east bank, however, it does not restrict flow. The blow-off discharge structure is in excellent condition.

PHOTO #7: The spillway discharge channel, looking down at the natural river in the background.

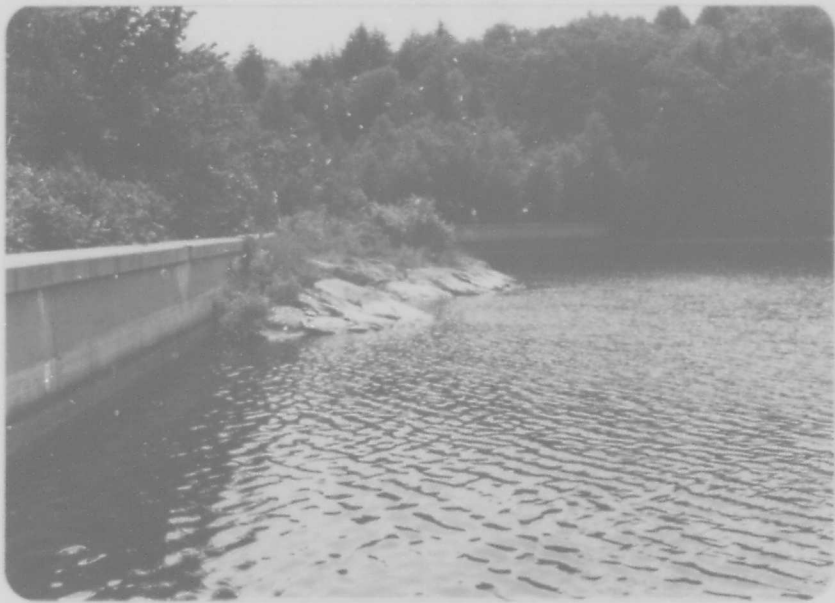
4) Concrete Gravity Dike (Popps Mountain) - Generally the dike is in good condition. Along the full length of the upstream face about 2 feet above the water line, scouring of the concrete has occurred.

PHOTO #11: View looking south along the concrete dike.

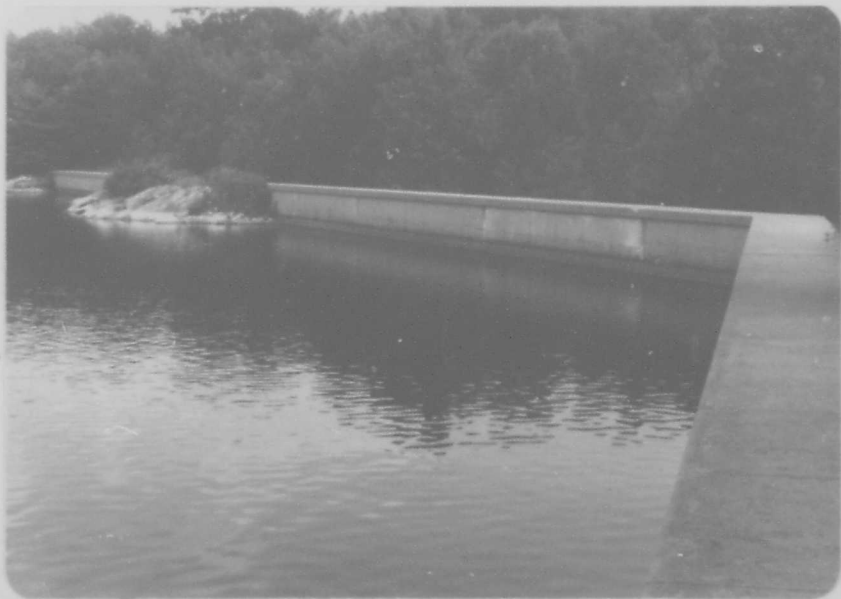
PHOTO #12: View looking north along the concrete dike.
