HOUSATONIC RIVER BASIN,  
DANBURY, CONNECTICUT.

WEST LAKE RESERVOIR DAM  
( CT 00070 )

PHASE I INSPECTION REPORT.  
NATIONAL DAM INSPECTION PROGRAM

JULY 1980

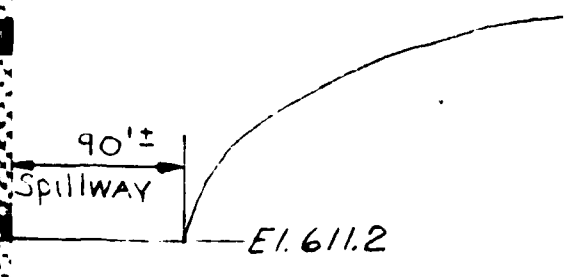
**PLATE 1**

No information on post-construction changes are available. However, comparing the drawings (sections) with actual conditions show a terraced area at the toe of the dam had been added (Appendix B - Plate 1).
