NATIONAL PROGRAM FOR INSPECTION OF NON-FEDERAL DAMS  
HIGHLAND LAKE DAM (CT.) (U) CORPS OF ENGINEERS WALTHAM  
MA NEW ENGLAND DIV JUN 79

| REPORT DOCUMENTATION PAGE | | READ INSTRUCTIONS<br>BEFORE COMPLETING FORM |
|---|---|---|
| 4. TITLE (and Subtitle)<br>Highland Lake Dam | | 5. TYPE OF REPORT & PERIOD COVERED<br>INSPECTION REPORT |

## PHASE I INSPECTION REPORT

### HIGHLAND LAKE DAM

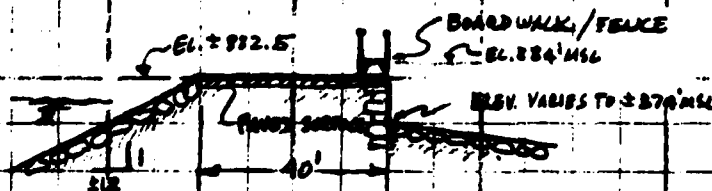
TYPICAL SPILLWAY SECTION

THE SPILLWAY CONSISTS OF TWO PAVED OVERFLOW SECTIONS WHICH ARE DEPRESSED PORTIONS OF THE ROADWAY SURFACE OF WEST LAKE STREET. EACH DEPRESSION IS (±) 75' LONG AT ITS BASE AND THEIR SIDES, RAISE AT (±) 5% TO THE CONTINUING (FLATTER) GRADE OF THE ROAD. FOR ALL PRACTICAL PURPOSES, THE ROAD AT THE EXTREME LEFT AND RIGHT SIDES OF THE SPILLWAY HAS A GRADE ELEV. OF (±) 884' MSL. THE CENTRAL PORTION OF THE ROAD BETWEEN THE DEPRESSIONS, ALTHOUGH AT GRADE ELEV. (±) 883' TO 884', HAS A STONE/EARTH WALL AT THE LAKE SIDE WITH TOP AT EL. (±) 885.4' MSL. ACTUALLY, THE BASE ELEV. OF THE TWO DEPRESSIONS IS SLIGHTLY DIFFERENT (EL. 882.3' FOR THE RIGHT DEPRESSION AND 882.6' FOR THE LEFT). HOWEVER, FOR THE PURPOSE OF THIS COMPUTATION BOTH DEPRESSIONS WILL BE ASSUMED AT ELEV. 882.5' MSL. THE SPILLWAY IS TRANSVERSE IN CROSS SECTION. THE BREADTH AT THE CREST FOR BOTH DEPRESSIONS IS (±) 40'; THE  $\frac{3}{4}$  FACE IS (±) VERTICAL AND THE  $\frac{1}{4}$  FACE IS AT (±) 2" TO 1" SLOPE. BOTH OVERFLOW SECTIONS ARE CONSIDERABLY RE-

TRUCTED BY A (±) 5' WIDE BOARDWALK @ (±) EL. 884' MSL WITH (±) 4' HIGH CHAINLINK FENCE AT BOTH SIDES. THE BOARDWALK IS SUPPORTED AT (±) 6' INTERVALS.
