DOT/FAA/CT-83/10

Evaluation of an Improved Flame Resistant Aircraft Window System

Final Report
May 1984

US Department of Transportation
Federal Aviation Administration
Technical Center
Atlantic City Airport, N.J. 08405

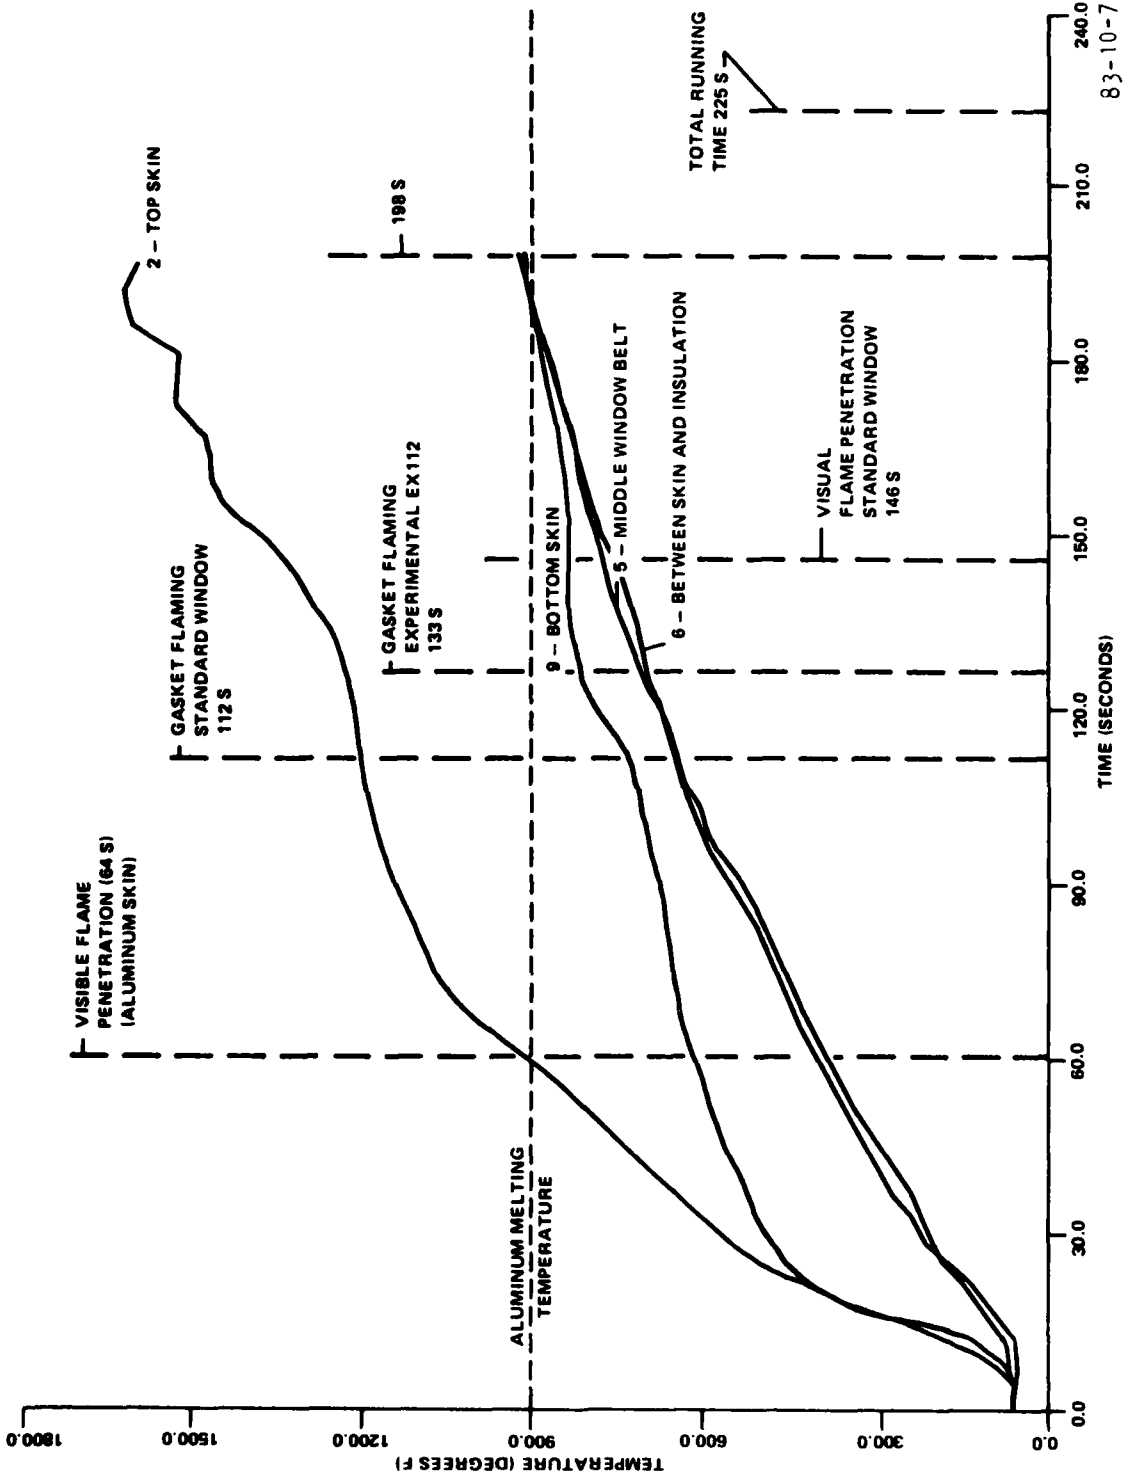
83-10-7

RESULTS: The temperature rise of the DC-10 fuselage segment during fire exposure in test 1 is indicated by the profiles presented in figure 7 for the aluminum skin and belt areas. These data show that the aluminum skin above the windows started to melt in 64 seconds (1.07 minutes) which was confirmed by an analysis of the photographic coverage. However, the skin below the windows and belt area did not reach the incipient melting temperature for aluminum of 900° F until 198 seconds (3.3 minutes) after fuel ignition. The fire damage to the skin above the improved (EX 112) window system is shown in figure 8 and above the acrylic window in figure 9. A more detailed interior view of the failure mode of the fuselage skin in these areas is presented in figure 10. An overall exterior view of the fire damage sustained by the DC-10 fuselage segment is presented in figure 11.

FIGURE 7. TEMPERATURE RISE OF THE DC-10 SKIN, BELT AND THE INTERFACE BETWEEN THE INTERIOR PANEL AND INSULATION BATT (TEST 1)

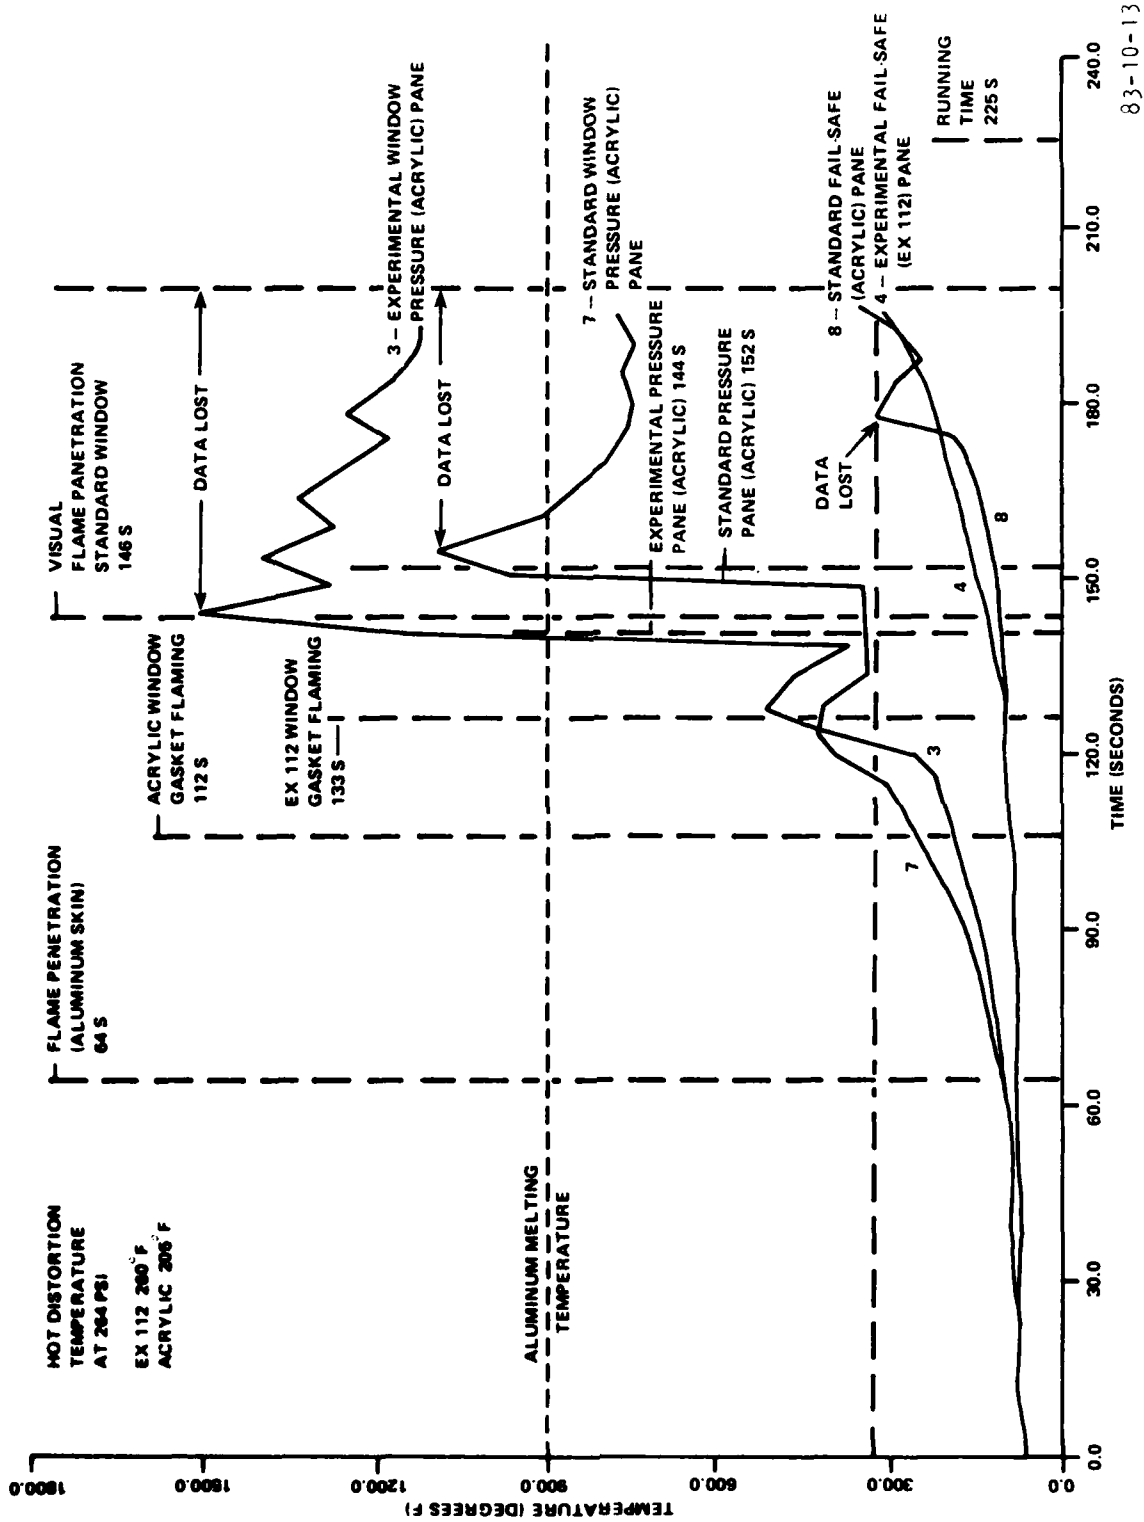
83-10-13

The temperature data obtained from the thermocouples embedded in the pressure and fail-safe window panes for both the experimental (EX 112) and standard (acrylic) window systems are presented in figure 13. The profiles numbered 3 and 7 show that the temperature rise of the pressure panes on the experimental and standard window systems reached 900° F in 144 seconds (2.4 minutes) and 152 seconds (2.5 minutes), respectively. The temperature profiles obtained for the experimental (EX 112) and standard acrylic fail-safe panes show that the EX 112 pane reached approximately 314° F in 199 seconds (3.3 minutes) and that the temperature data for the acrylic pane was lost. Additional data superimposed on the time temperature profiles in figure 13 show that the first visual flame penetration through the standard acrylic window system occurred in 146 seconds (2.4 minutes) after fuel ignition. While only very minor flame intrusion was observed through several small cracks in the EX 112 fail-safe pane (figure 14) after 225 seconds (3.75 minutes), which was the duration time of the test. The condition of the standard acrylic and experimental EX 112 fail-safe panes with their respective silicone rubber gaskets are shown in figure 15.

FIGURE 13. TEMPERATURE RISE OF THE STANDARD (ACRYLIC) AND THERMALLY IMPROVED (EX 112) WINDOW SYSTEMS DURING FIRE EXPOSURE (TEST 1)

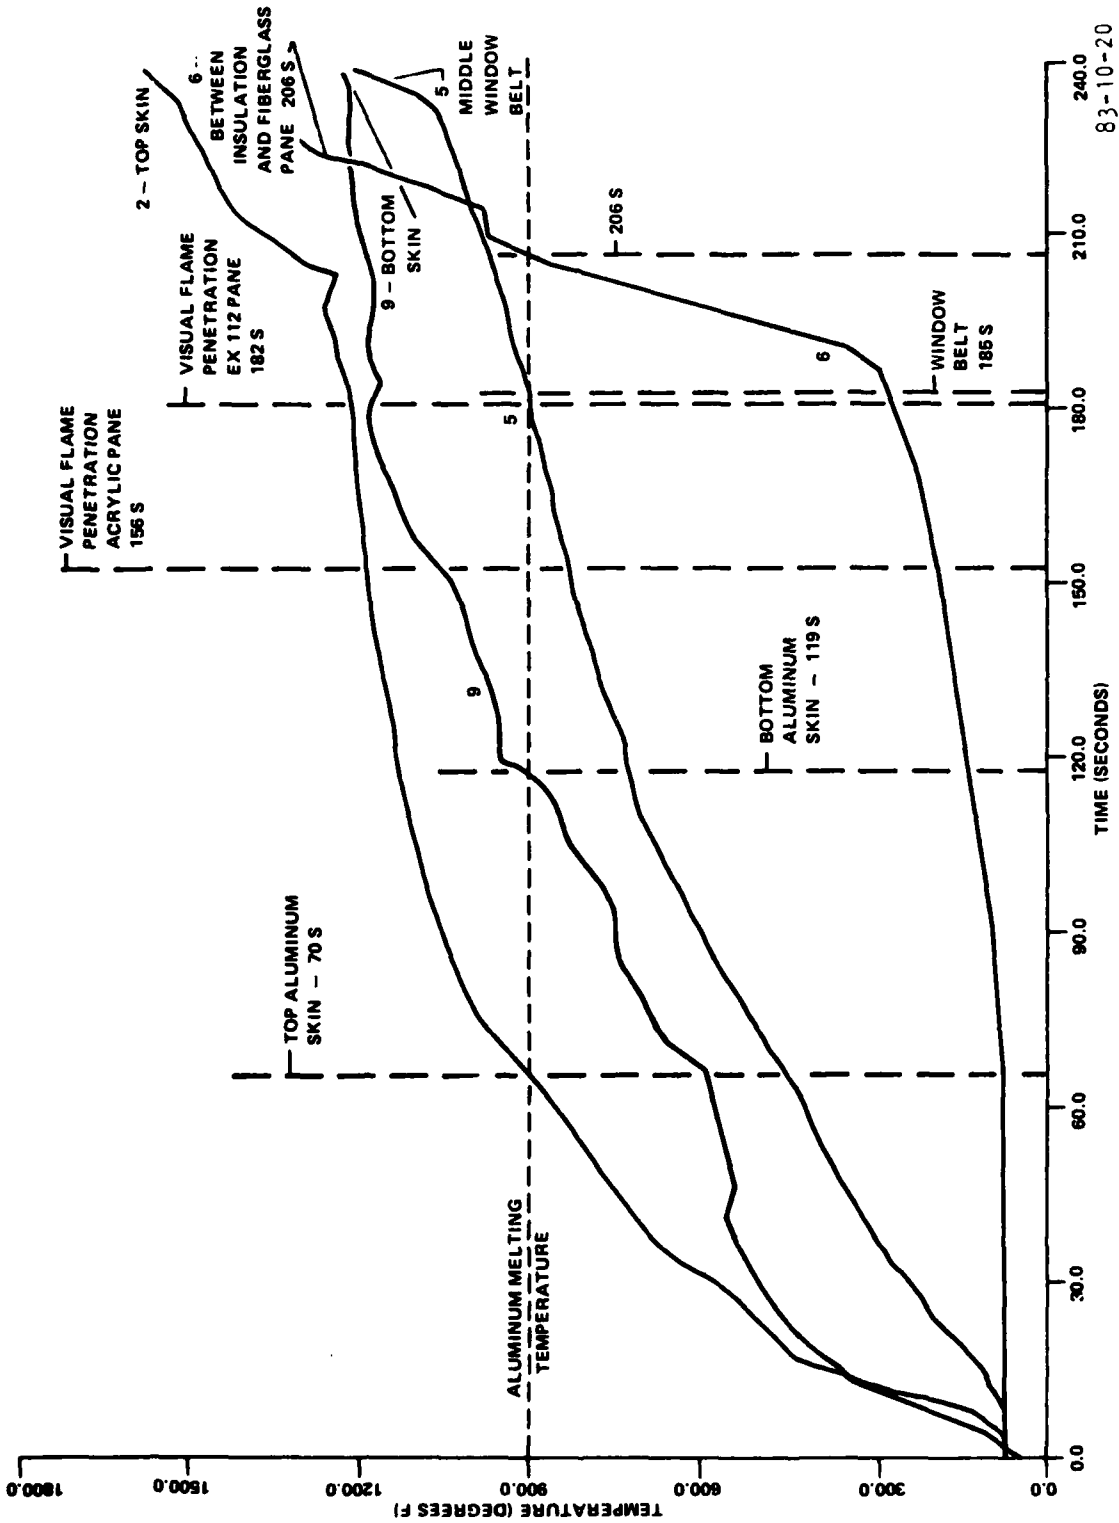
FIGURE 21. TEMPERATURE RISE OF THE DC-10 SKIN, DOUBLER AND BELT DURING FIRE EXPOSURE (TEST 2)

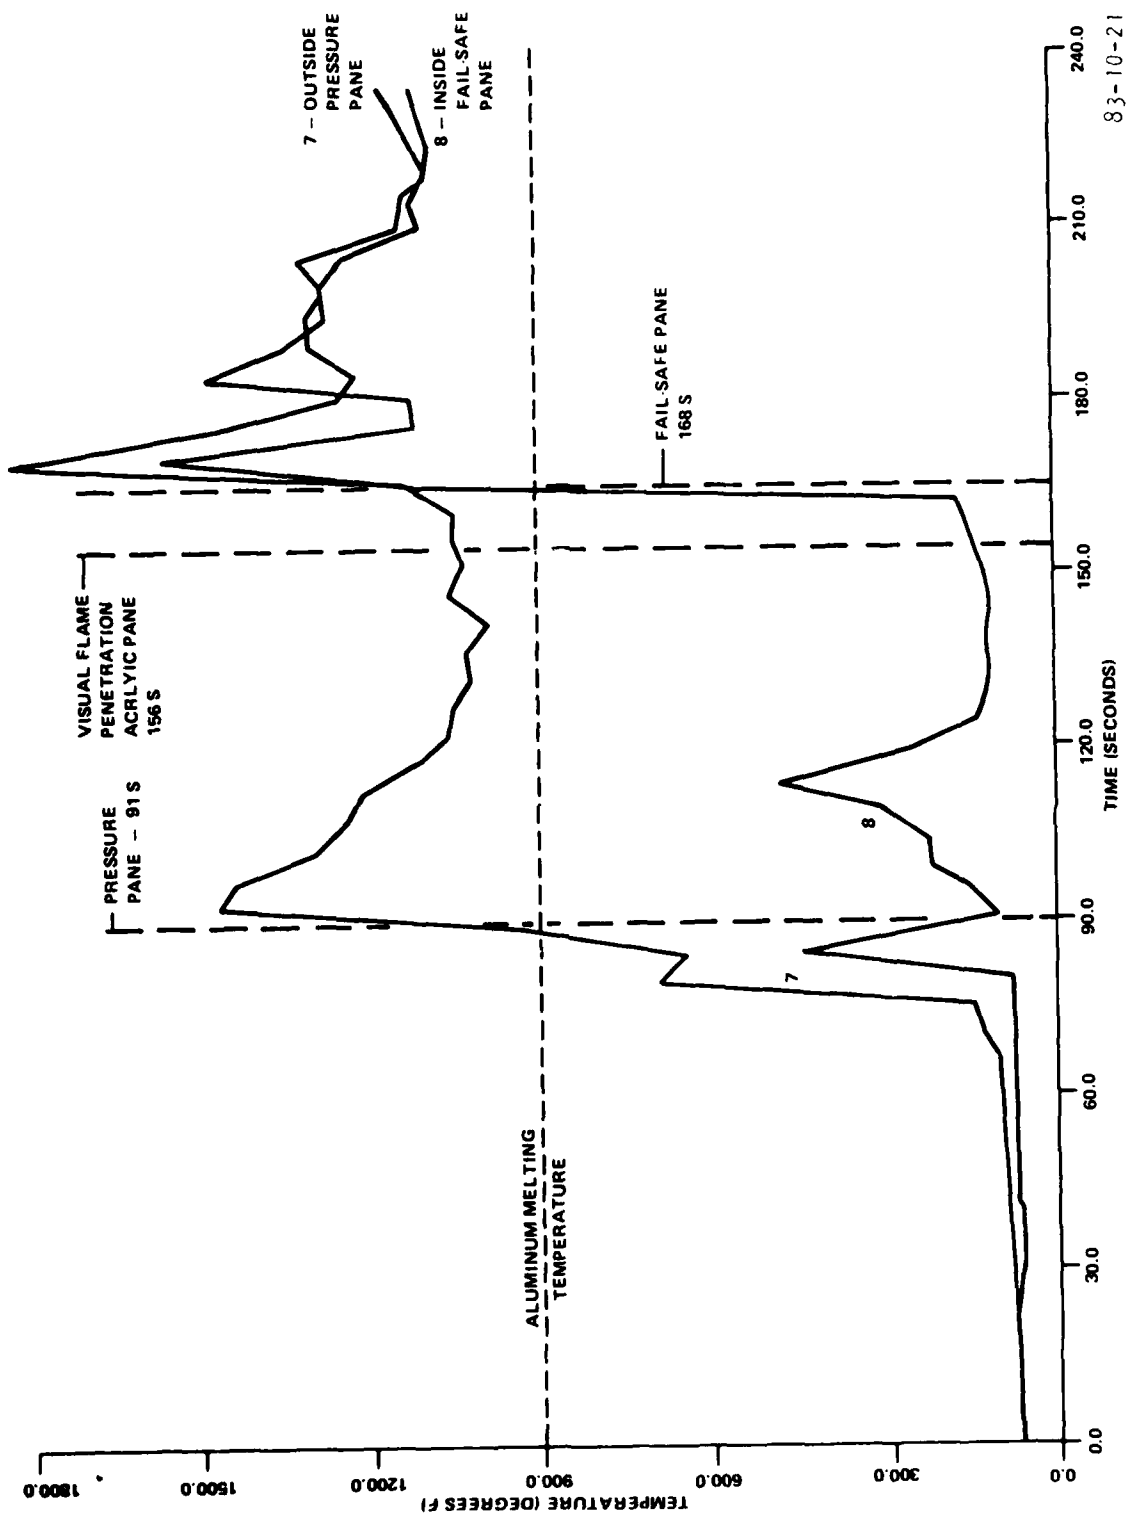
FIGURE 22. TEMPERATURE RISE OF THE STANDARD (ACRYLIC) WINDOW PANES DURING FIRE EXPOSURE (TEST 2)

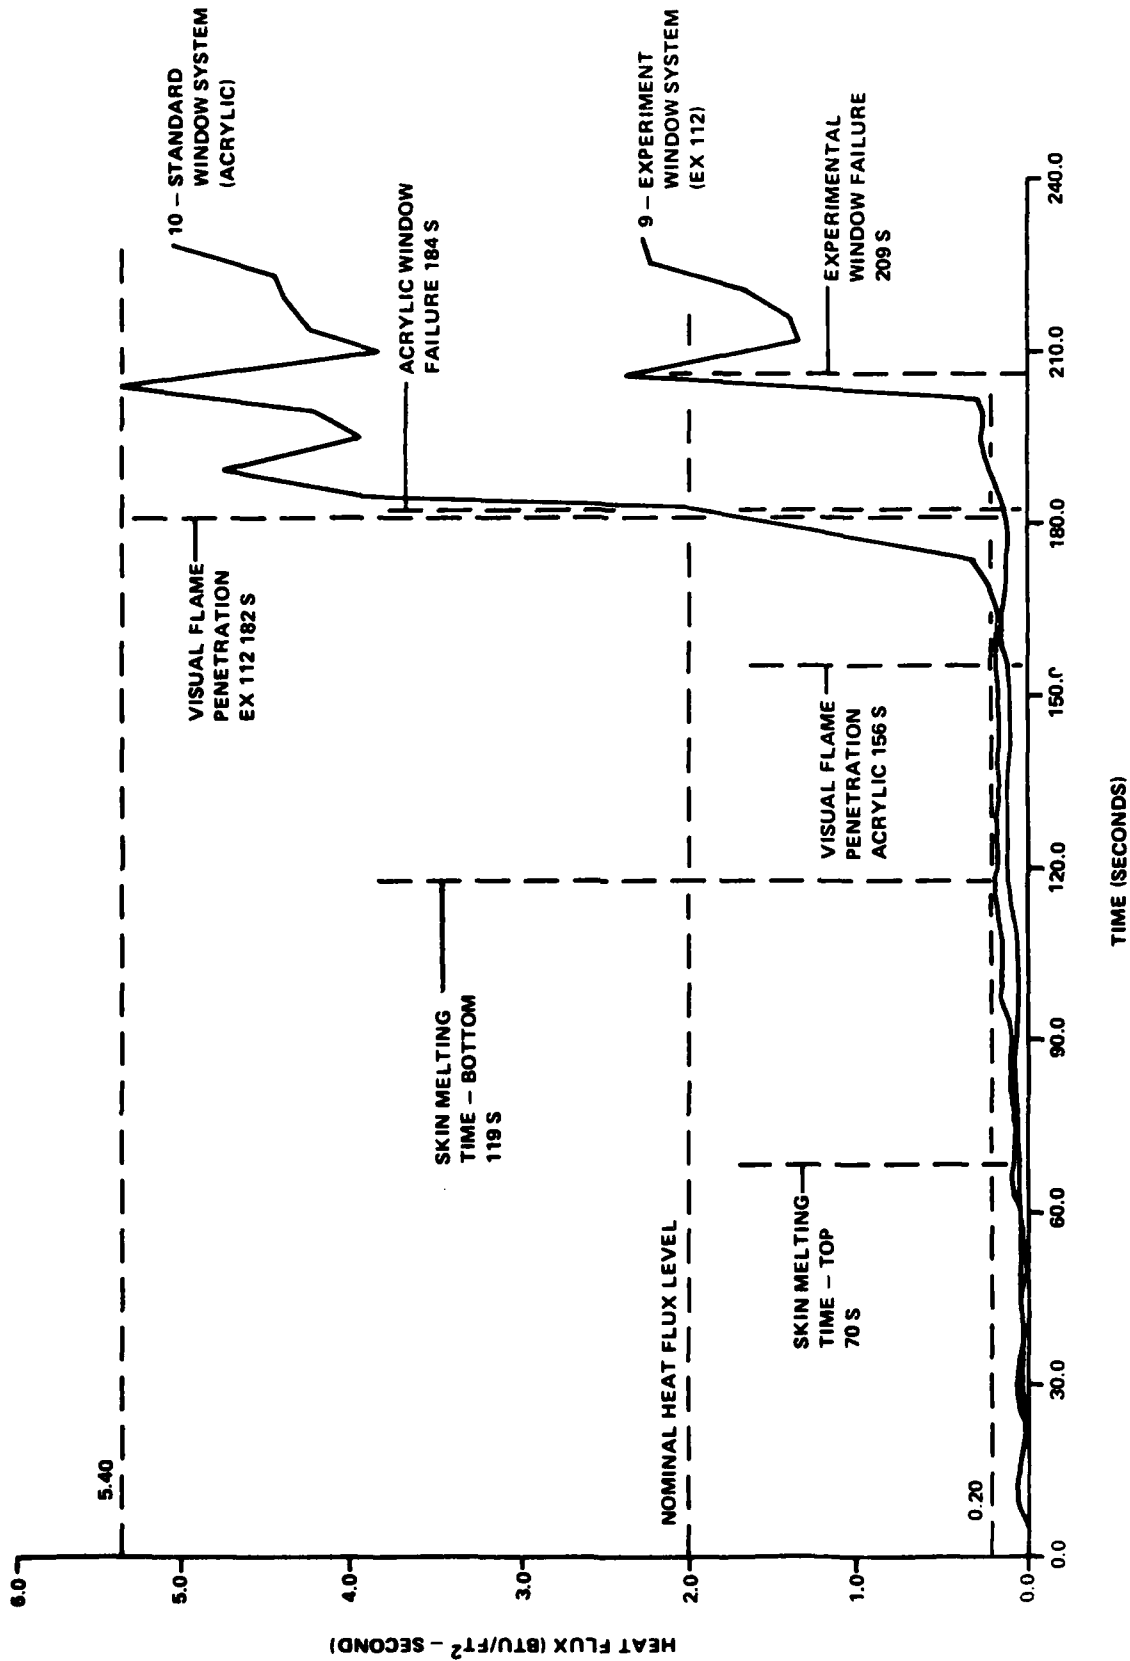
83-10-23

FIGURE 23. HEAT FLUX THROUGH THE STANDARD (ACRYLIC) AND THERMALLY IMPROVED (EX 112) WINDOWS DURING FIRE EXPOSURE (TEST 2)

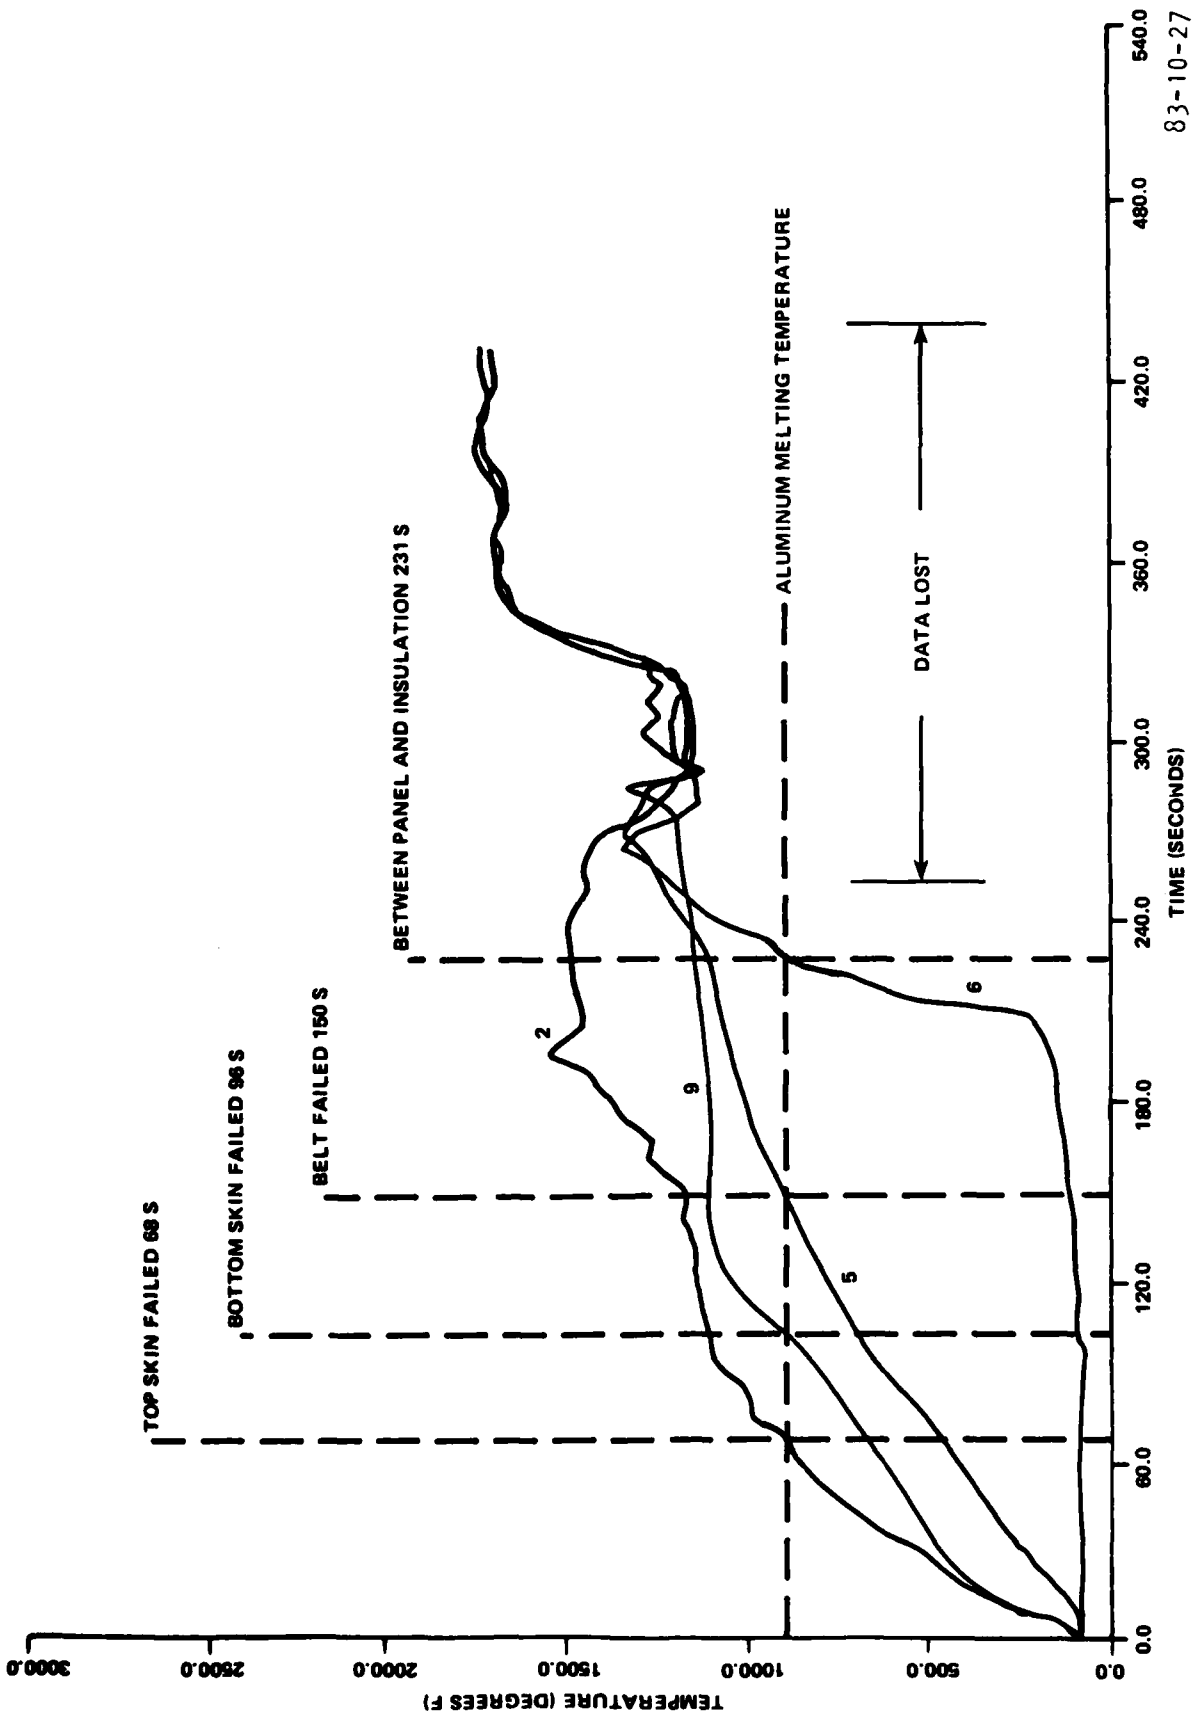
83-10-27

FIGURE 27. TEMPERATURE RISE OF THE DC-10 SKIN, BELT AND THE INTERFACE BETWEEN THE INTERIOR PANEL AND INSULATION BATT (TEST 3)

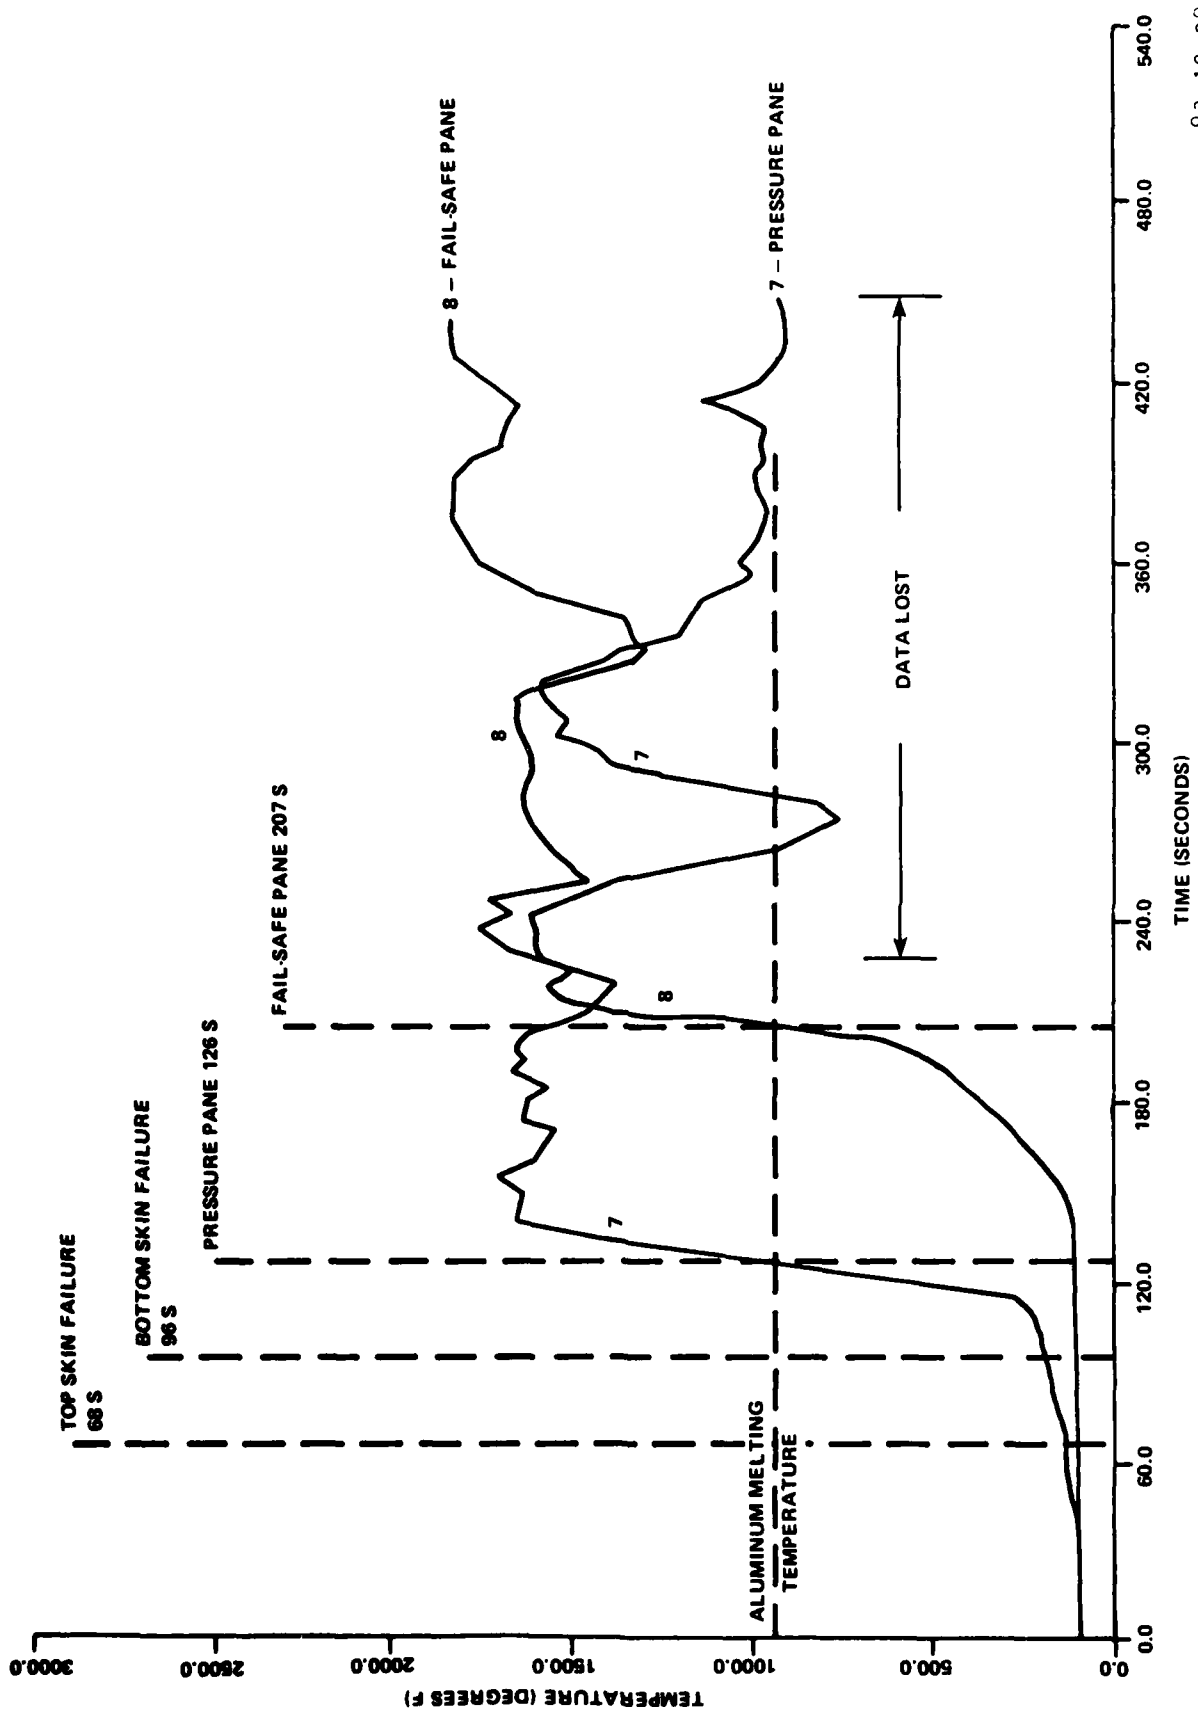
83-10 28

FIGURE 28. TEMPERATURE RISE OF THE STANDARD (ACRYLIC) WINDOW PANES (TEST 3)

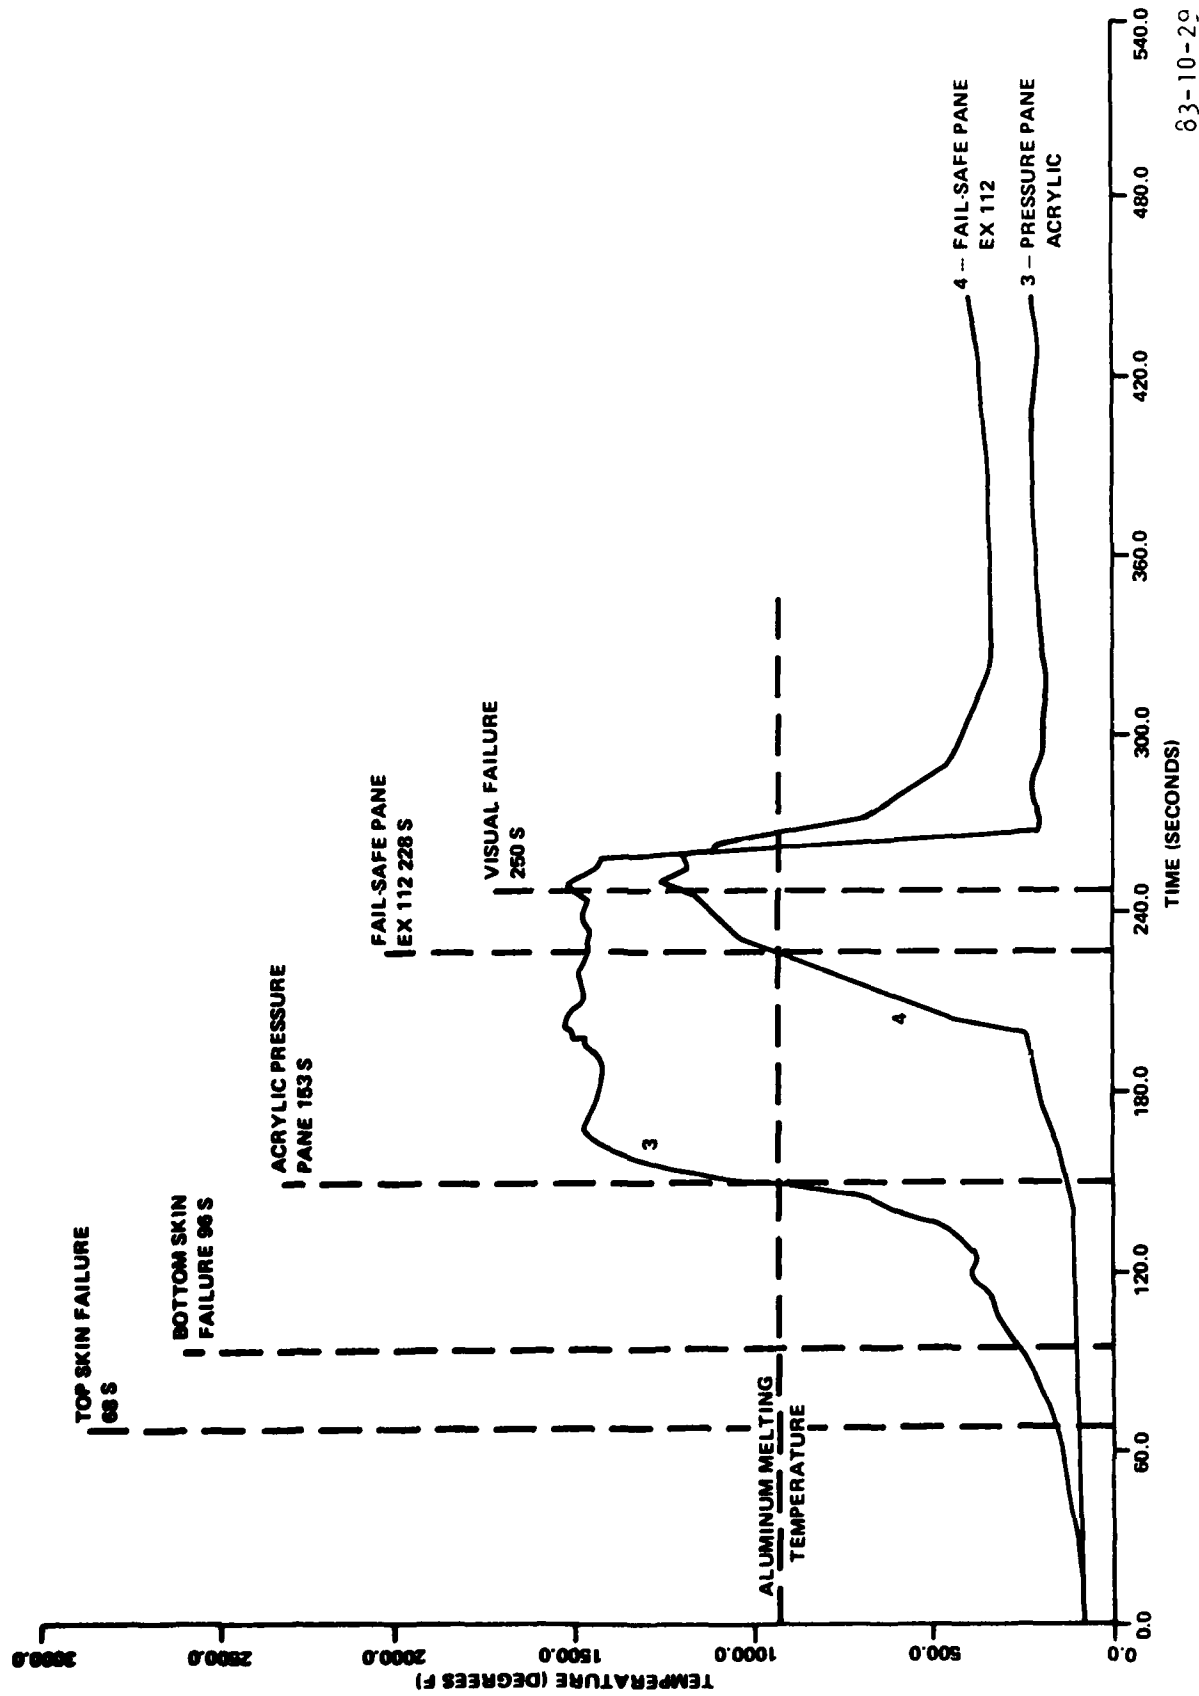
63-10-29

FIGURE 29. TEMPERATURE RISE OF THE THERMALLY IMPROVED (EX 112) FAIL-SAFE WINDOW PANE AND STANDARD (ACRYLIC) PRESSURE PANE DURING FIRE EXPOSURE (TEST 3)

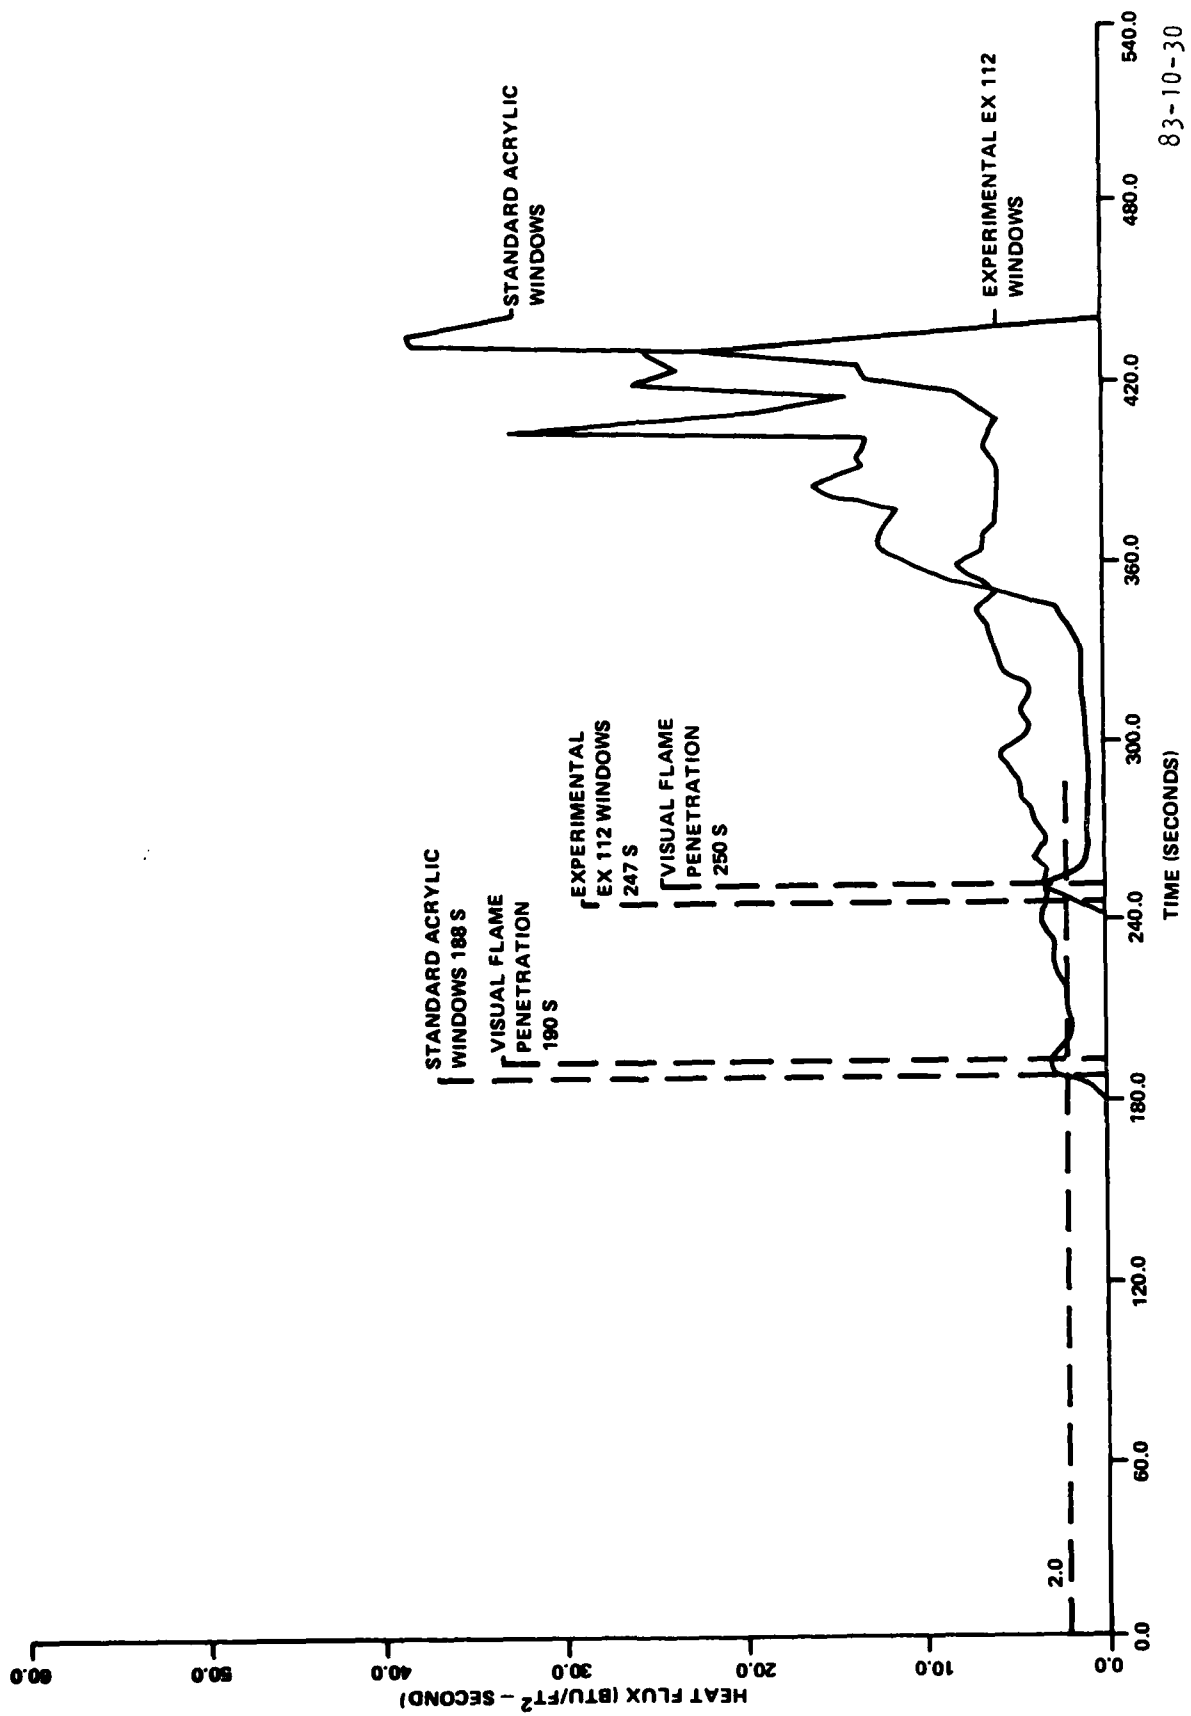
FIGURE 30. HEAT FLUX THROUGH THE STANDARD (ACRYLIC) AND THERMALLY IMPROVED (EX 112) WINDOWS DURING FIRE EXPOSURE (TEST 3)

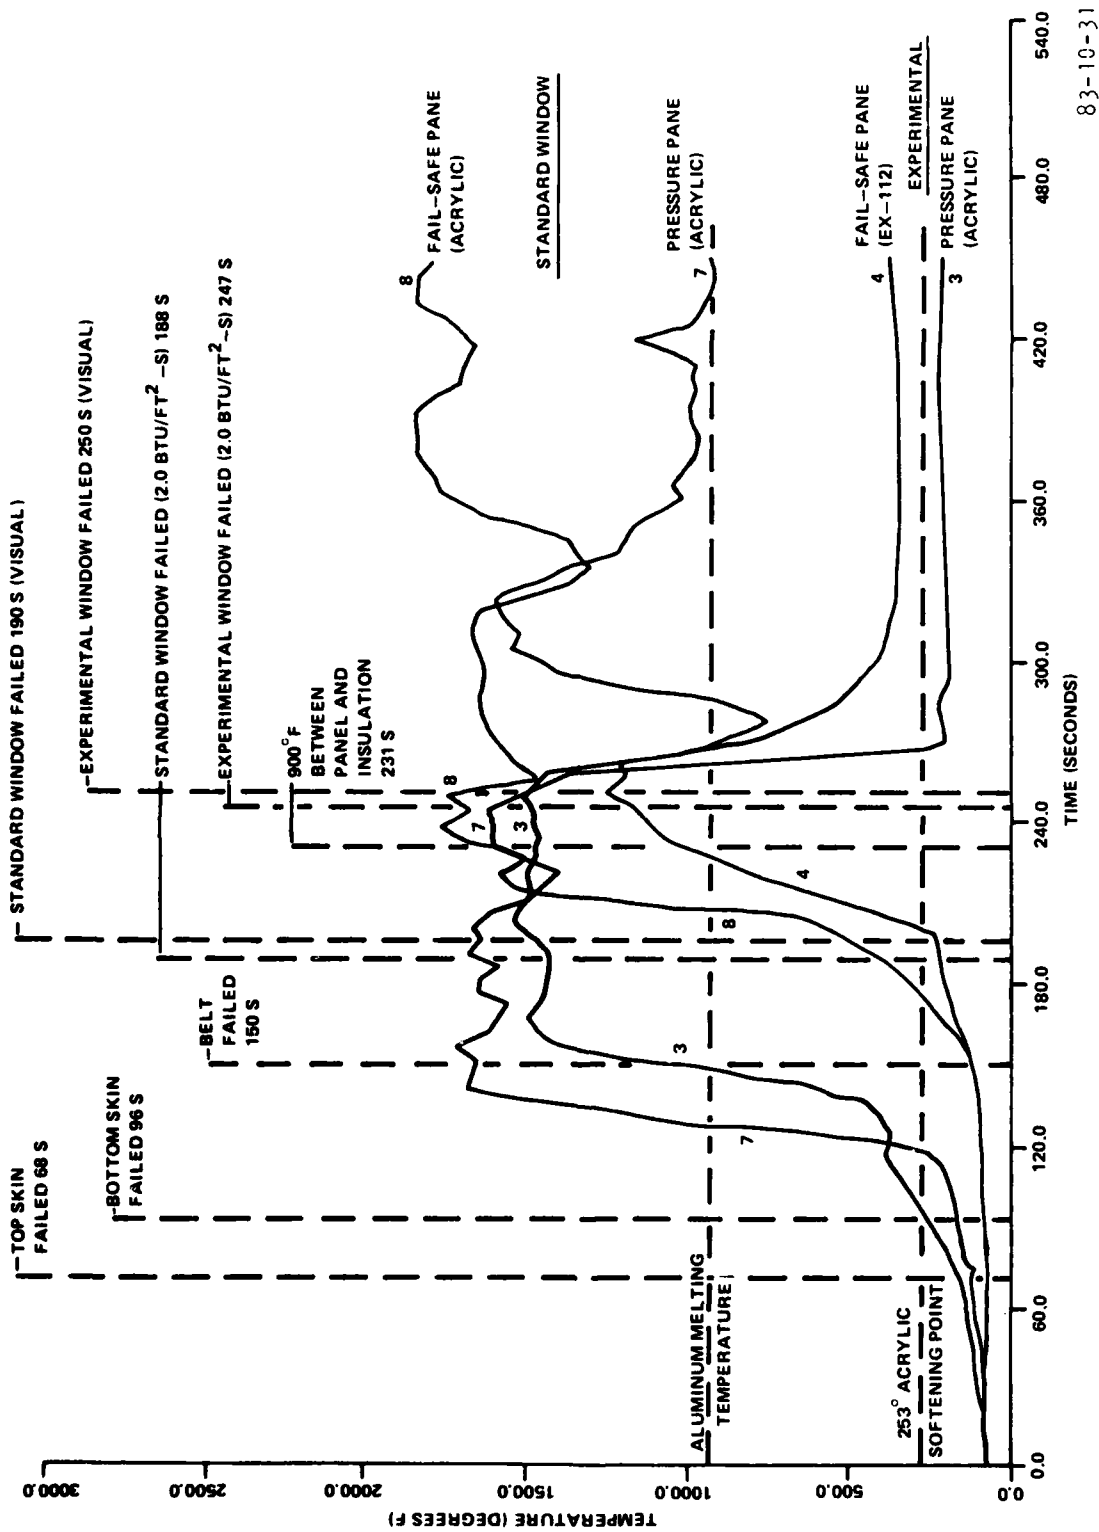
83-10-31

6. The DC-10 aircraft interior honeycomb panel resisted a temperature rise to 900° F from the adjacent fuel fire for a significantly longer period of time (67 seconds) than the aluminum interior panel, thereby, providing a potential barrier to flame penetration into the aircraft cabin.

7. The times-to-failure of the interior honeycomb decorative panel (test 3) and the interior aluminum decorative panel (test 4) indicate that the honeycomb panel configuration provided an improved thermal resistance of 67 seconds (1.1 minutes) over the aluminum panel based upon the time of each to reach 900° F, the incipient melting temperature of aluminum.

FIGURE 31. SUMMARY OF EXPERIMENTAL DATA OBTAINED FROM TEST 3 EMPLOYING THE STANDARD AND THERMALLY IMPROVED WINDOW SYSTEM WITH THE DC-10 INTERIOR HONEYCOMB PANEL CONFIGURATION

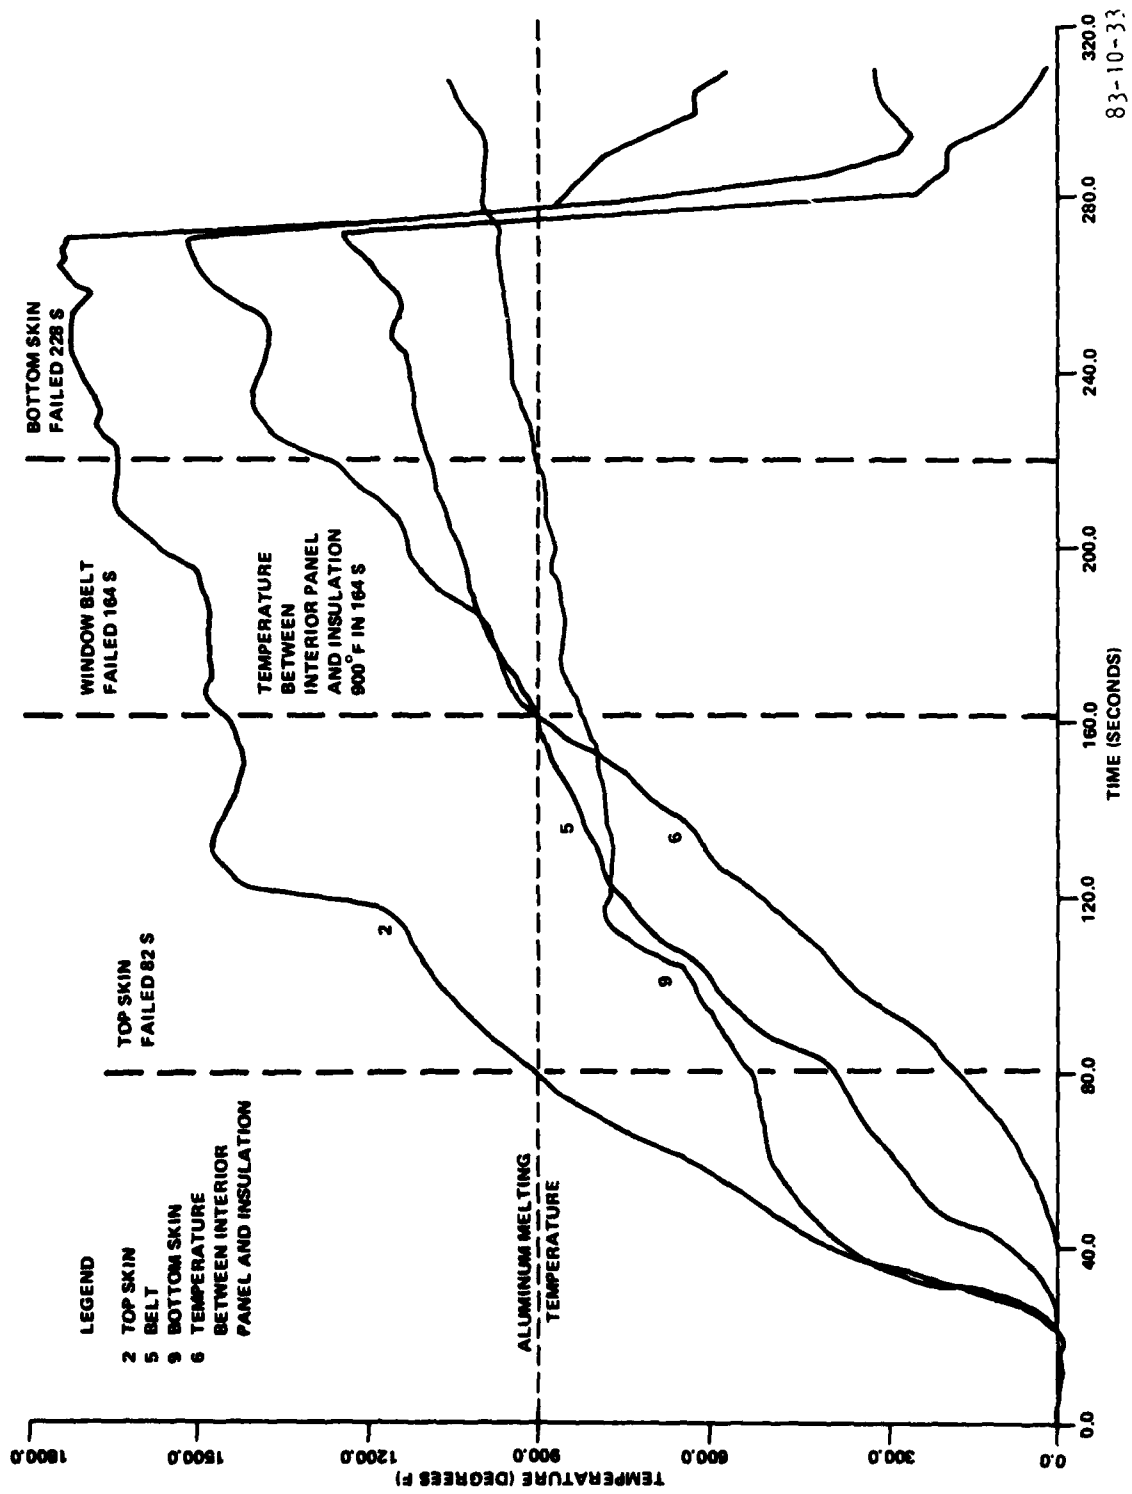
FIGURE 32. TEMPERATURE RISE OF THE DC-10 SKIN, BELT AND THE INTERFACE BETWEEN THE INTERIOR PANEL AND INSULATION BATT (TEST 4)

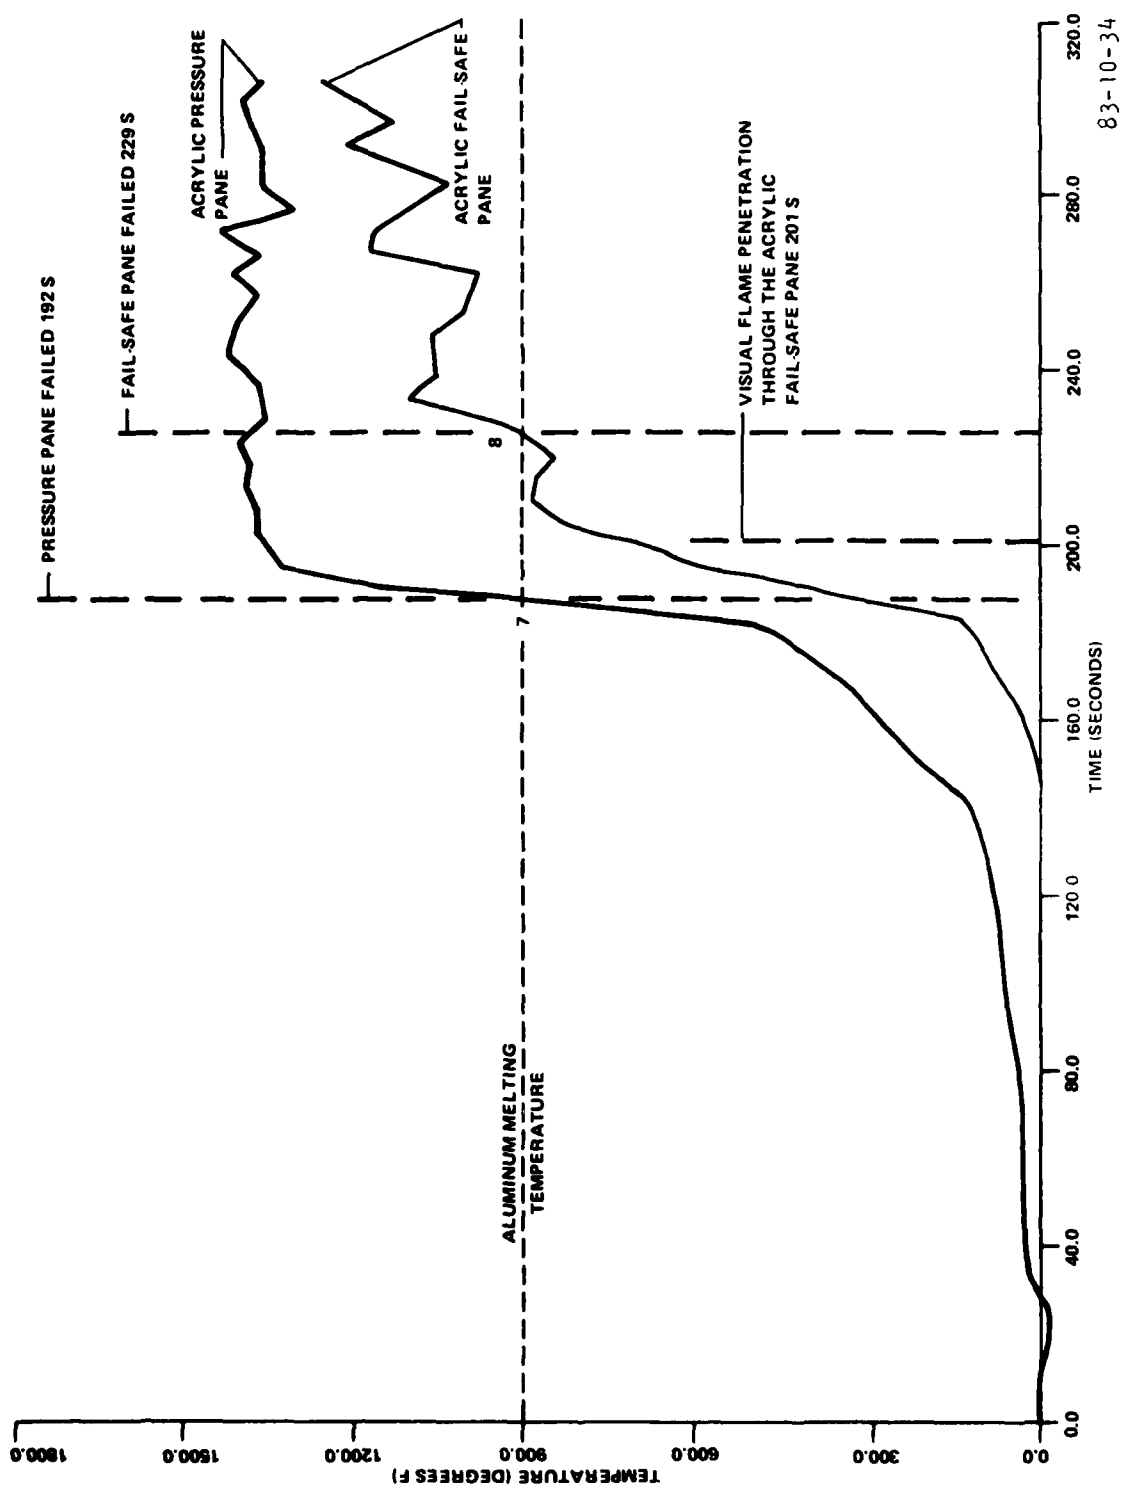
FIGURE 3.3. TEMPERATURE RISE OF THE STANDARD (ACRYLIC) WINDOW PANES DURING FIRE EXPOSURE (TEST 4)
