DOT/FAA/CT-83/10

Evaluation of an Improved Flame Resistant Aircraft Window System

Final Report
May 1984

US Department of Transportation
Federal Aviation Administration
Technical Center
Atlantic City Airport, N.J. 08405

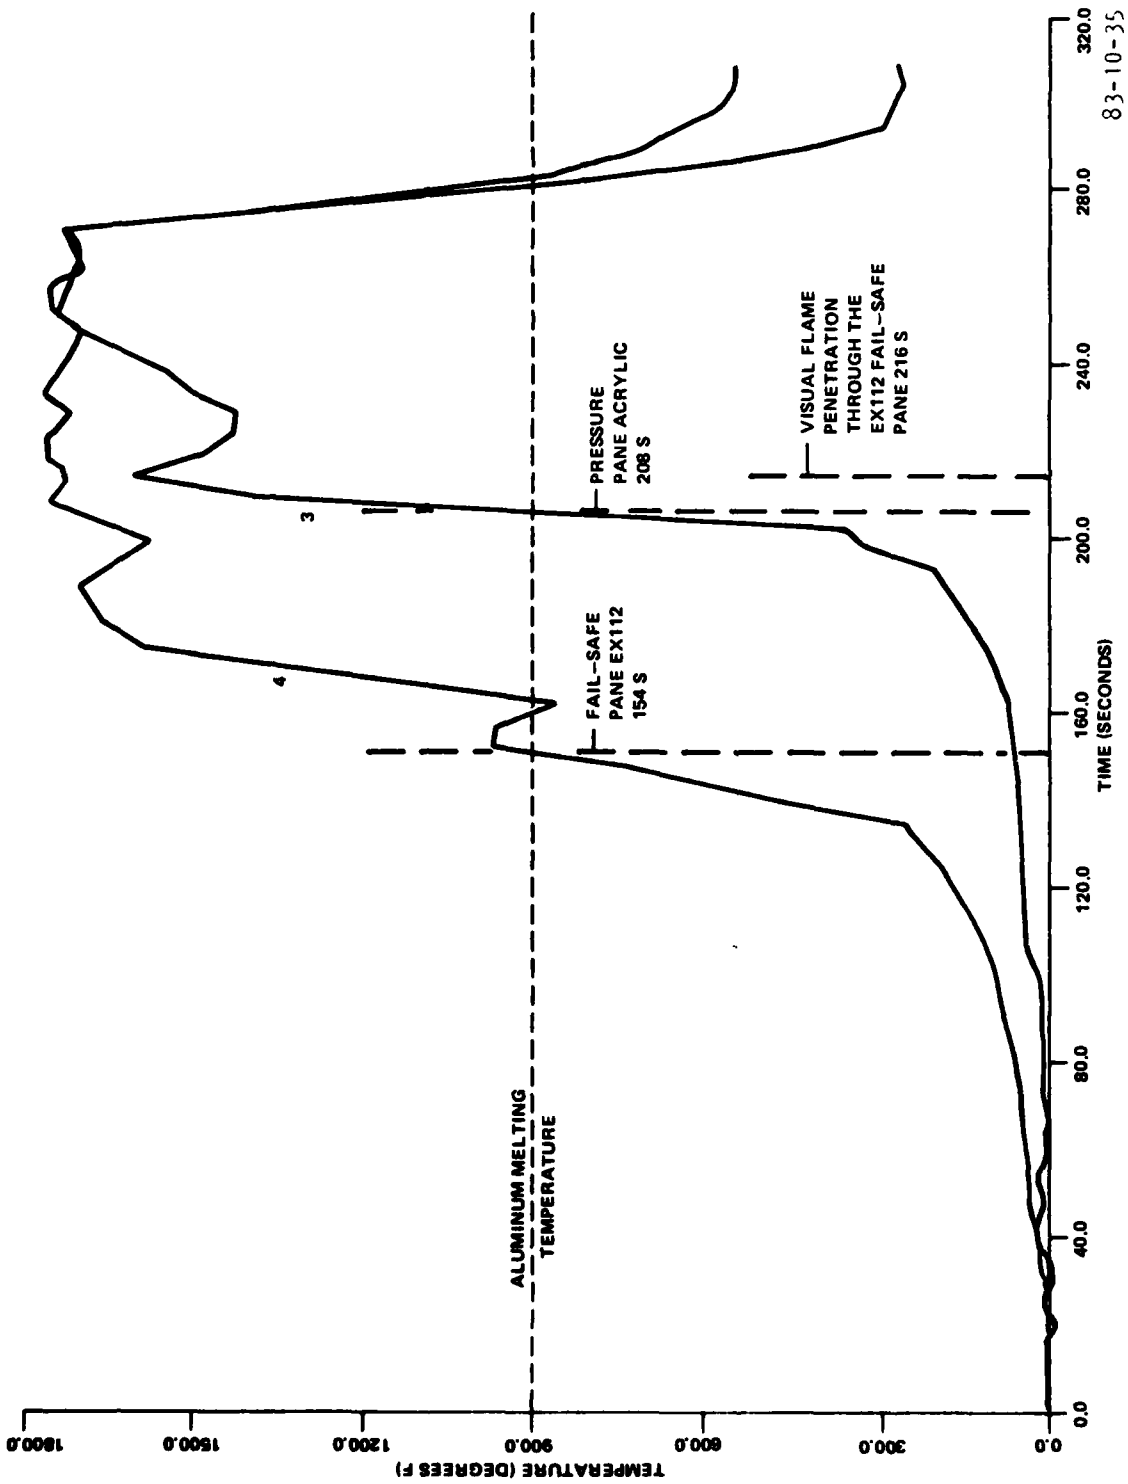
FIGURE 34. TEMPERATURE RISE OF THE THERMALLY IMPROVED (EX 112) WINDOW PANE AND STANDARD (ACRYLIC) PRESSURE PANE DURING FIRE EXPOSURE (TEST 4)

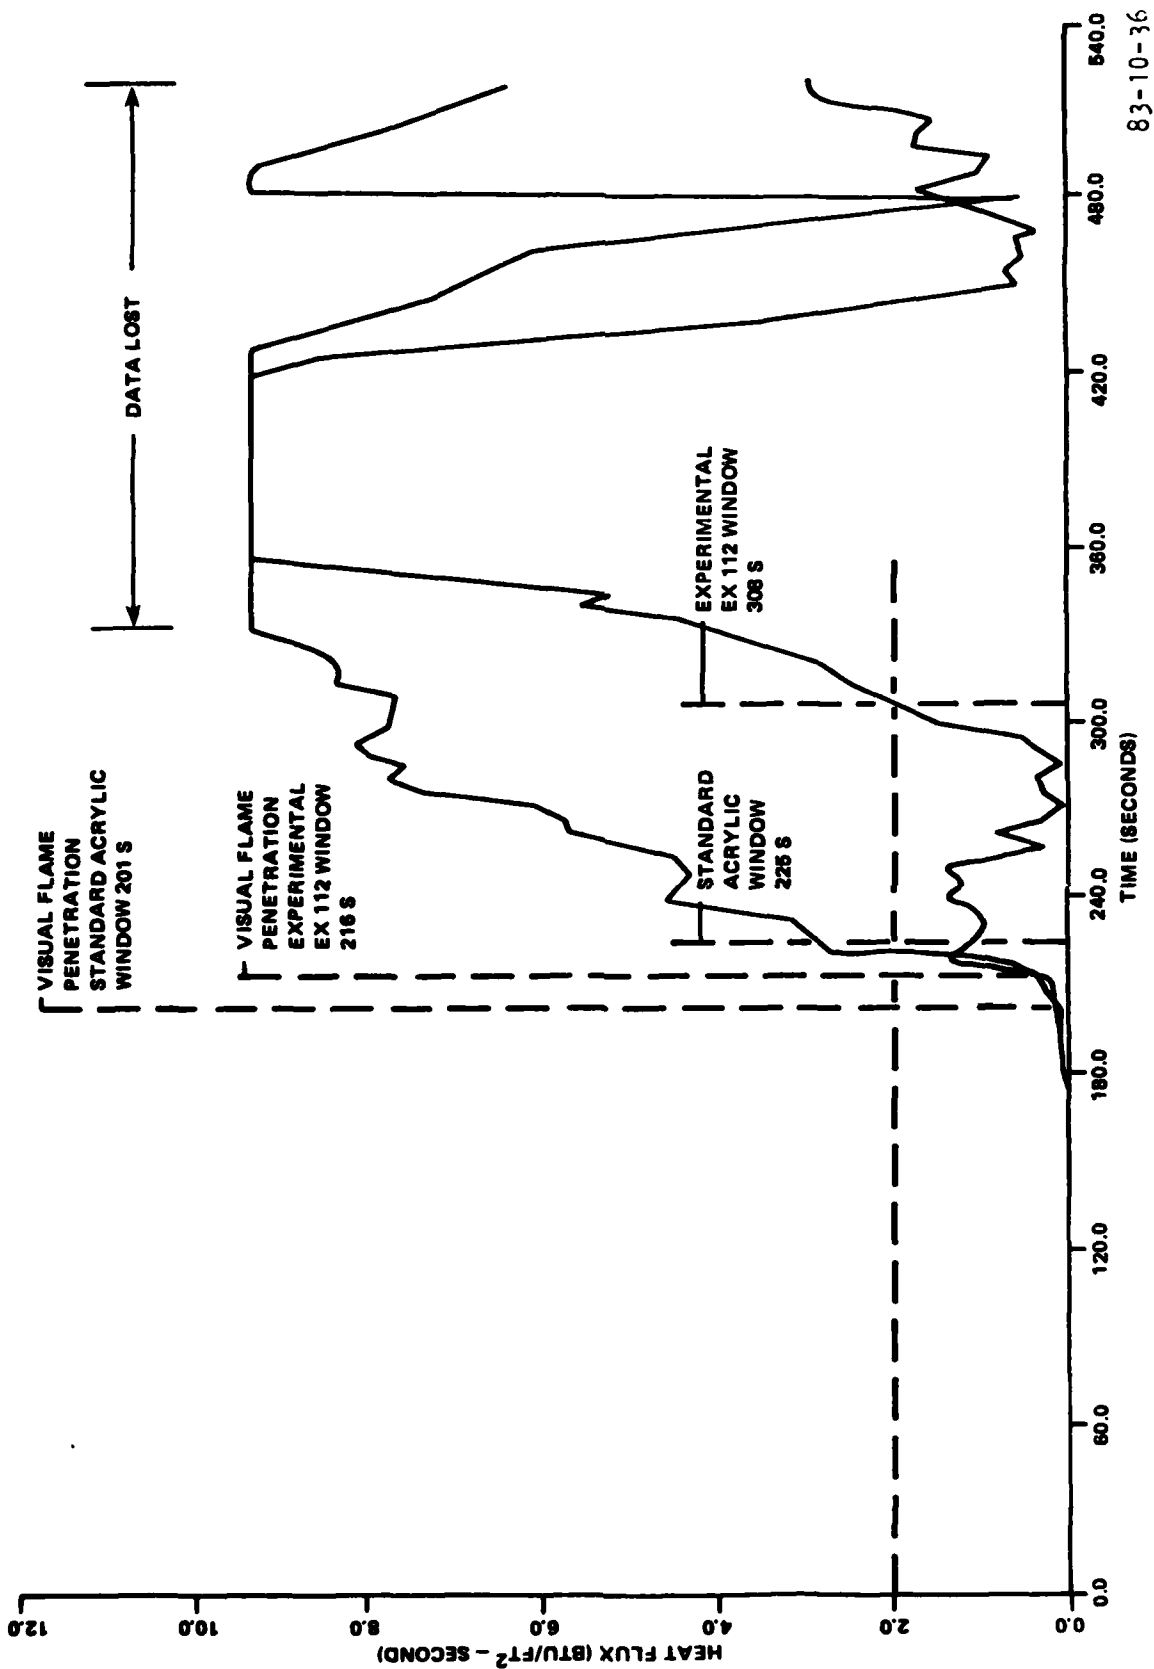
FIGURE 35. HEAT FLUX THROUGH THE STANDARD (ACRYLIC) AND THERMALLY IMPROVED (EX 112) WINDOWS DURING FIRE EXPOSURE (TEST 4)

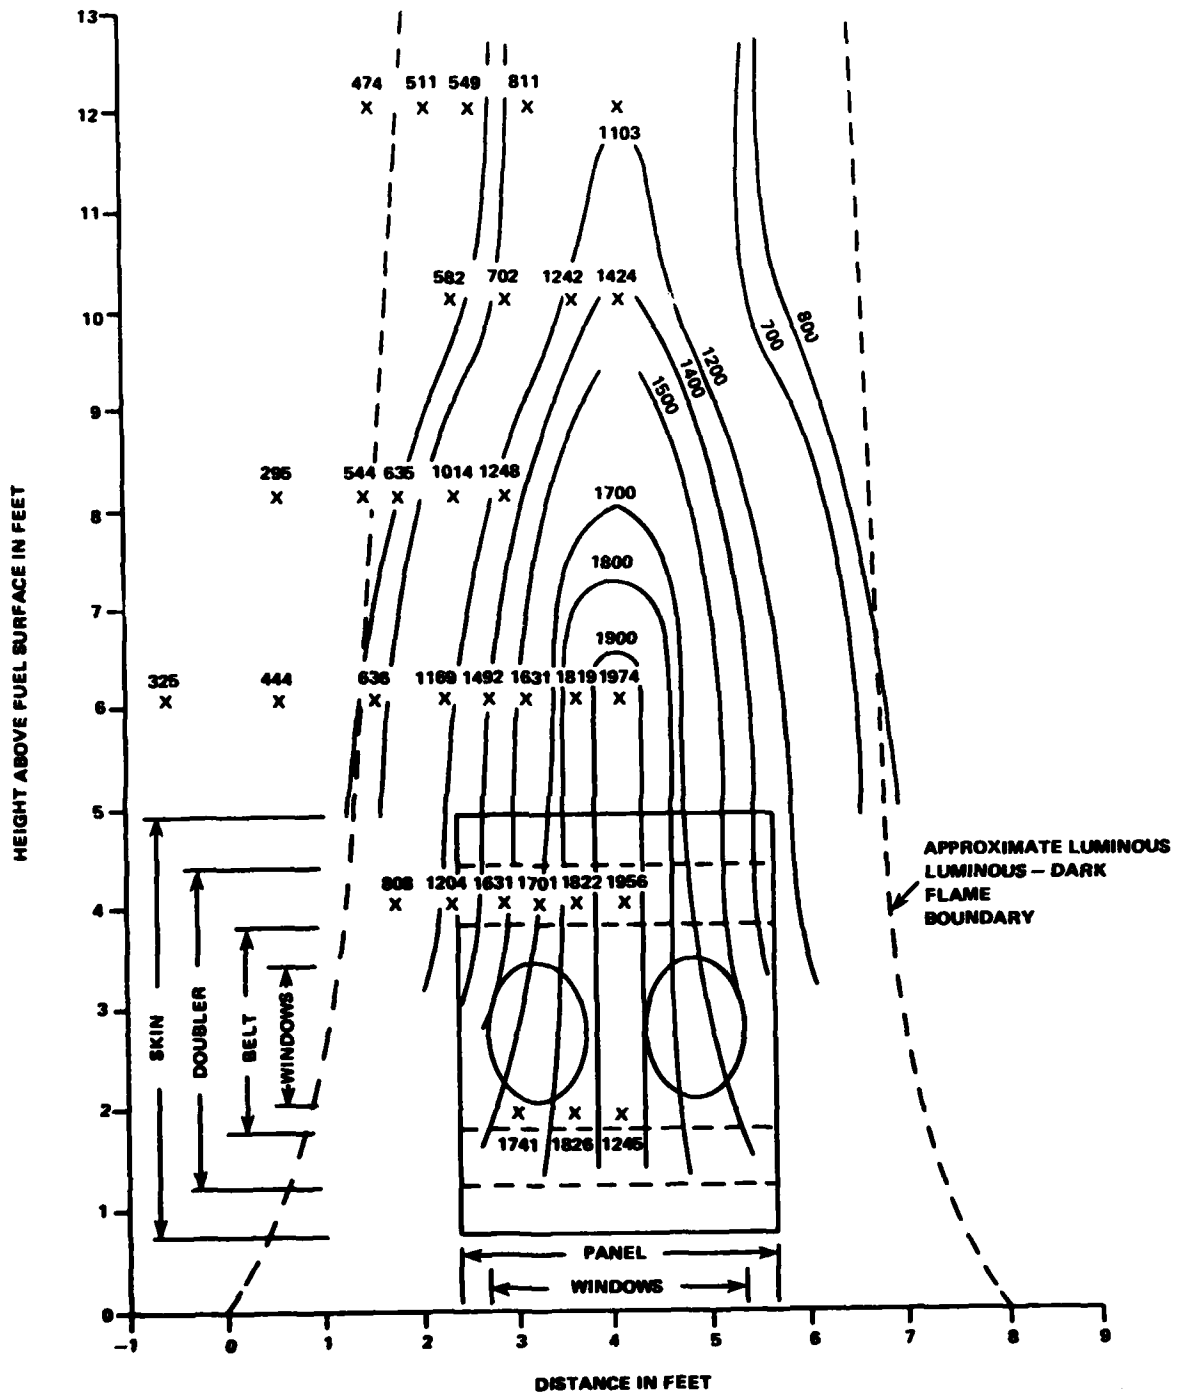
FIGURE B-1. FLAME PLUME TEMPERATURE PROFILES OF A FREE BURNING AVIATION FUEL FIRE SUPERIMPOSED OVER A DC-10 FUSELAGE WINDOW TEST SEGMENT IN THE C-133 TEST BED
