QUINNIPIAC RIVER BASIN
MERIDEN, CONNECTICUT
BRADLEY HUBBARD RESERVOIR DAM
CT 00132

PHASE I INSPECTION REPORT
NATIONAL DAM INSPECTION PROGRAM

SEPTEMBER, 1980

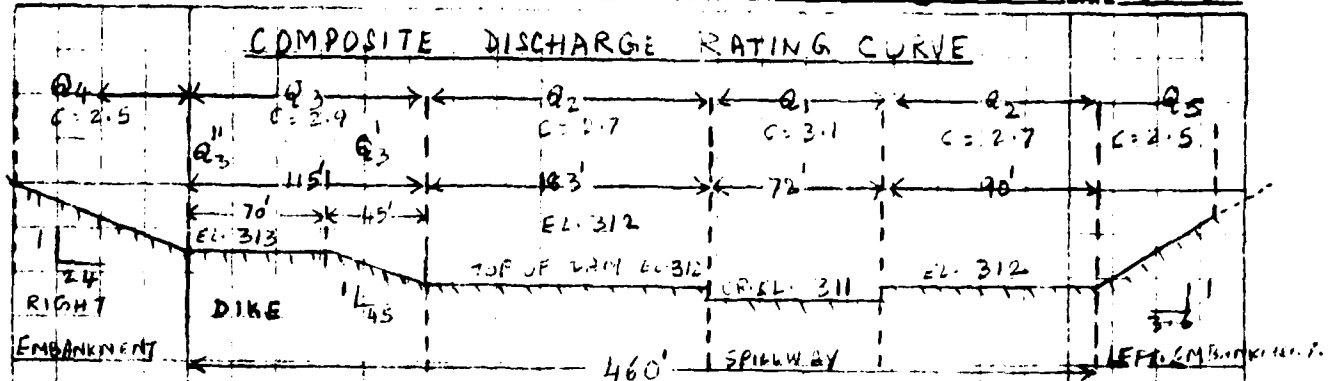
POTENTIAL OVERFLOW PROFILE

(BASED ON AVAILABLE INFORMATION & CE FIELD OBSERVATIONS)
