SECTION 32 PROGRAM
STREAMBANK EROSION CONTROL
EVALUATION AND DEMONSTRATION
WORK UNIT 2-EVALUATION OF EXISTING
BANK PROTECTION

FIELD INSPECTION OF SITES IN THE
MISSOURI RIVER DIVISION

Malcolm P. Keown, Elba A. Dardeau, Jr., Etta M. Causey

October 1980
Inspection Report 10

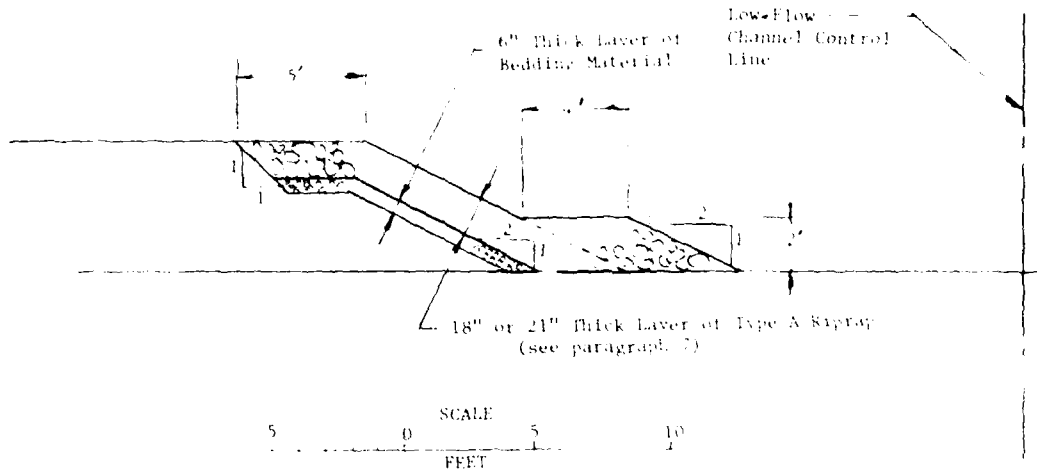
7. The side slopes of the low-flow channel were protected by an 18-in.-thick layer of Type A stone riprap placed over a 6-in.-thick layer of bedding material in reaches where minimum protection was required (Figure 4); in high-velocity or turbulent environments (bends, downstream from structures, etc.), a 21-in.-thick layer of Type B riprap was placed over the bedding material. Riprap was required at 12 locations through the Stage I reach (Figures 3 and 5) to stabilize the low-flow channel. All materials were brought onsite by truck; an orange peel bucket and crane was then used for below water placement, and a Gradall for above water placement. The Type A and Type B stone riprap was specified to meet the following gradations:

Figure 4. Little Blue River at Independence, Mo. Slopes of low-flow channel protected by stone riprap. (13 September 1948)

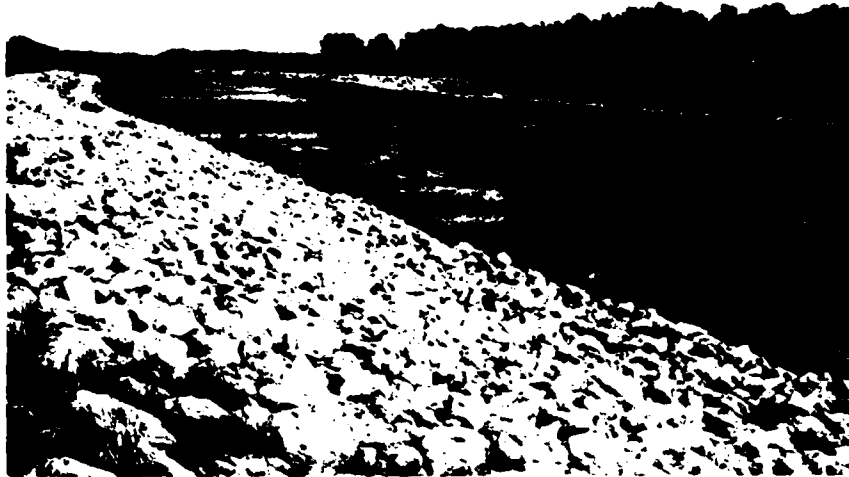
Figure 24. Republican River at Milford Dam Outlet Channel, Kans. General appearance of the middle reach of the outlet channel at the time of the May 1977 inspection. (Source: Reference 11)

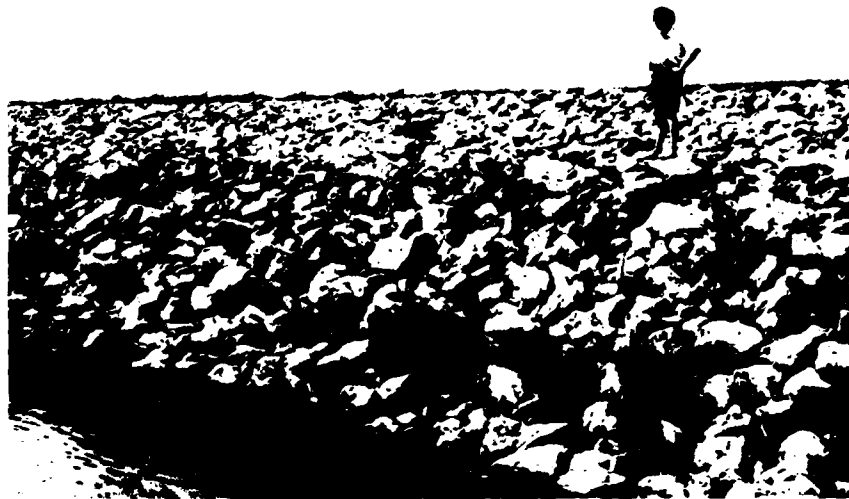
30. In December 1974, MRK inspected the outlet channel to evaluate the overall performance of the revetment toes. The inspection team found that the toes had performed their intended function well. The team probed the streambed at the base of the slope at several locations to determine the outer extremity of the riprap movement; in addition, they removed a small amount of rock to locate the original elevation of the base of the toe and to estimate the thickness of the stone layer formed by the downward movement of the riprap. They noted that the rock had moved downslope as the bed degraded until the bank was covered with a two-rock-diameter thickness. Approximately half of the toe stone was still in reserve at the original base of the revetment. The four special test sections were inspected in detail in order to compare the performance of the various toe geometries. MRK obtained surveyed cross sections that extended from the top of the revetment to the bed and a short distance out into the channel for each test section (Figures 20-23).

Figure 25. Republic River at Milford Dam Outlet Channel, Kans. Typical view of the revetment toes as seen by the MRD-MRK inspection team in May 1977. The engineer in the photograph is standing on the horizontal blanket at the break in slope between the blanket and the slope to the water. (Source: Reference 11)

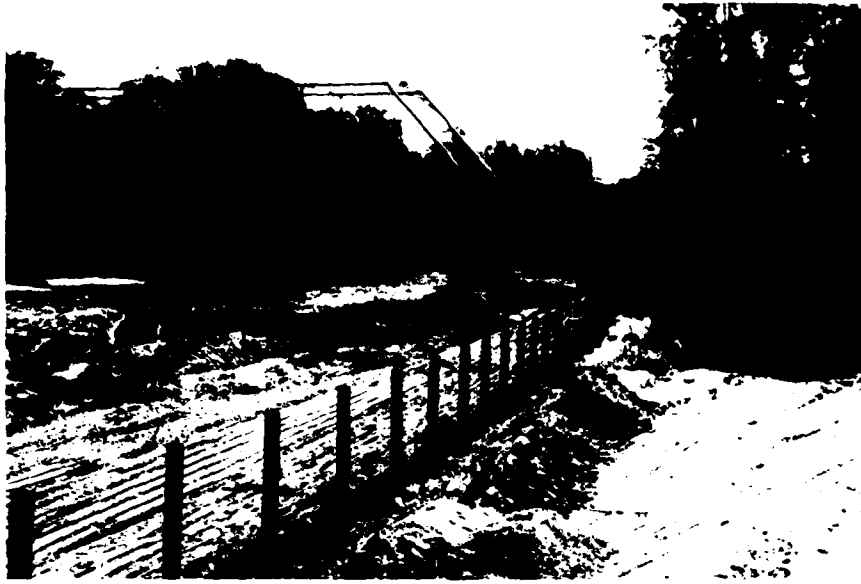
a. Downstream view of wire fence revetment. Schroyer Bridge is in the background

Figure 38. Big Blue River near Marysville, Kans. Two views of the completed project. (July 1977)

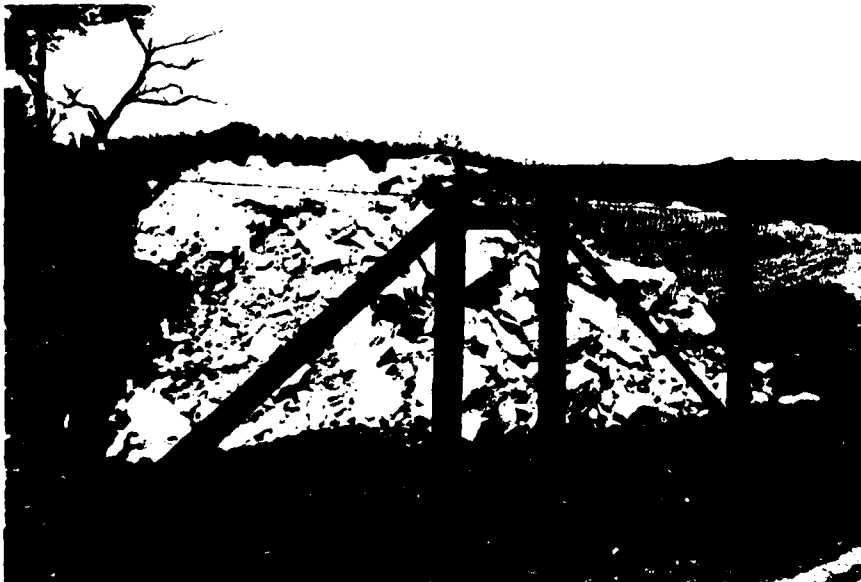
b. Wire fence revetment viewed toward end of dike 3

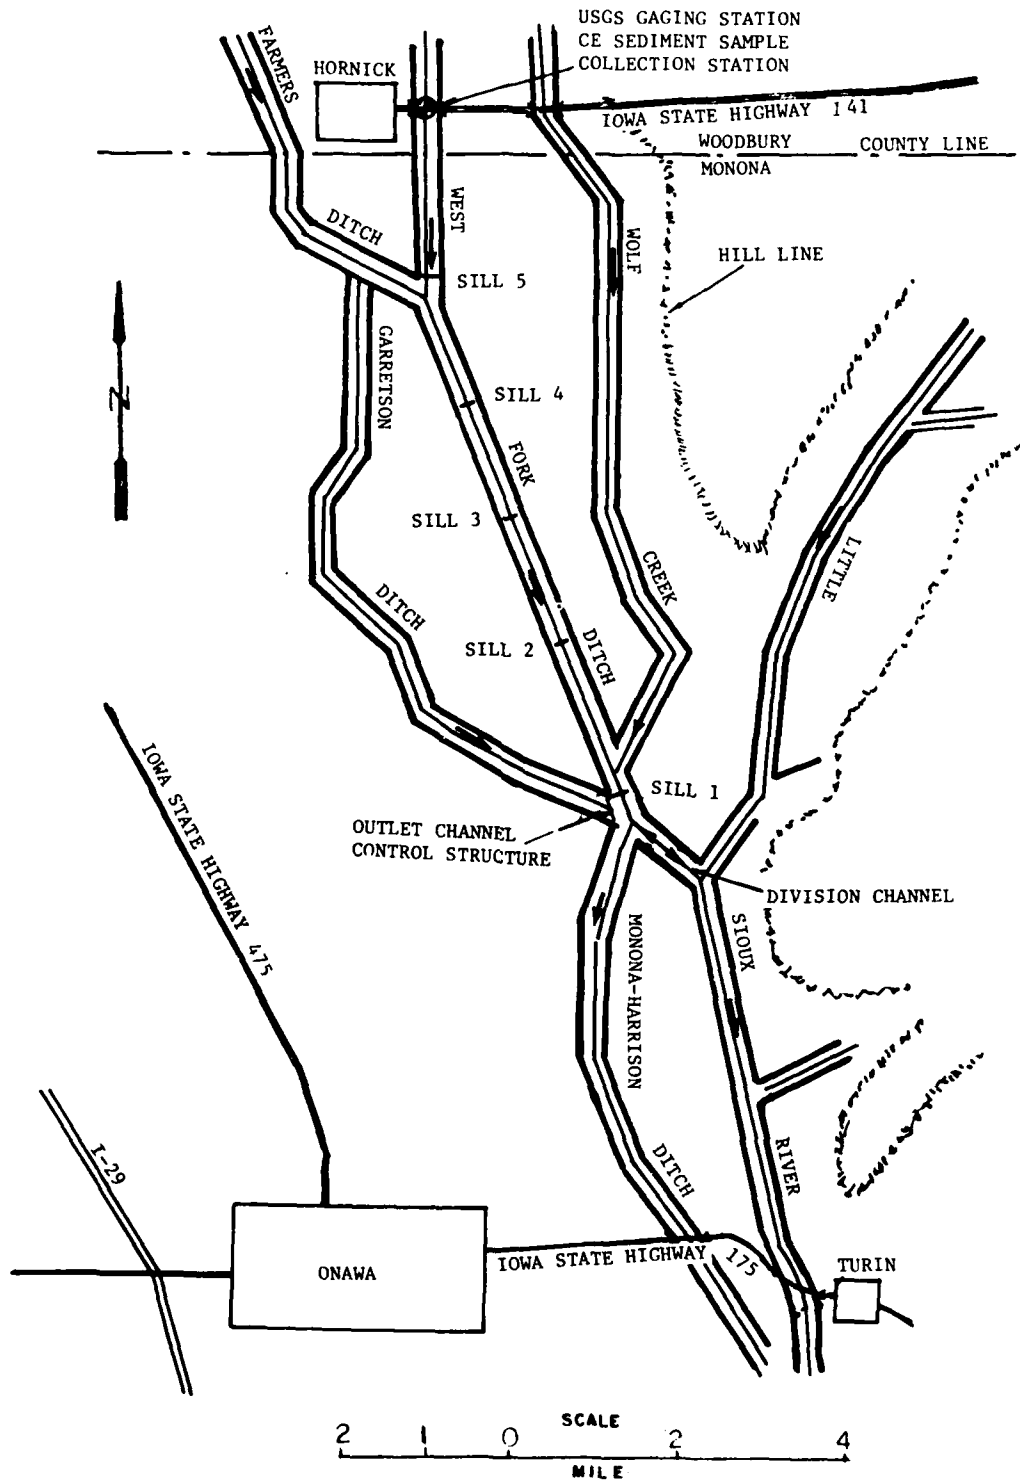
Figure 52. West Fork Ditch at Onawa, Iowa. Heavy lines paralleling streams represent levees

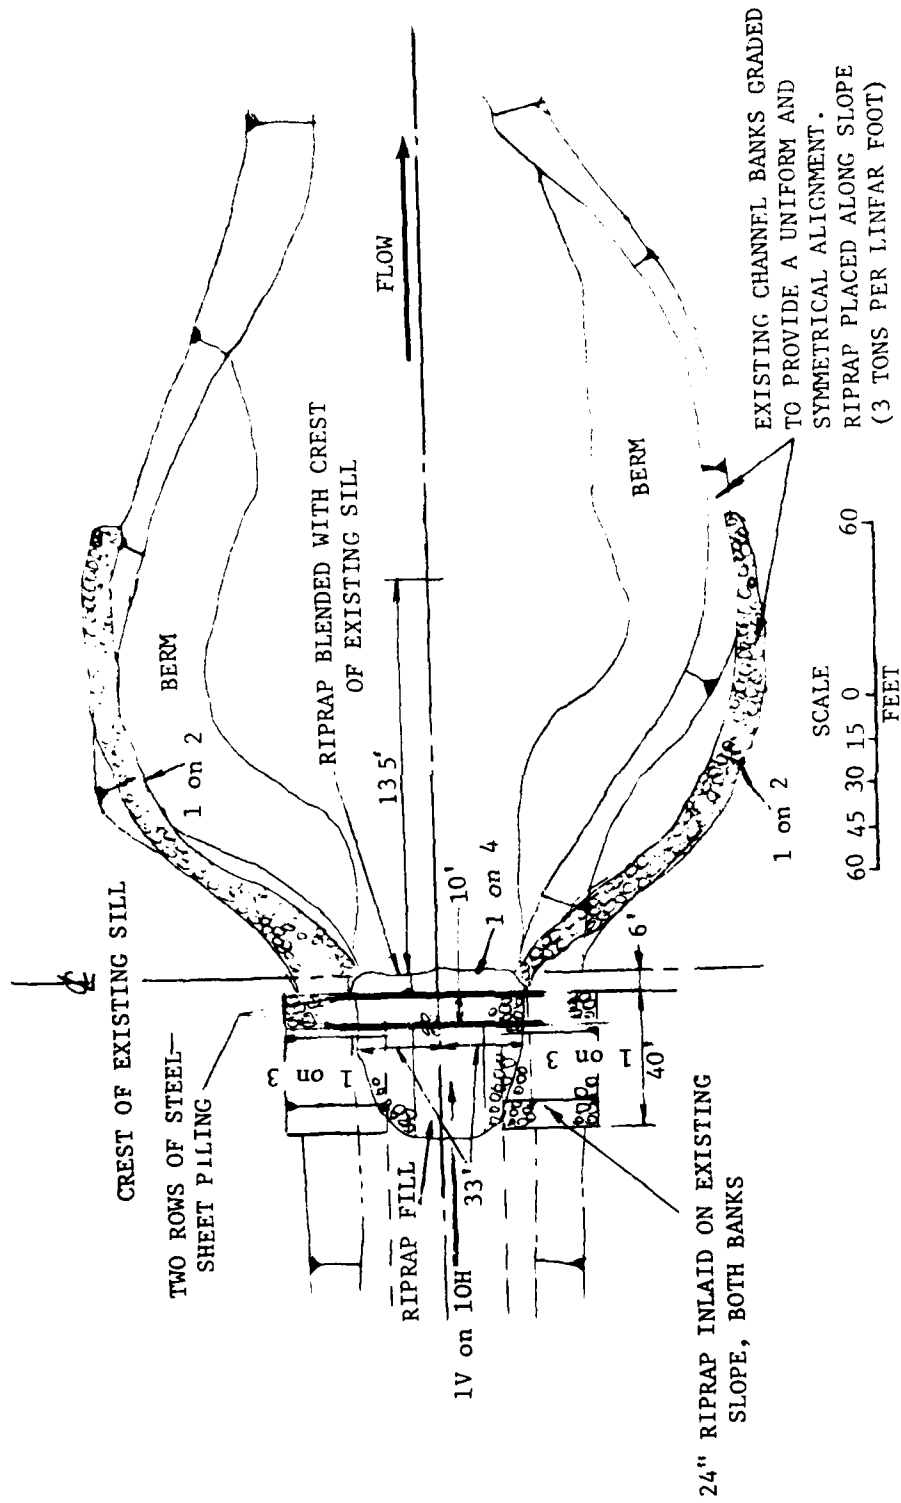
Figure 56. West Fork Ditch at Onawa, Iowa. Plan view of 1973 sill modification

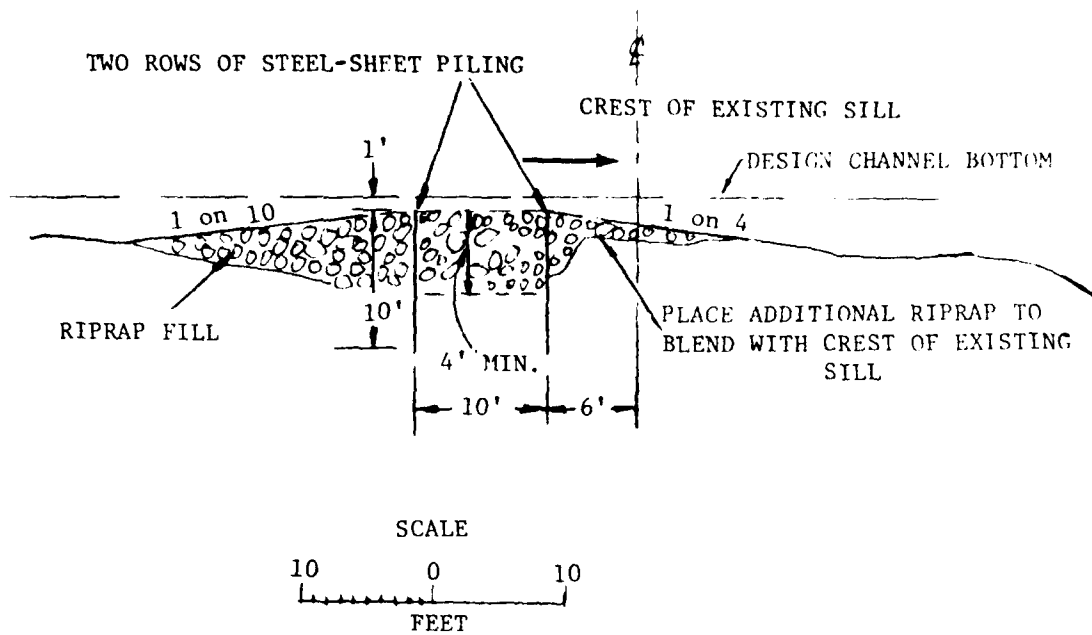
Figure 57. West Fork Ditch at Onawa, Iowa. Cross-sectional view (structure center line) of 1973 sill modification

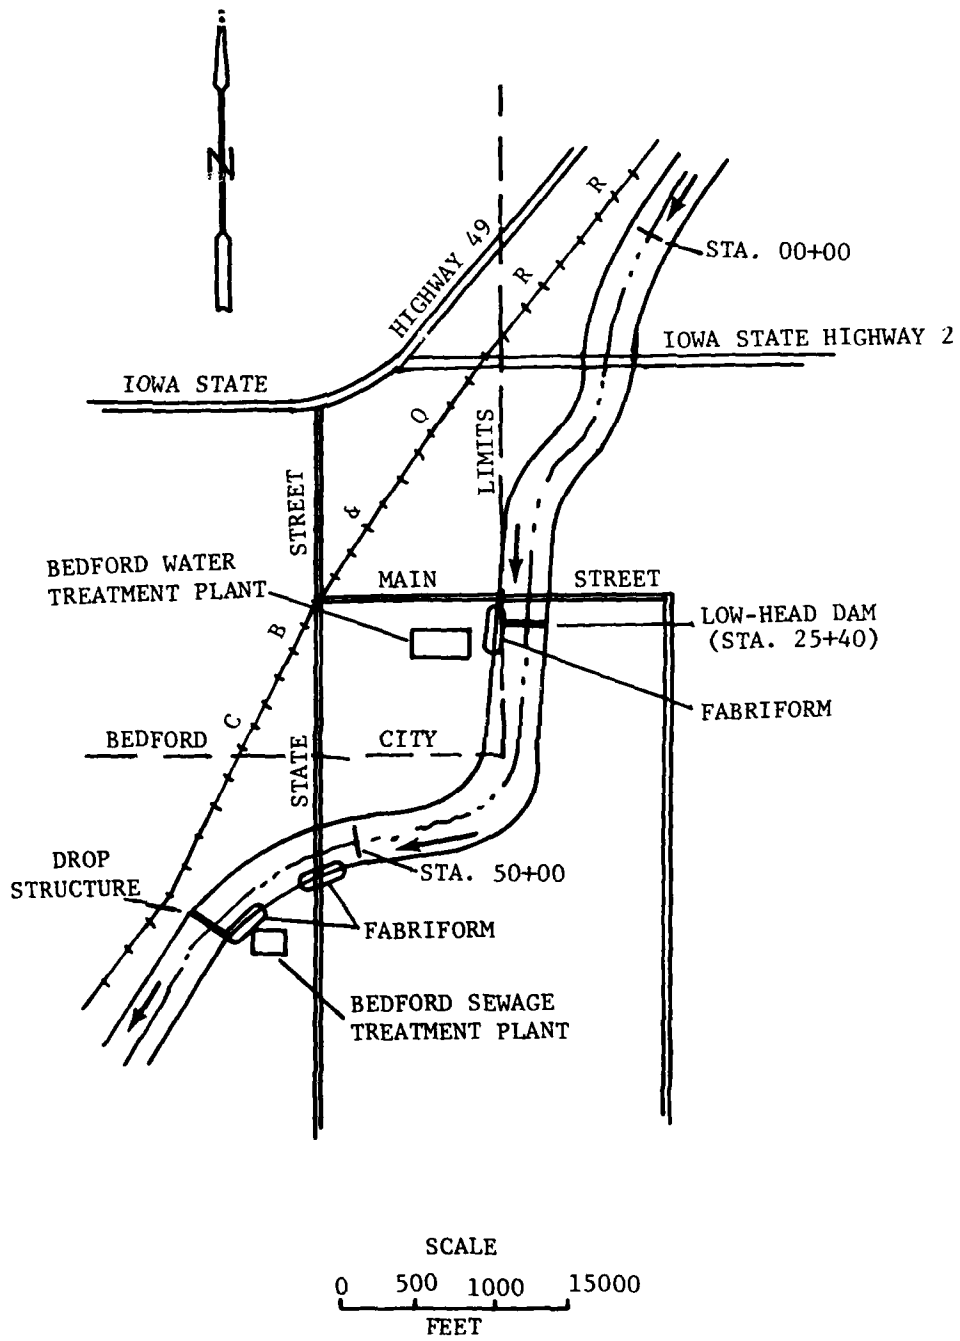
90. Flooding in October 1973 accelerated erosion adjacent to three existing facilities. Although channel degradation and bank erosion had occurred prior to the flood, the increased degradation and erosion worsened to such an extent at these locations that their safety was classified as critical. MRK specified the following emergency measures (Figure 67):

Figure 67. 102 River (East Fork) at Bedford, Iowa

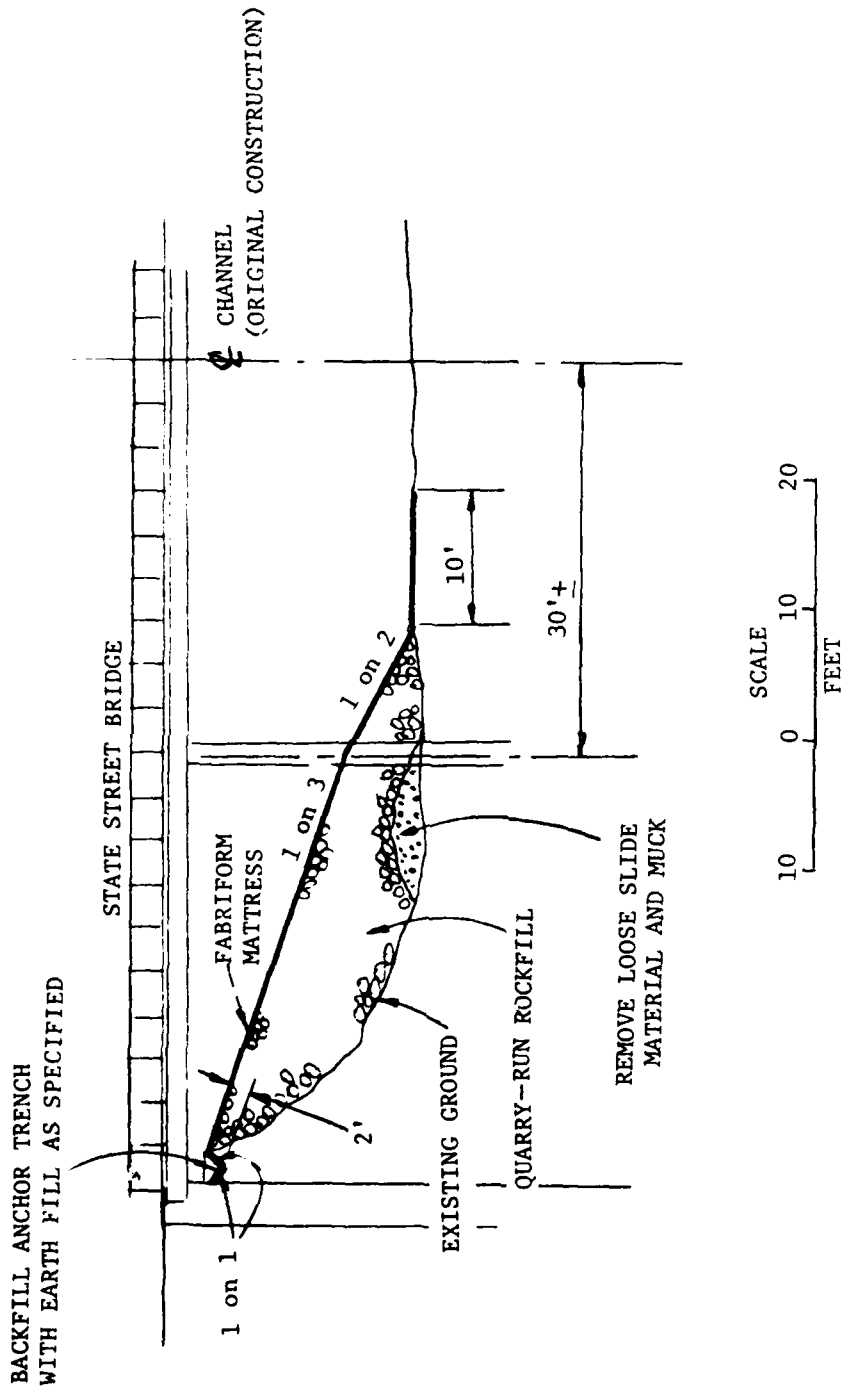
91. MRK chose to stabilize the slope at these three problem areas using Fabriform, manufactured by Construction Techniques, Inc., Cleveland, Ohio (Figures 68-71). Fabriform is a double-walled woven nylon material which is filled with fluid fine-aggregate concrete. The fabric was specified to be of the filter point type (8 in. between points), thus providing capability for drainage. Prior to placement of the Fabriform mattress the banks were shaped with quarry-run stone (no gradation specified; Figure 72). After placement of the mattress on the prepared bank, grout was pumped into the Fabriform. The grout was required to have the following specifications per cubic yard: Portland cement 900 to 1,000 lb, aggregate 2,200 to 2,000 lb, and water 570 to 610 lb. Air entrainment was specified to be in the range 3 to 6 percent of the total mixture.

Figure 68. 102 River (East Fork) at Bedford, Iowa. Fabriform revetment on left bank at State Street Bridge (sta 52+42)
