MOUNT HIGBY RESERVOIR DAM  
CT. 00140

PHASE I INSPECTION REPORT  
NATIONAL DAM INSPECTION PROGRAM

FEBRUARY, 1979

Identification No: CT 00140  
Name of Dam: Mount Higby Reservoir Dam  
Town: Middletown  
County and State: Middlesex County, Connecticut  
Stream: Fall Brook  
Date of Inspection: 8 November 1978

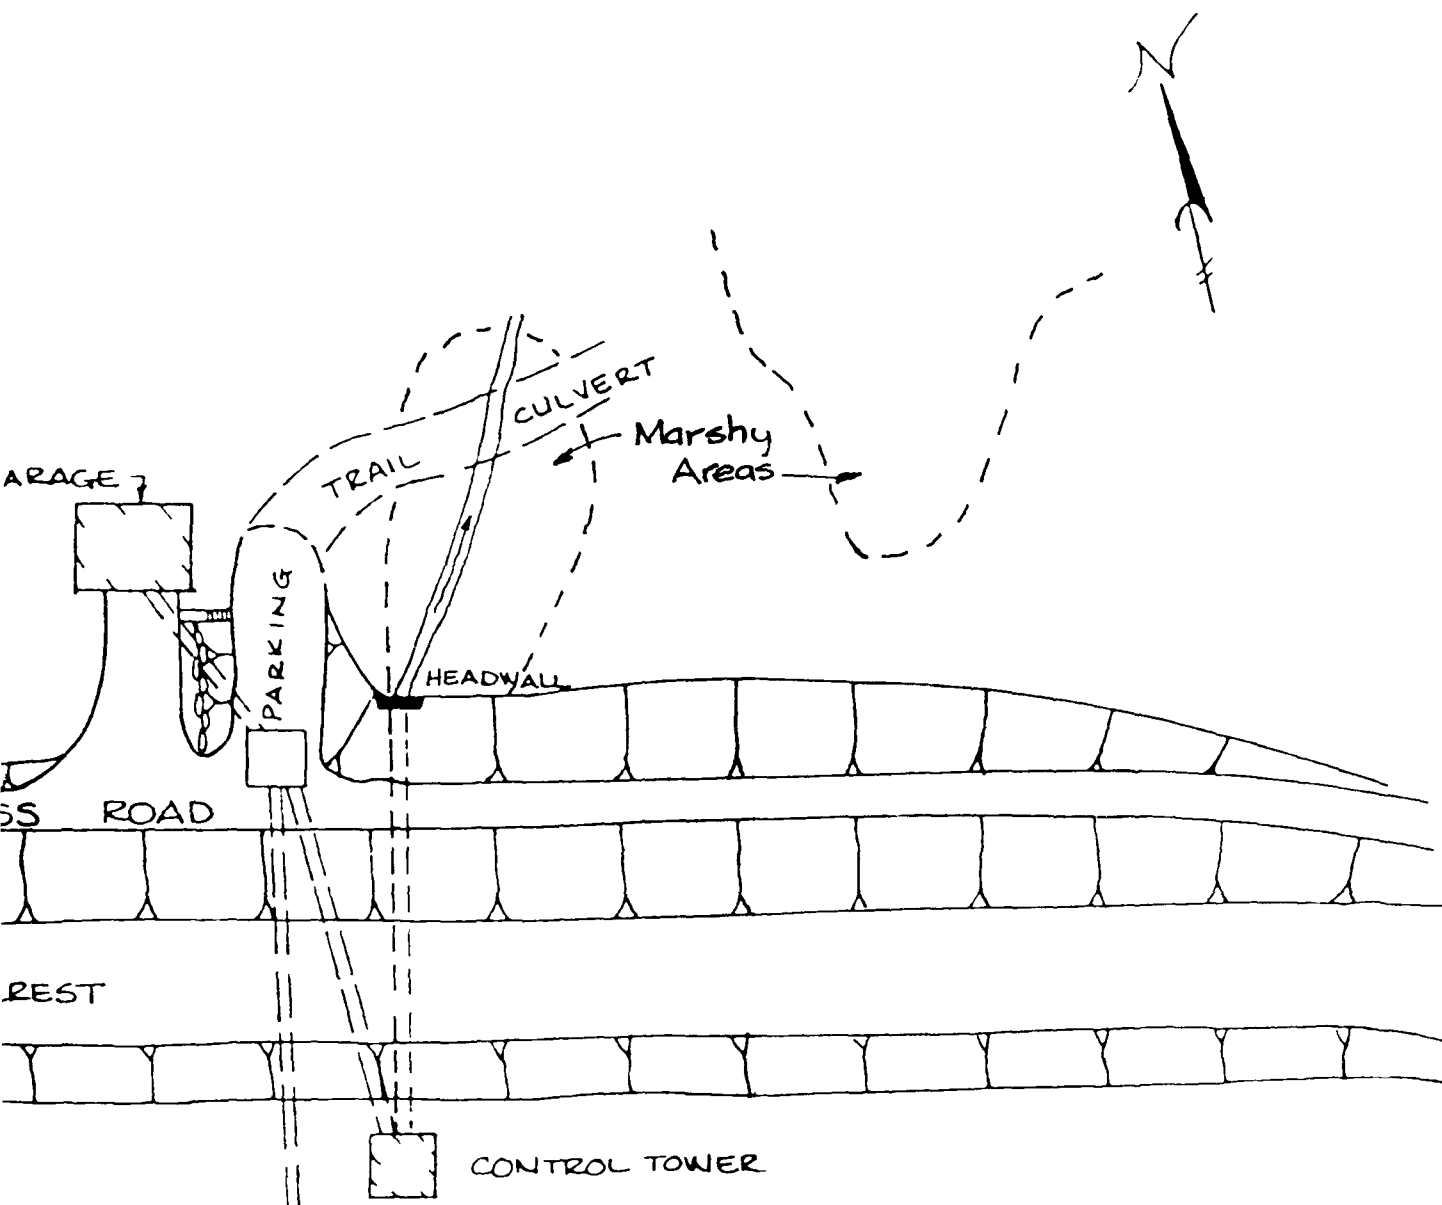
SKETCH PLAN & PROFILE  
FIGURE 1 - SHEET D-1

The left abutment appears to be founded on bedrock, as evidenced from rock outcrops along the spillway channel. The right abutment foundation material is not known. Sketch plans and profiles of the dam and appurtenant structures are shown on Figure 1, Sheet D-1, Appendix D.

No data on the design of the dam or appurtenances has been recovered and probably none exist. In the course of the inspection, measurements were taken and a sketch plan and profile layout of Mount Higby Reservoir Dam and appurtenances has been prepared. These sketches are shown on Figure 1 in Appendix D.

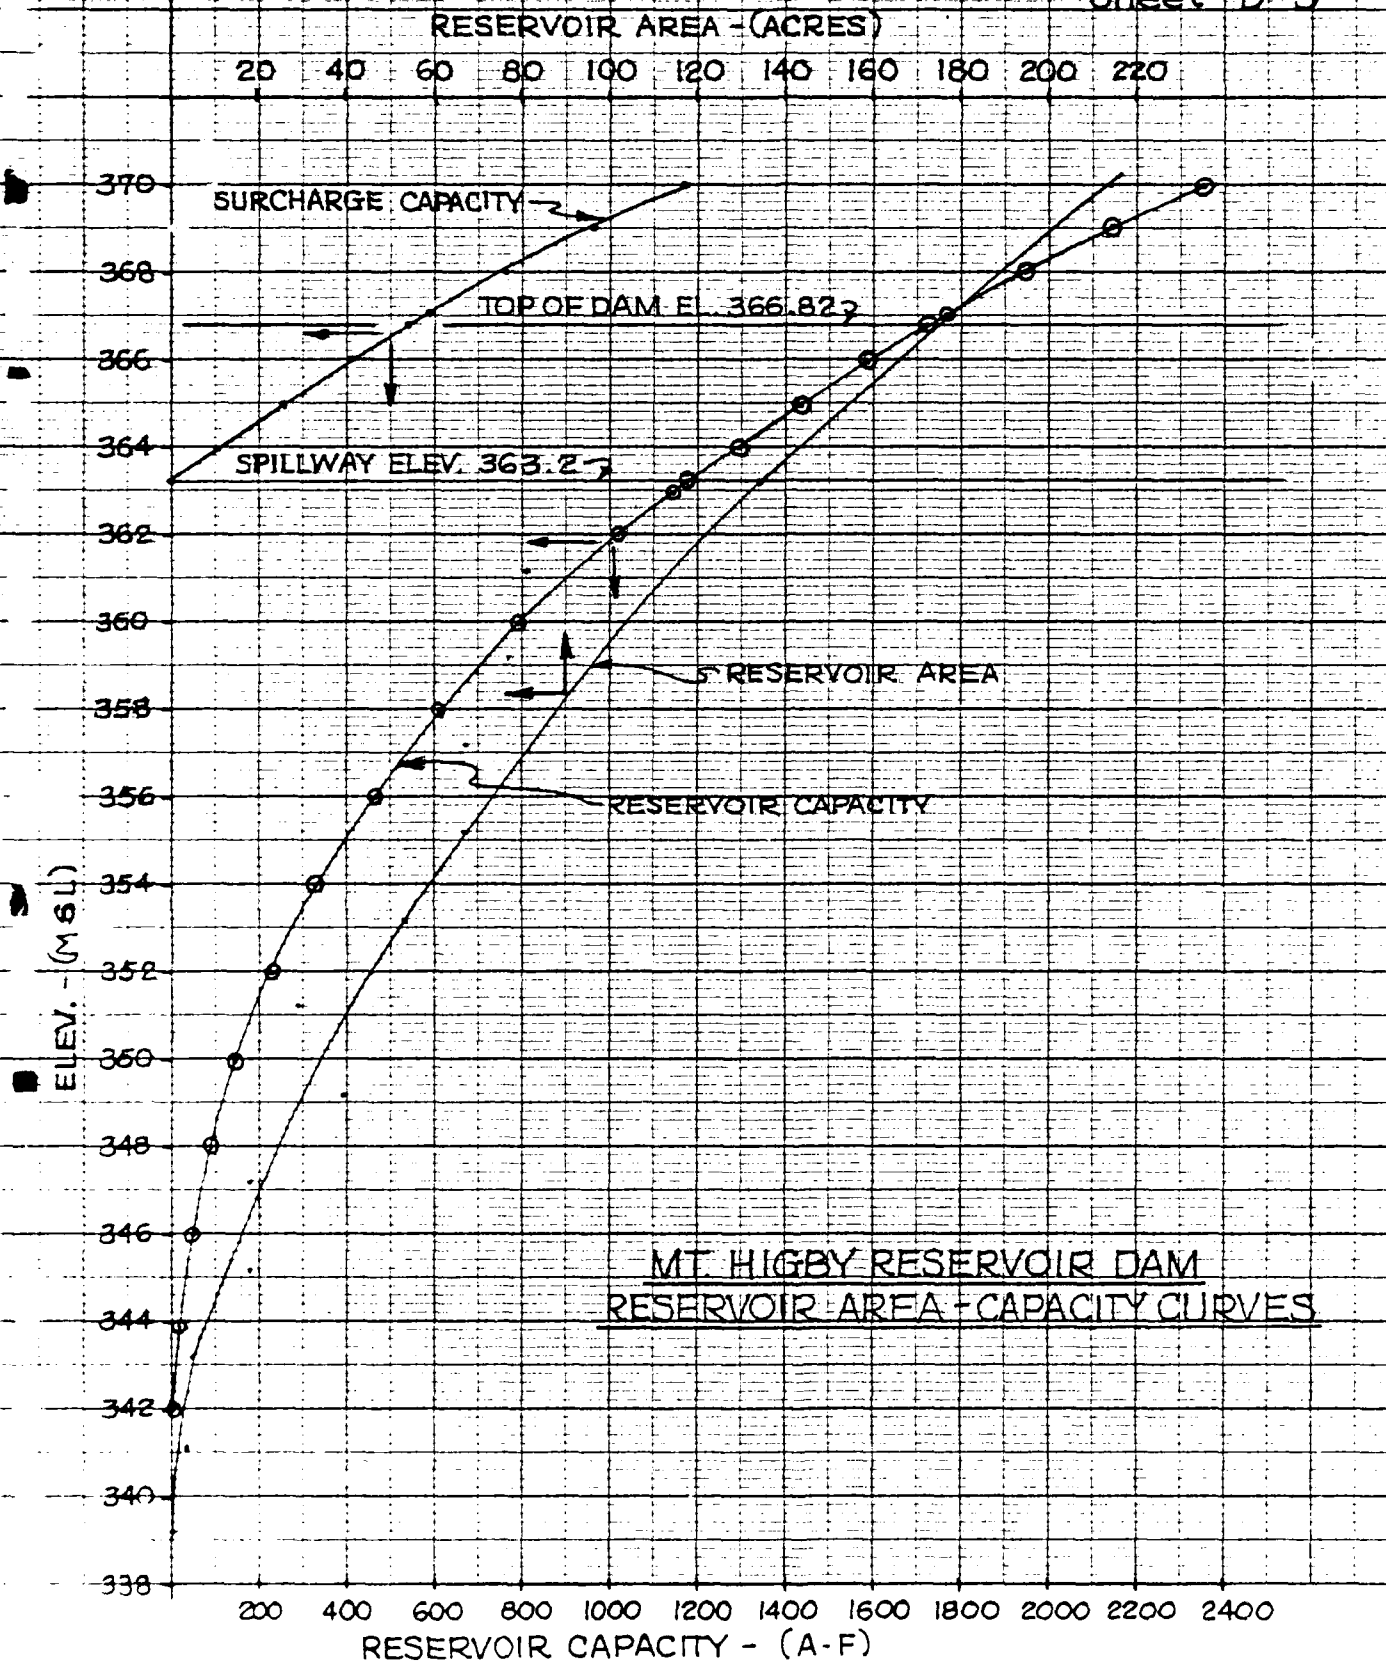
FIGURE 3  
Sheet D-5

Reservoir area and capacity curves and tables, for use in flood routings, are shown on Fig. 3, Sheet D-5 and Sheet D-6, Appendix D. For determining surface areas and surcharge capacities, planimetered areas were taken from contours delineated on USGS 2,000 ft. per in. quadrangle sheets.

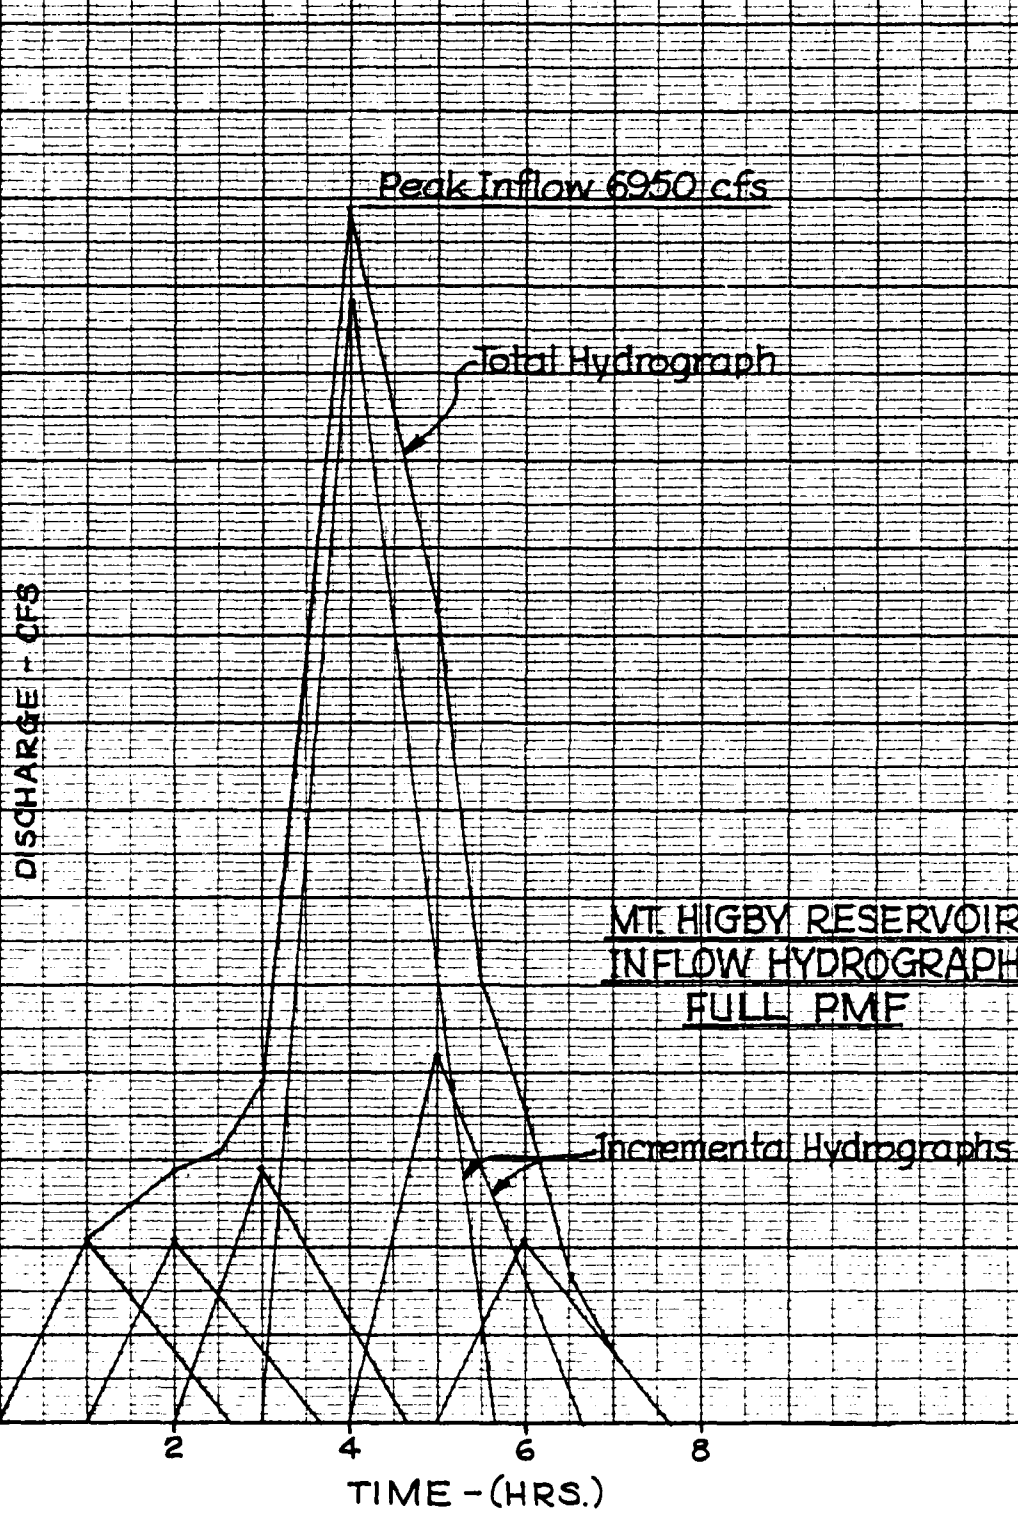
FIGURE 4  
Sheet D-9

A triangular incremental unitgraph was assumed for the inflow hydrographs, using a computed lag time value of 0.7 hours to derive a time-to-peak for the triangular hydrograph of 1 hour (see computations on Sheets D-7 and D-8, Appendix D). A PMF inflow hydrograph is shown on Fig. 4, Sheet D-9, Appendix D, indicating a peak inflow of about 6,950 cfs or a CSM of about 4,800.

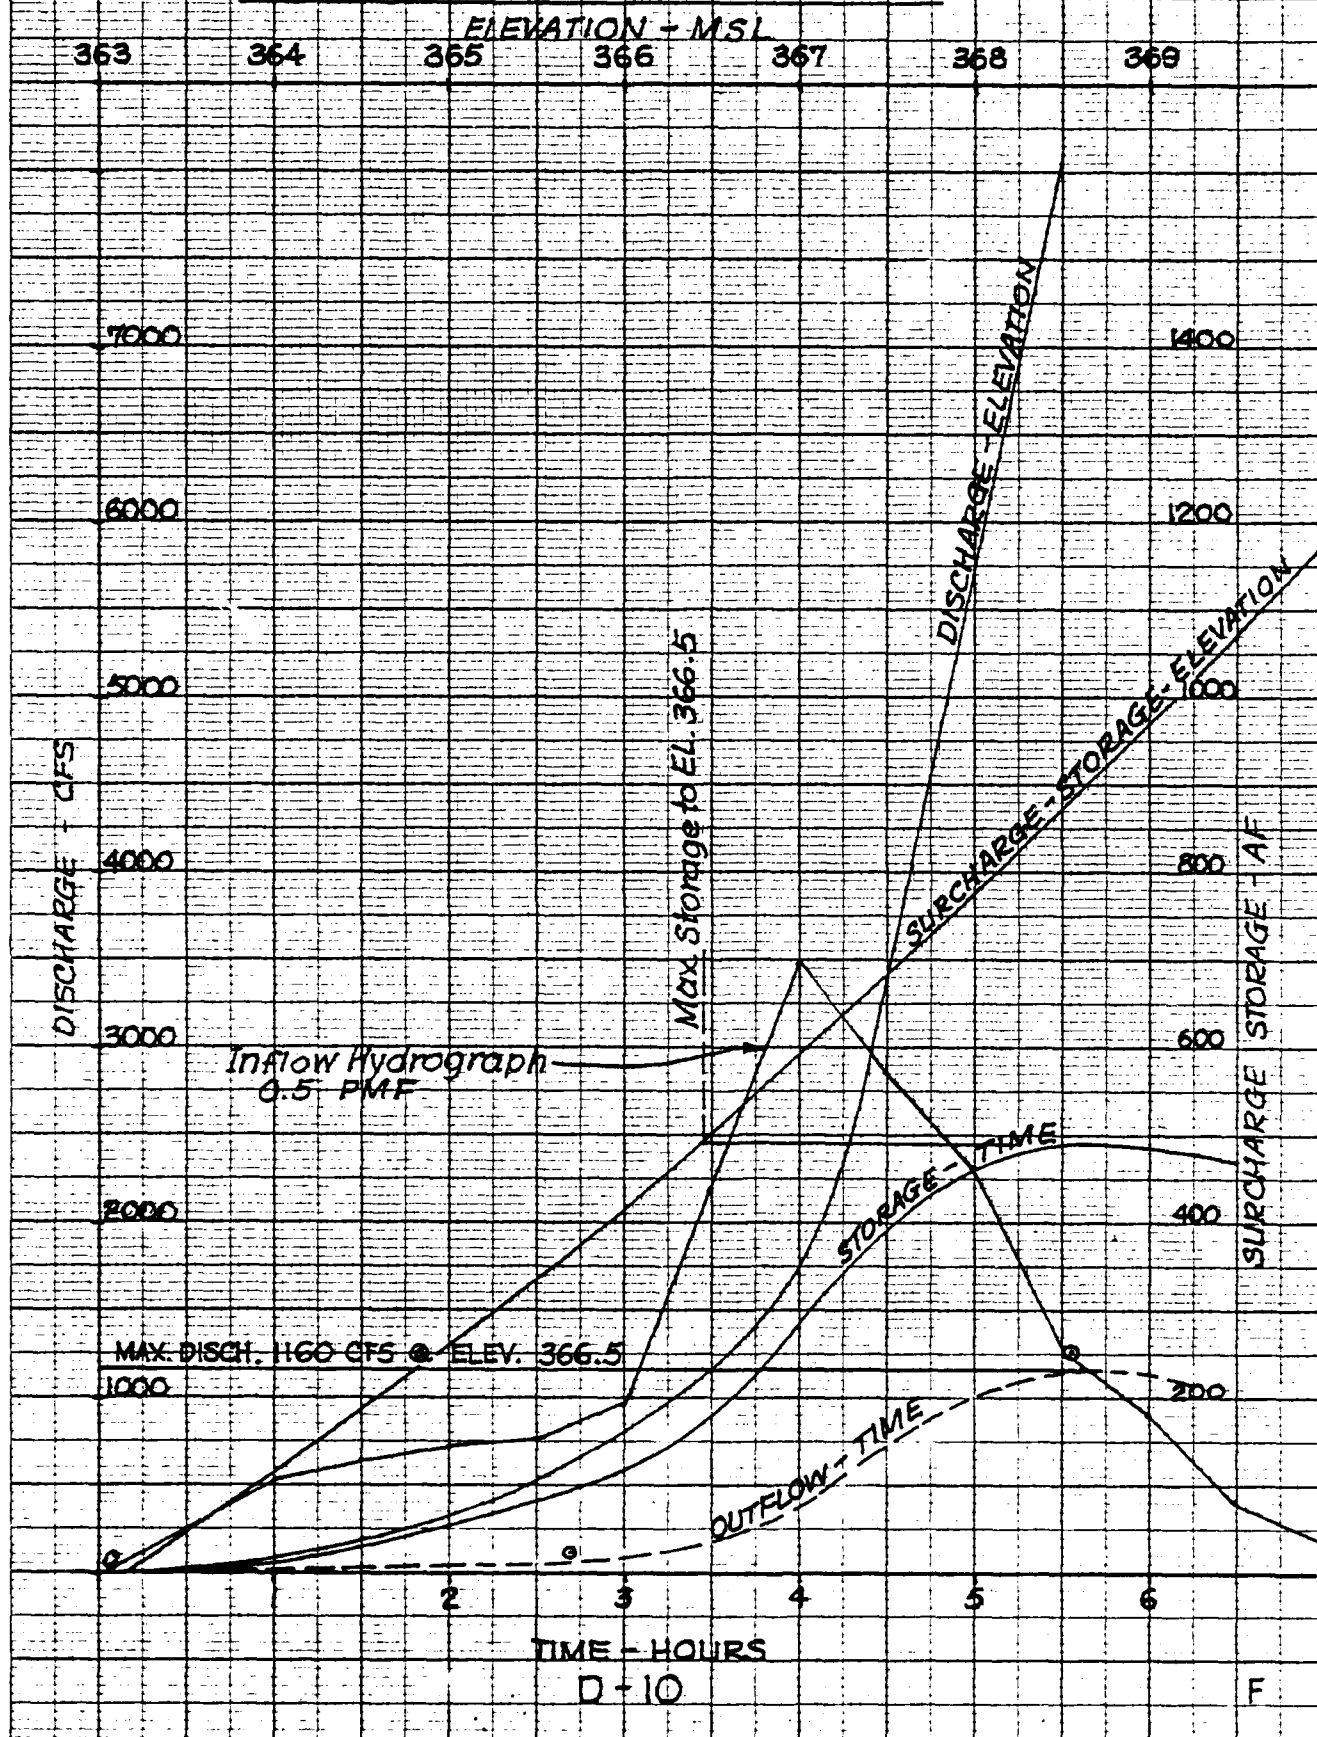
FIGURE 5  
Sheet D-10

Flood routings were performed for both  $\frac{1}{2}$  and full PMF. Results of these routings are shown on Figures 5 & 6, Sheets D-10 and D-11, and are summarized as follows:
