NATIONAL PROGRAM FOR INSPECTION OF NON-FEDERAL DAMS
MULBERRY RESERVOIR DA. (U) CORPS OF ENGINEERS WALTHAM
MA NEW ENGLAND DIV JAN 80

SERRY RESERVOIR DAM
CT 00130

PHASE I INSPECTION REPORT
DAM INSPECTION PROGRAM

JANUARY 1980

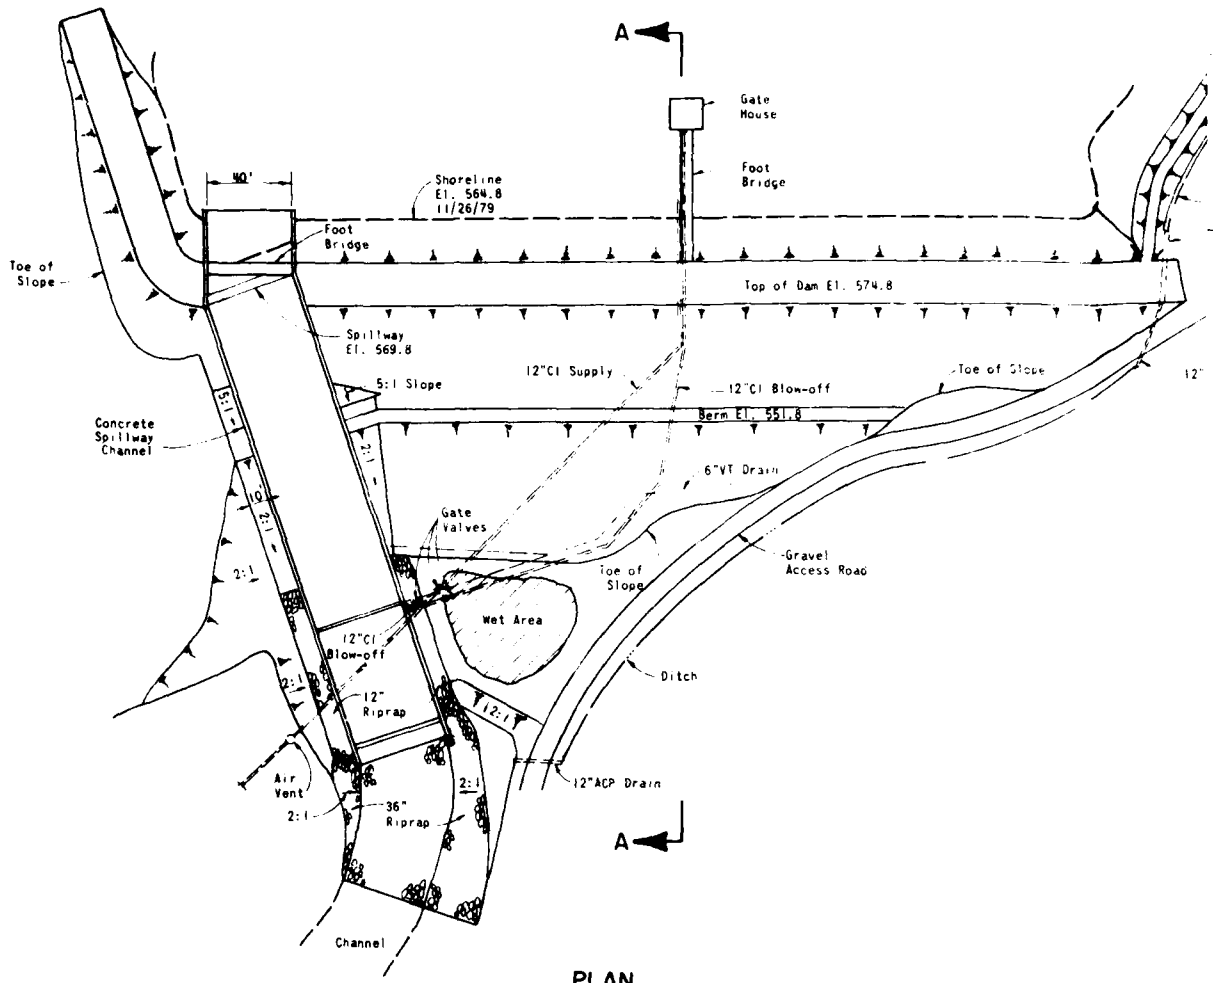
FIGURE 2

Field inspections and surveys revealed that the dam was constructed substantially as shown on the plans. The dike which forms a diversion channel and the pipe installed at the left end of the dam (See Figure 2, Appendix B) to divert an area of undesirable water quality away from the reservoir are not shown on the construction plans.

There are no indications of instability along the edges of the reservoir in the vicinity of the dam. At the left abutment a small dike forms a channel for diversion of a drainage area with poor water quality away from the reservoir and into a 24-inch pipe with an invert elevation of 571.2 or 1.4 feet above spillway level. The pipe passes through the dam and exits to the ditch on the left of the gravel access road as a 12-inch diameter pipe (See Figure 2, Appendix B).
