MECHANICSVILLE DAM

CT 00182

PHASE I INSPECTION REPORT
NATIONAL DAM INSPECTION PROGRAM

SEPTEMBER, 1979

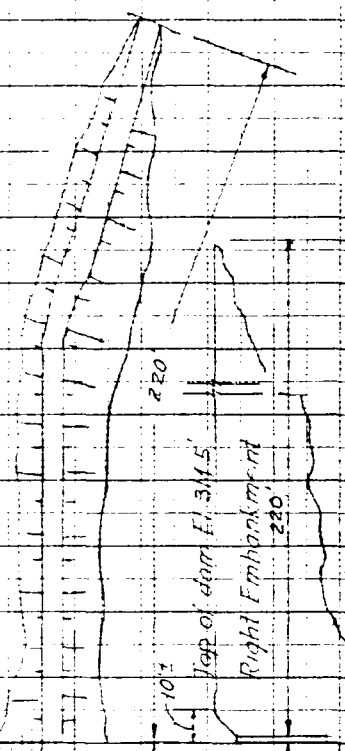
PROFILE ALONG CREST OF DAM & RIGHT DIKE

Bridge deck - partly deteriorated
 Crest of overflow - Assumed Elav. 305.0 Discharge 8/21/79 = 300 cfs.
 Laid up rock dam - unmortared joints
 Replacements with concrete at selected locations where original blocks were displaced (not continuous)
 Concrete sill slabs
 RIVERBED El. 290 ±
 Scour hole below apron
 Depth of scour unknown
 Apron about 1 ft above tailwater 8/21/79
